1958 වර්ෂය සඳහා පුරාවිද්‍යා කොමසාරිස් තැනගේ පාලන වාර්තාව

Administration Report of the Archaeological Commissioner for 1958

P. E. P. Deraniyagala, Esq.

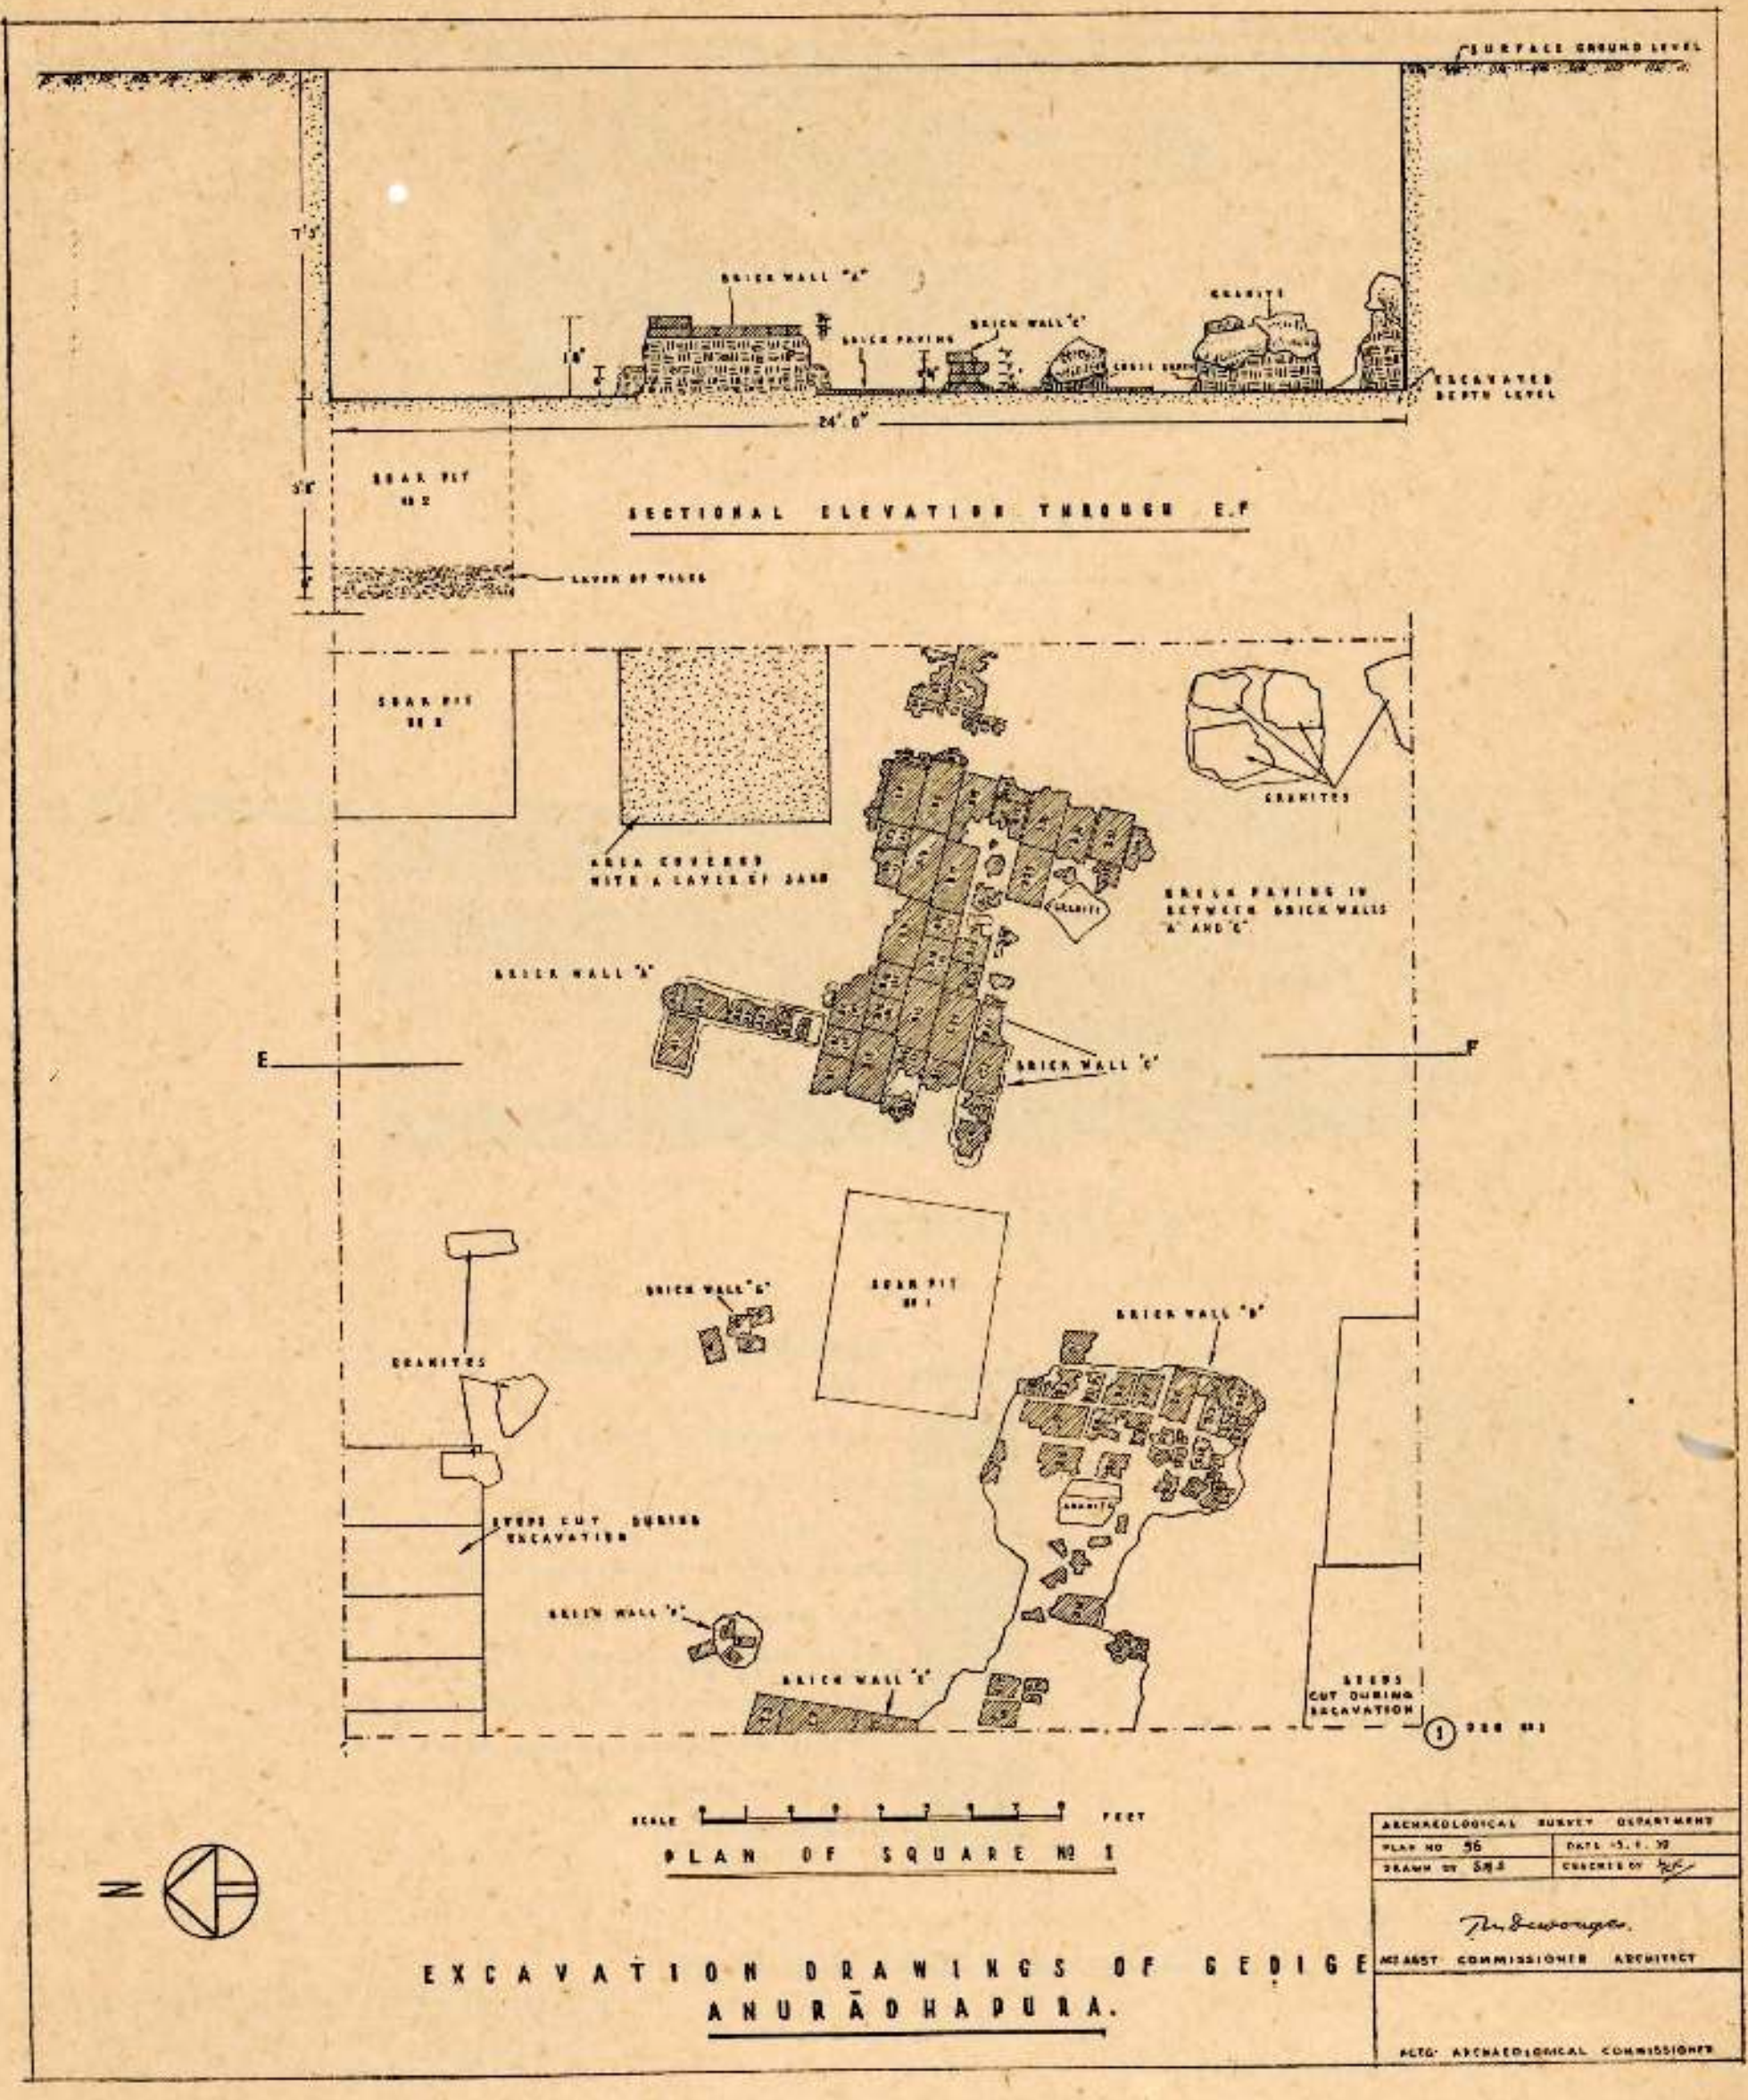
APPENDIX II (a)
II වැනි උපග්‍රන්ථය (අ)

Pit One. (Vide appendix II (*a*)) The layer of top soil, which had an average depth of 13 in., was very dry, compact, and very dark in colour. Only a few sherds were in it. At a depth of 16 in. from the surface, a glazed sherd with traces of mica, and a bead were found. The layers with plenty of sherds, commence from the depth of 21 in. and continue regularly down to the depth of 11 ft. the maximum reached so far. Various kinds of sherds varying in colour, decorations and technique belonging to vessels of different shapes and sizes were secured. More or less the same distribution of the sherds in the various levels has been observed in the pits that have so far been dug ; thus a relative chronology of the pottery can be traced, and later on, when the digging will be extended and other elements of details will be available, for perfecting an absolute chronology which will be of the greatest help in further excavations.

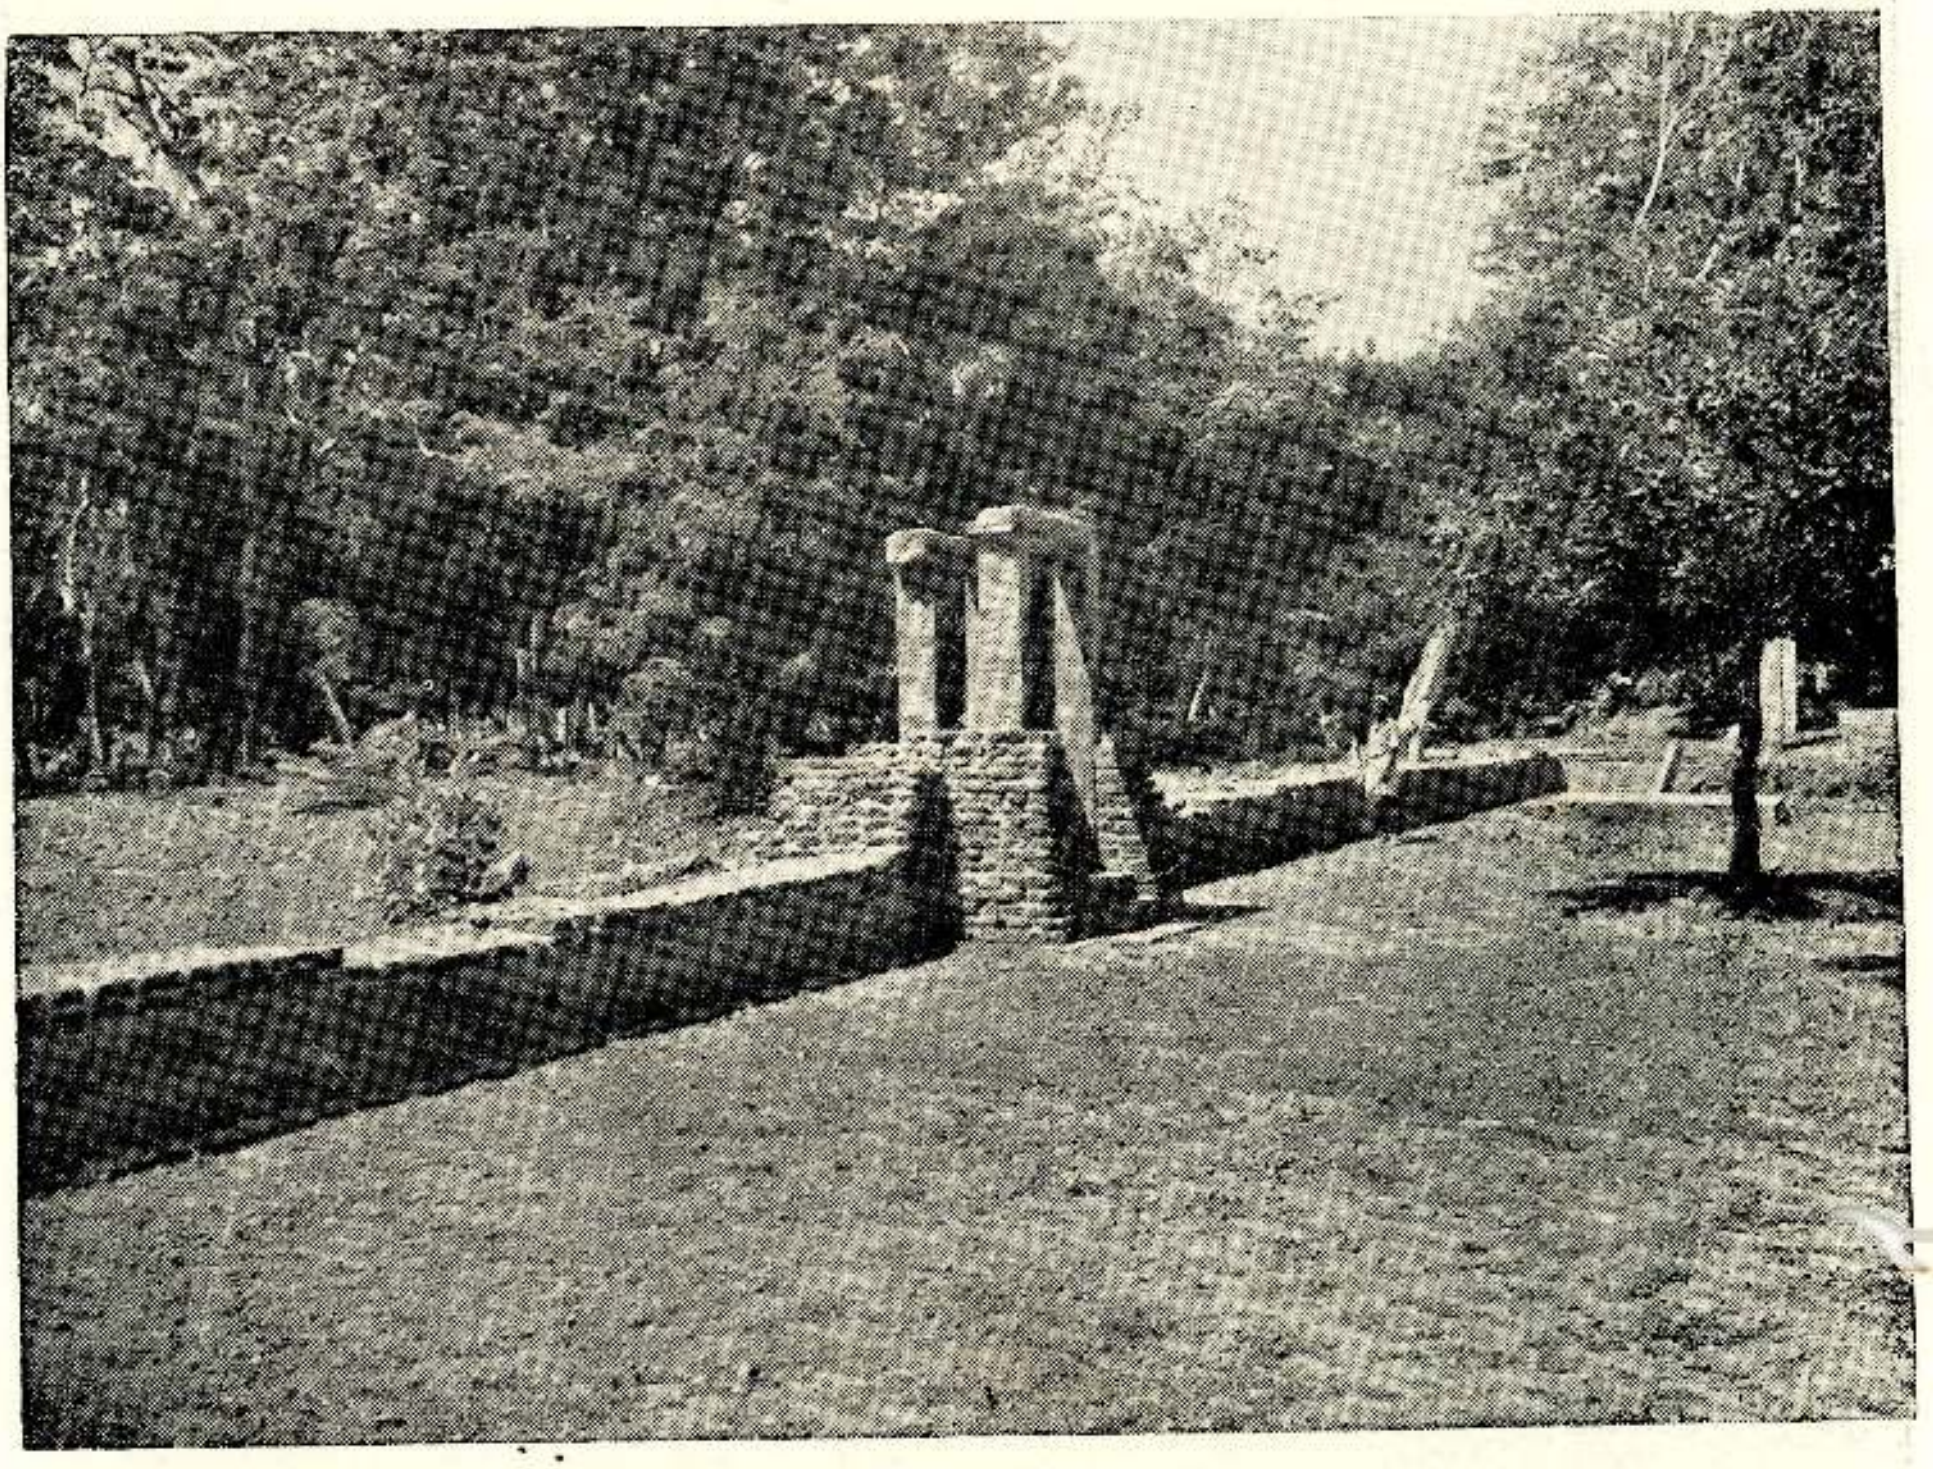
PLATE III

ANURADHAPURA: MONASTERY WEST OF ABHAYAGIRIYA, PRAKARA WITH DOUBLE DOORWAY AFTER CONSERVATION

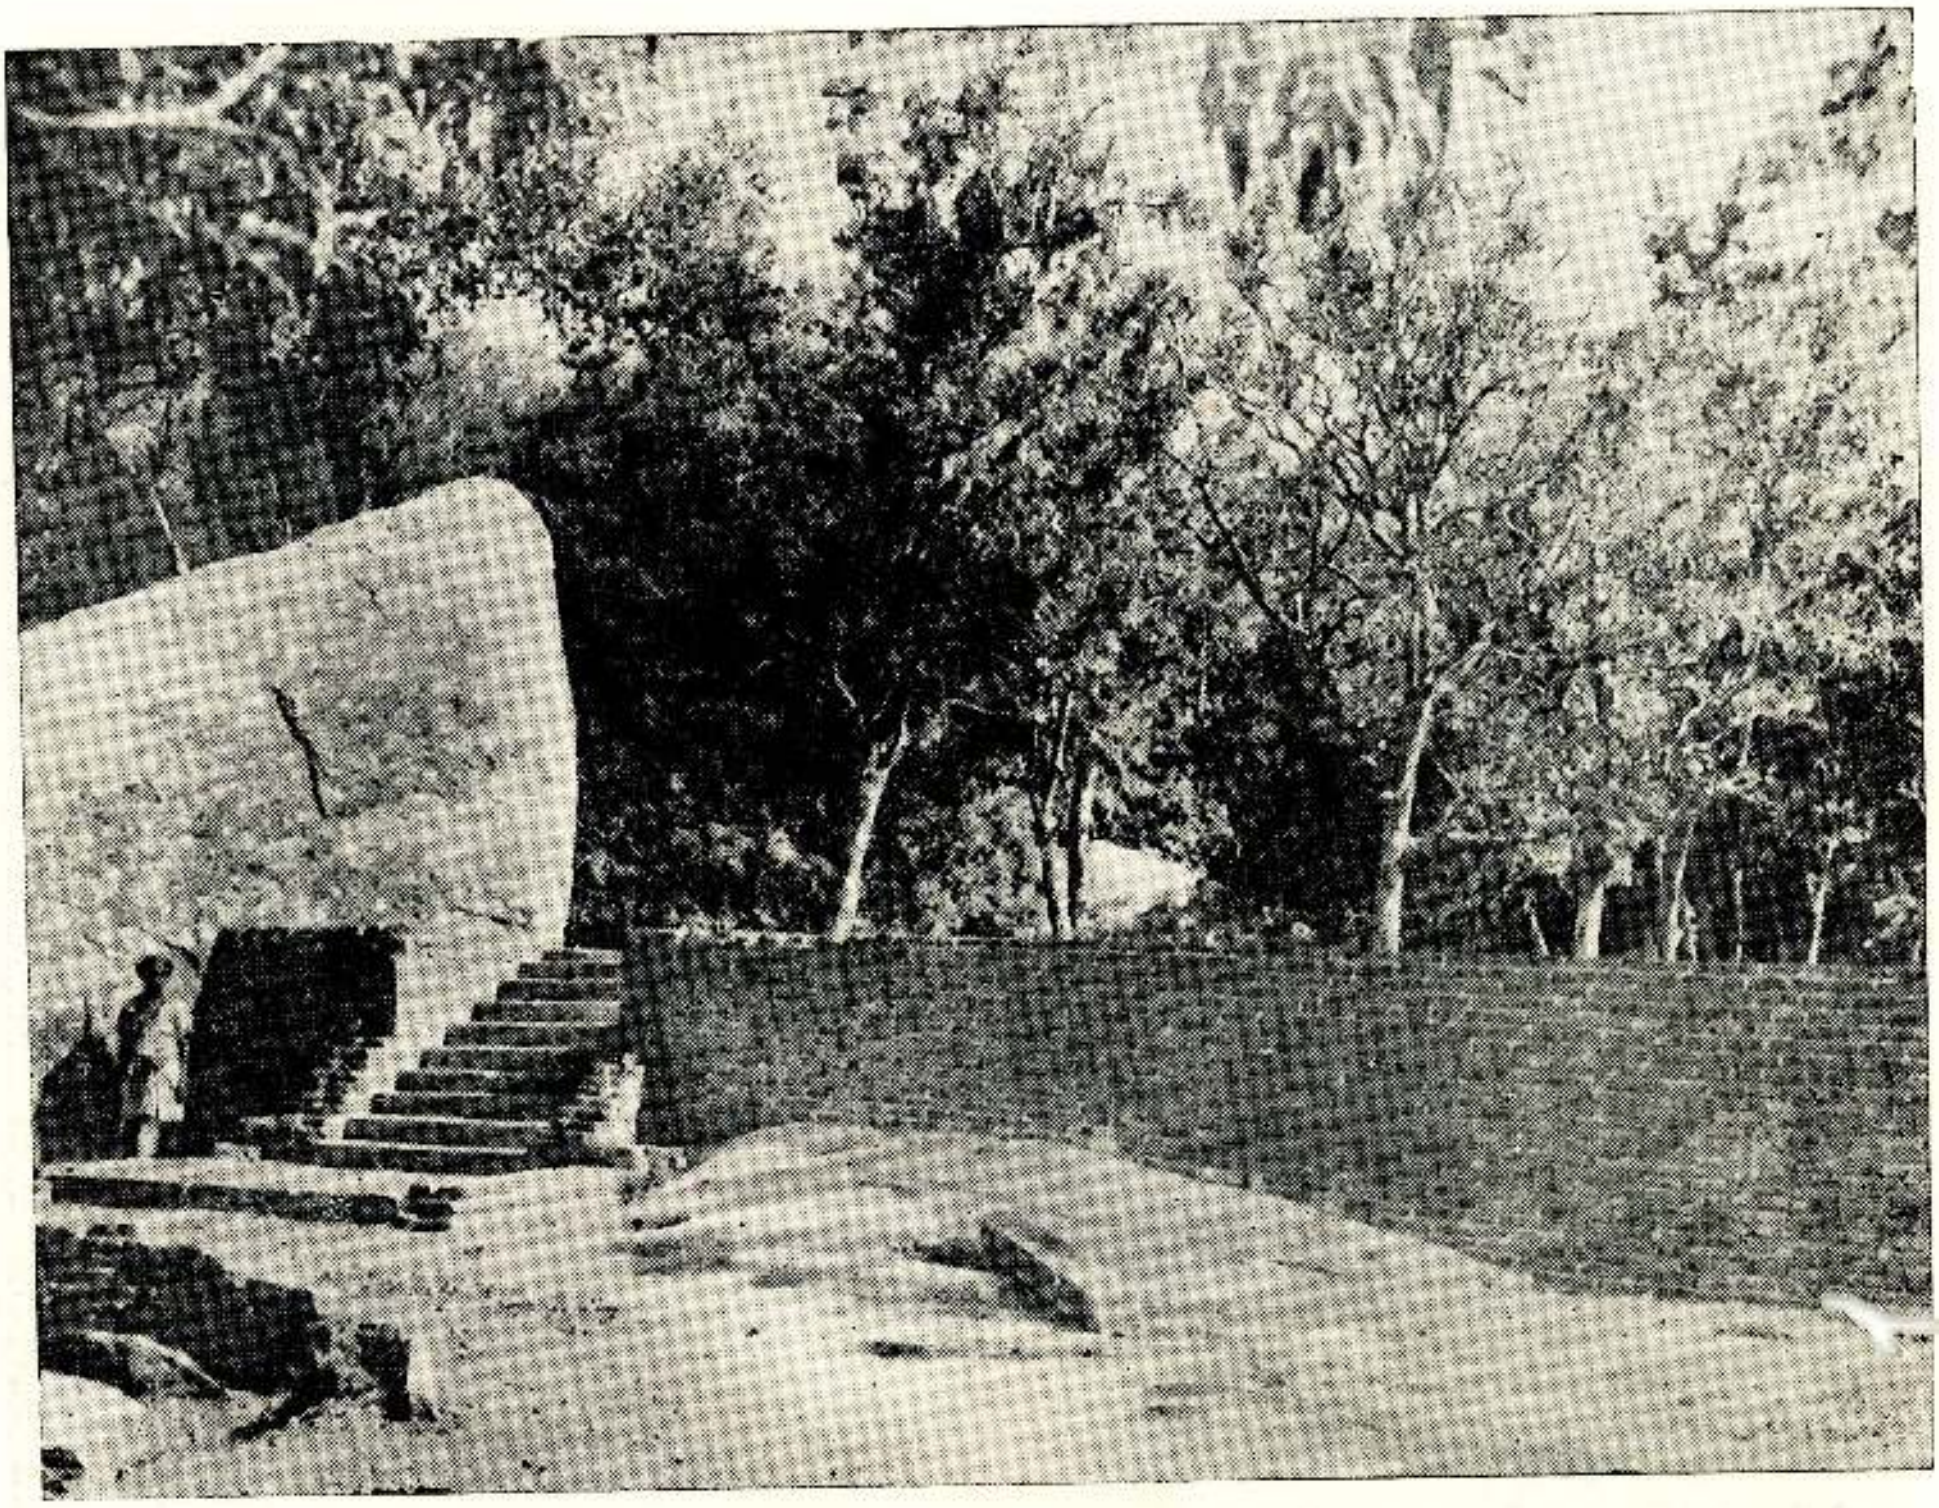
PLATE V

MIHINTALE : KALUDIYA POKUNA, WALL AND FLIGHT OF STEPS AFTER CONSERVATION

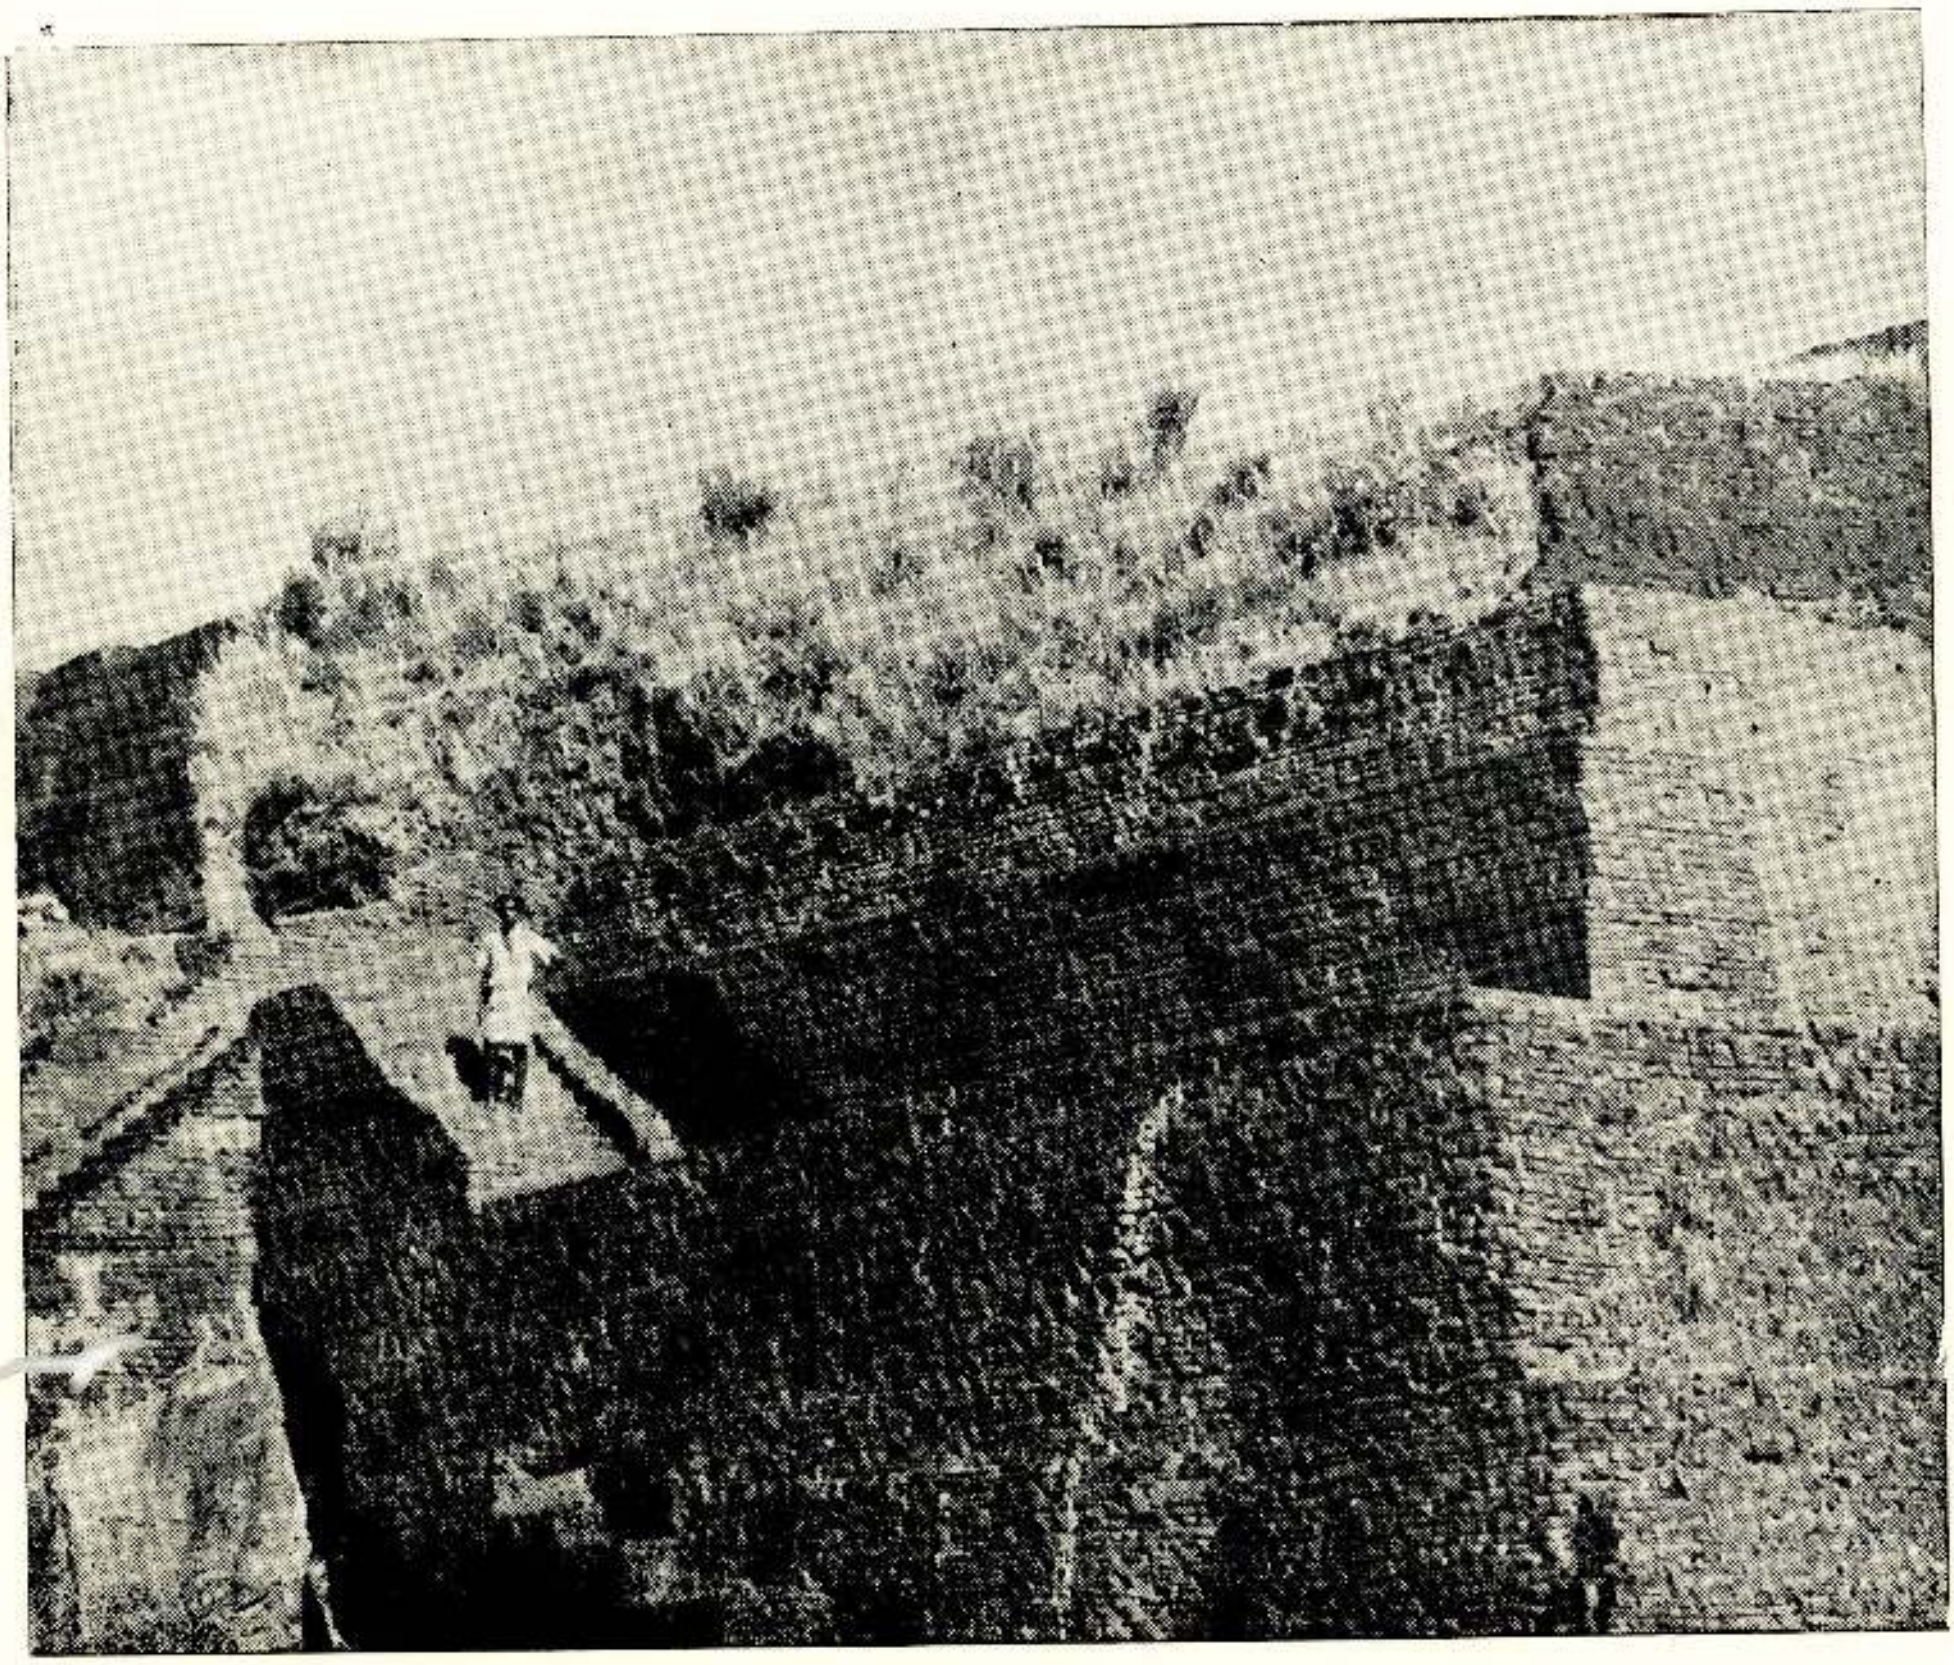
PLATE VIII

SIGIRIYA : CONSERVATION WORK ON SUMMIT

Summit of Rock.—Conservation of the retaining wall of the 2nd path was undertaken on the summit of the rock. The north east and south east corners of the wall were conserved to its full height. A flight of steps (Plate VIII) connecting the 1st and 2nd paths was conserved at the North Western corner. As some of the limestone slabs of the paving of the path were missing, bricks were laid instead. The upper wall above the second path was conserved to a length of 45 feet and to a height of 4 feet.

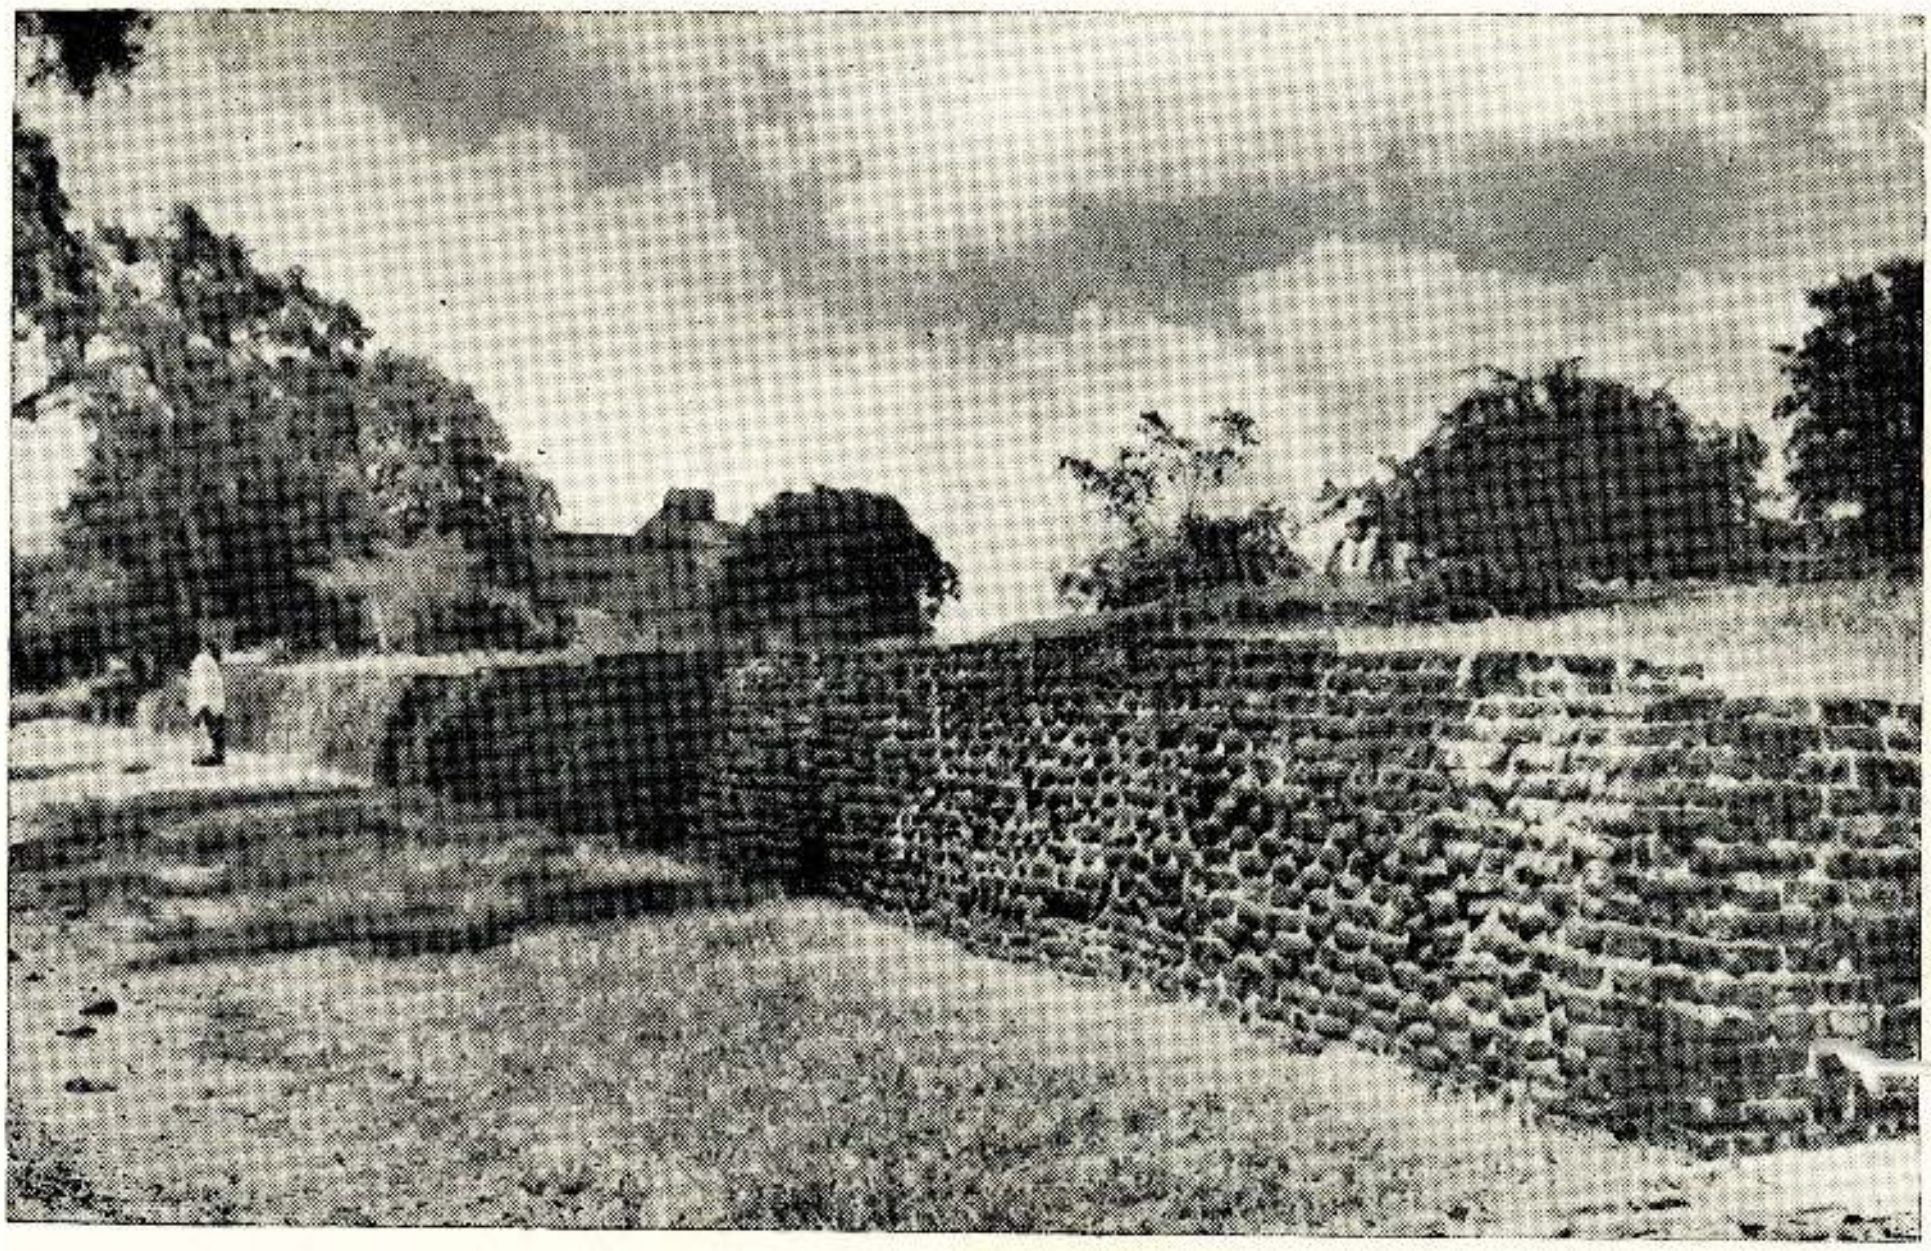
PLATE IX

POLONNARUWA : RETAINING WALL WEST OF BADDHASIMA PASADA AFTER CONSERVATION

The main retaining wall on the western side of the Baddhasima Pasada was excavated and conserved (Plate IX). The southern side of the wall between the east and west of the main flight of steps was also attended to. The citadel wall at the south-east corner collapsed and immediate action was taken to prevent further damage. The conservation of this wall was taken in hand immediately.
