Administration Report of the Archaeological Commissioner for the Financial Year 1965-66

C. E. Godakumbura, M.A., Ph.D., D. Lit. (London)

January, 1968

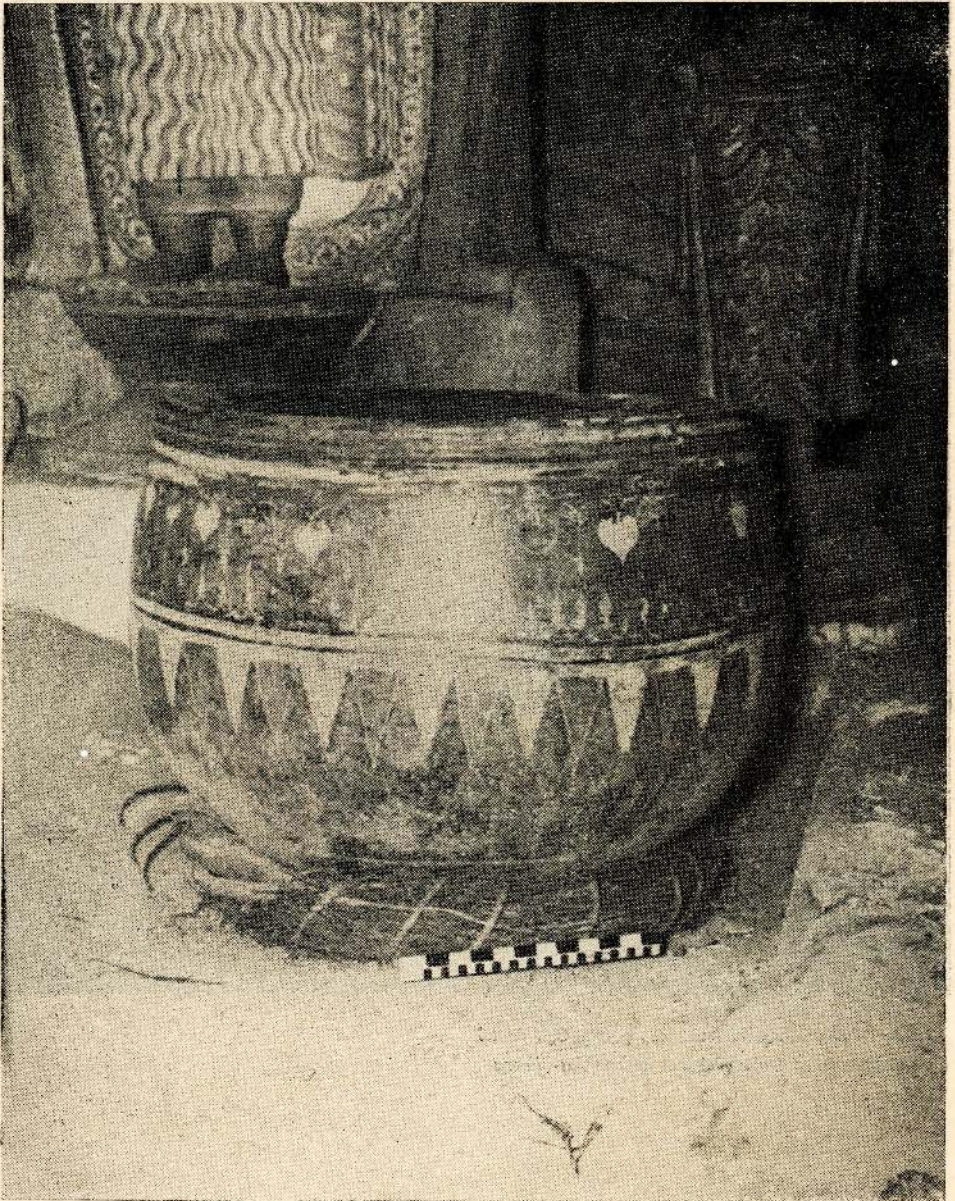
PLATE I

දහකිරිගල රජමහාවිහාරස්ථානයෙන් ලැබුණු මැටි පාත්‍රයක්
A clay bowl from Danaqirigala Rajamaha-vihara

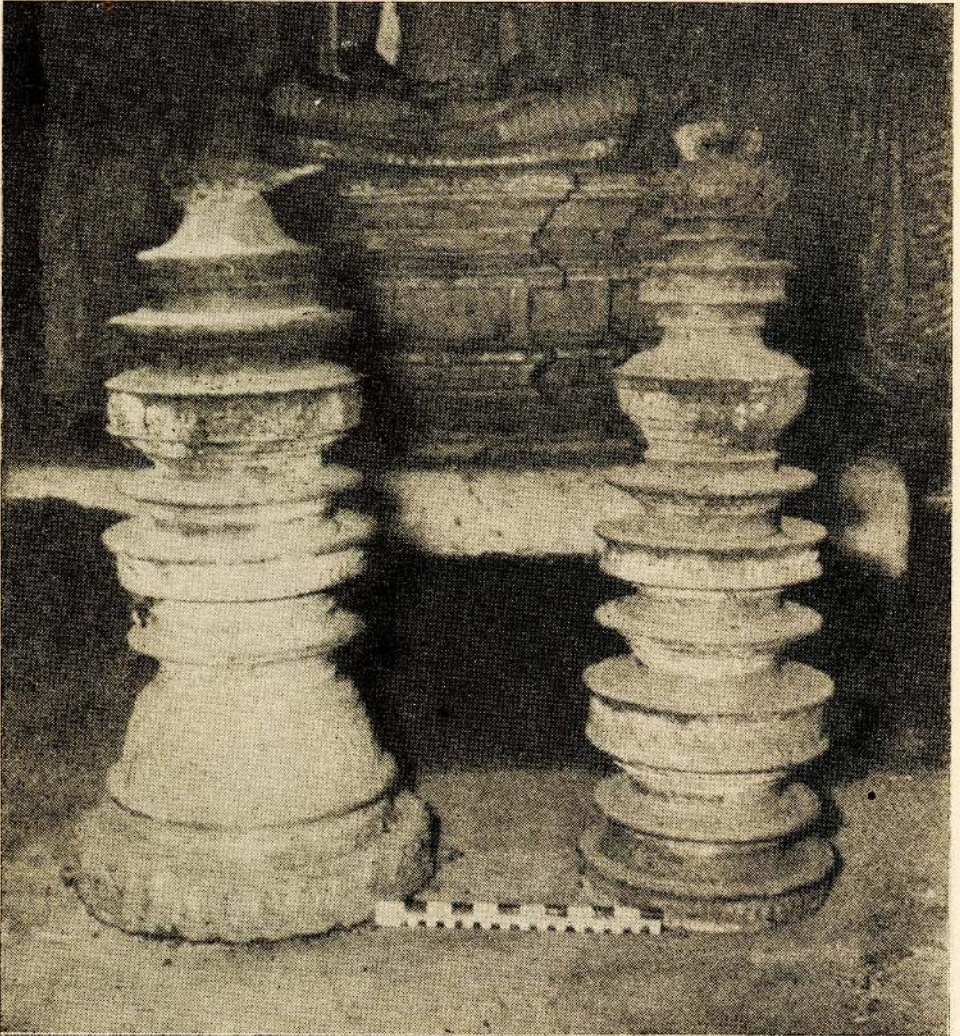
II වන ඡායා රූපය
PLATE II

දකුණින් පැහැදිලිව පෙන්වා දෙන ලද උඩුකුණු මැටි පහන්
Clay lamps from Danagirigala Rajamaha-vihara

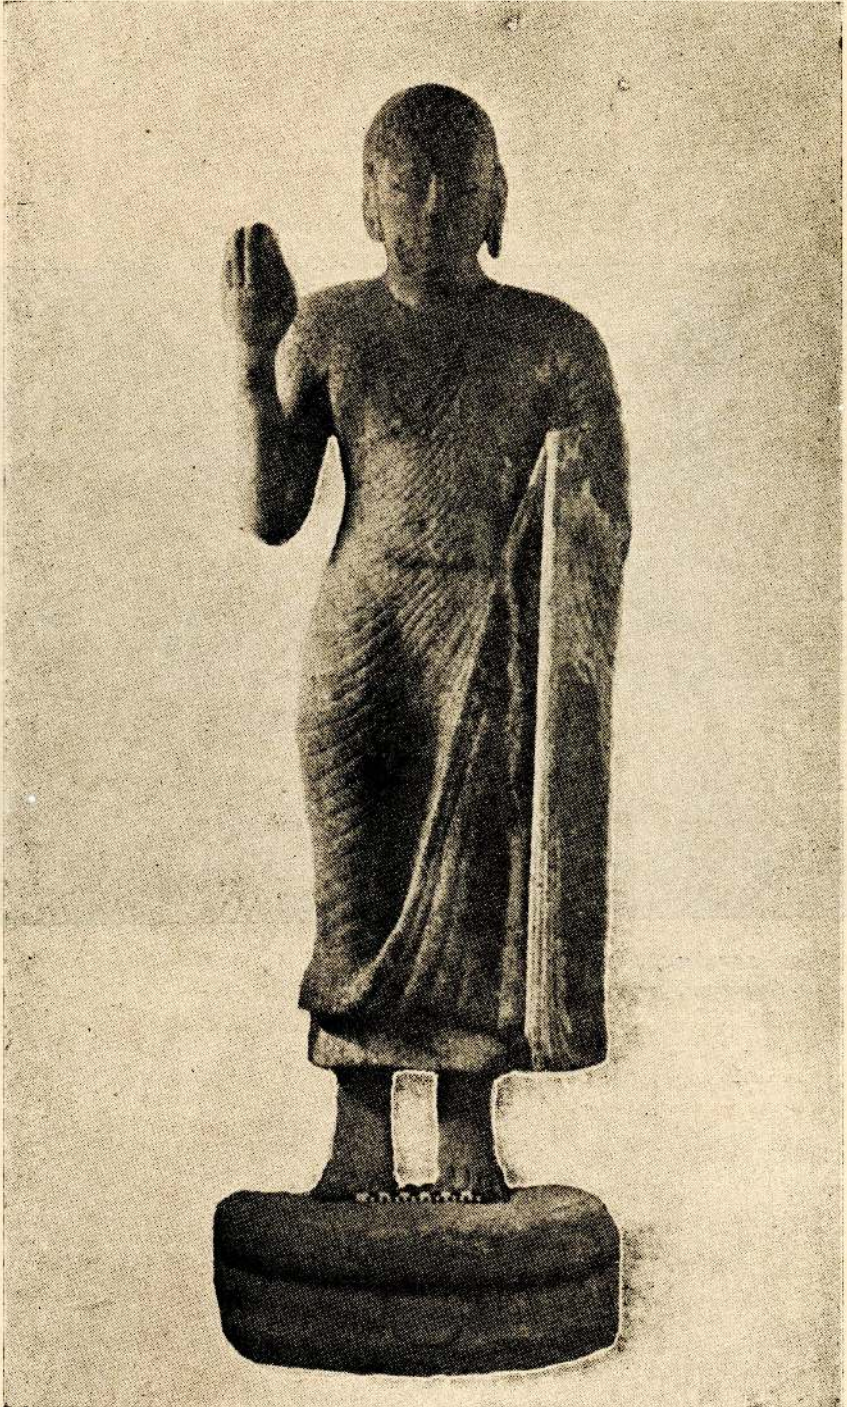
III චන ඡායා රූපය
PLATE III

දන් අම්බලන්තොට පුරාවිද්‍යා කෞතුකාගාරයෙහි පිහිටුවා ඇති බුදු පිළිමය
Buddha Statue now erected at the Ambalantota Archaeological Museum

A colossal image of the Buddha, height 10 ft. with head, feet and arms severed, found at the temple premises opposite the museum on the farther side of the road was set up in the museum and conserved (Plate III). The statue now stands on its original lotus pedestal and has all its severed fragments put together and is quite impressive in its new setting.

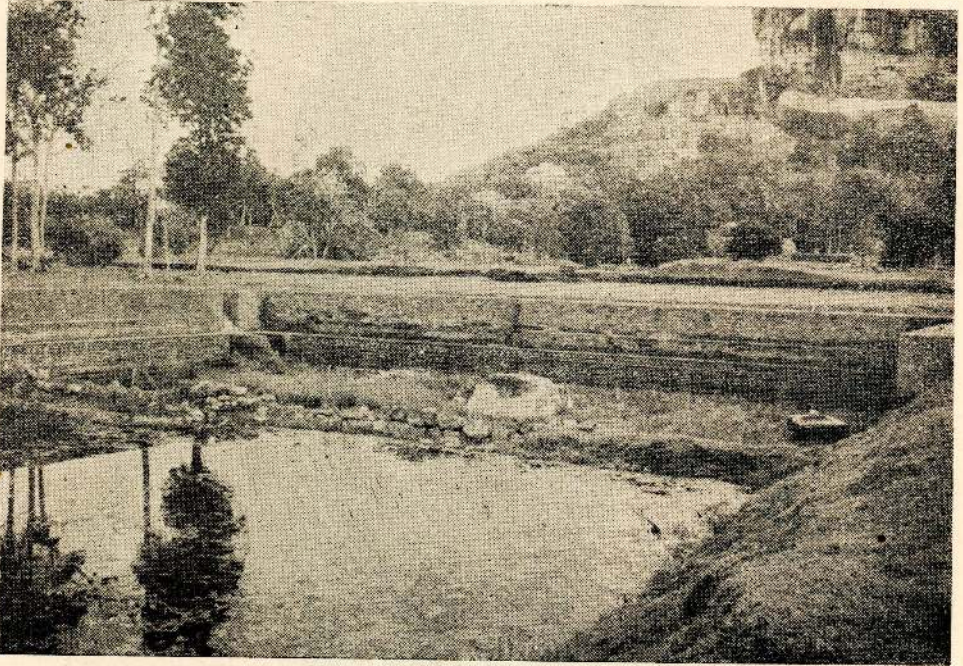
IV වන ඡායා රූපය
PLATE IV

සීගිරියේ මගුල් උයනේ තහවුරු කරන ලද පොකුණක්
A pond in the pleasure-garden at Sigiriya after Conservation

These ponds were excavated as far back as 1954 and only one pond that on the north-west was then conserved. The fact that the conservation was thus far delayed owing to other commitments has led to the brickwork being further damaged. Hence, another pond in the complex, that at the south-west corner, was taken in hand this year, and the conservation of the shorter arm completed. The manner in which a natural islet of rocks has been blended with superb scenic effect into the shorter arm of this pond is an object lesson in architecture (Plate IV and Plan I). Instances are not wanting in modern times of people destroying the natural charm of a landscape in order to fit it into the procrustean bed of a pre-conceived plan. In both ponds so far conserved the brick-wall which girts it on the farther side is provided with an opening which has a corbelled arch at top. A flight of steps leads from inside the brickwork and into the water. These ponds would probably have been used for bathing and the passage may have served the bathers to enter the pond in their bathing outfit from a changing room behind the wall. It is too early to hazard a guess as to the actual import of these more or less hidden entrances, but it is quite possible that they served a pleasure-loving king to spring a surprise on youthful women bathers. This possibility gains support from the fact that several flights of steps are located on the brickwork all round the lakes which were the more obvious entrances and exits for the bathers. There are references in literature to kings bathing in the company of a bevy of girls.

The conservation work consisted mainly of re-exposing the excavated walls of the pond, and having the fallen bricks put back in position. The mouldings were restored as far as their bricks could be retrieved, but where the mouldings were not clear the walls have been rendered with a 'broken-face'. All parts of the wall found intact have been strengthened by 'pointing' but retained without alteration. Where new brickwork had to be done the modern engineering brick was used instead of the ancient bricks to indicate the new work. Nevertheless, the new bricks were used only as 'stretchers' in order not to upset too much the pattern of the ancient brickwork.

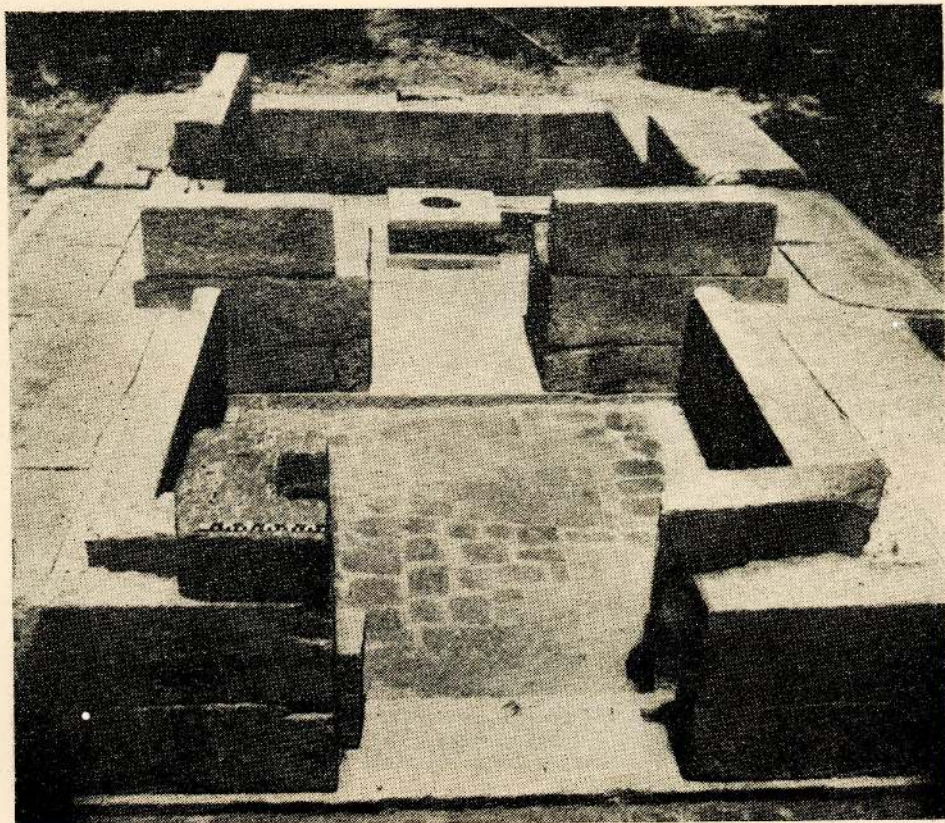
PLATE V

පදවියේ සිවදේවලයේ පැවැත්වූ දර්ශනය නගවුරුකිරීමෙන් පසු
Interior view of the Siva-devala at Padaviya after Conservation

Siva-dēvālē—The conservation of the Siva-devale at Padaviya was taken in hand during the year. The ancient brickwork was retained as far as possible without dismantling and resetting. The stones on this structure were numbered and dismantled, except where they were embedded in the brickwork, after which a strong cement concrete foundation was set up. The stones of the walls will now be re-assembled.

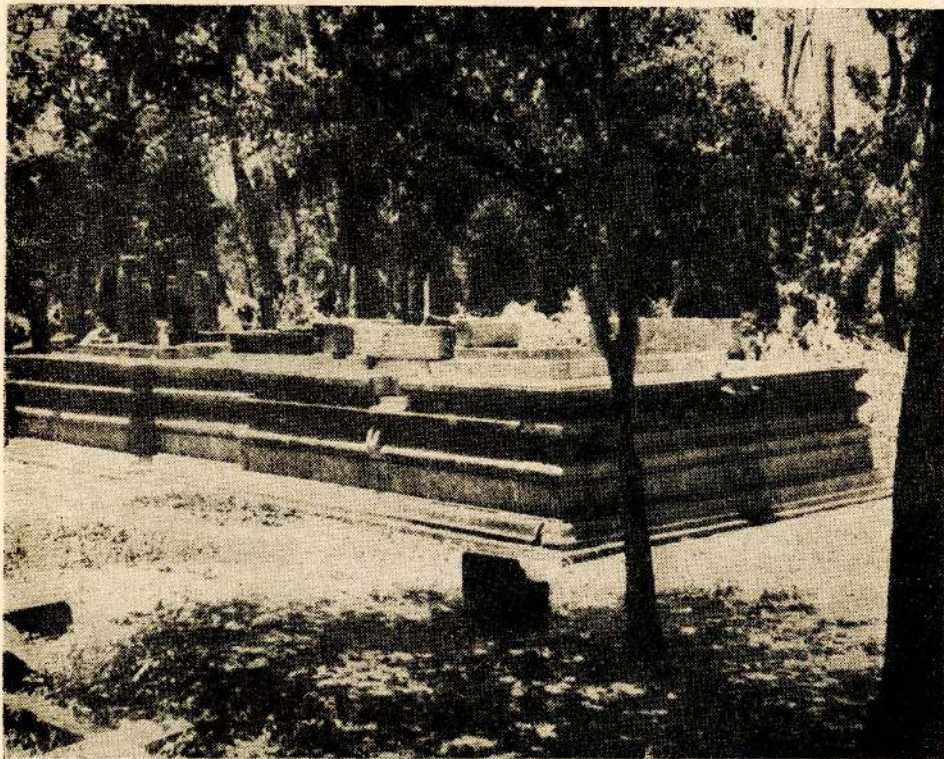
PLATE VI

පදවියේ සිව්දේවාලය, තහවුරුකිරීමෙන් පසු
Siva-devala at Padaviya after Conservation

The roots of a large ebony tree (*Diospyros ebenum*) gripped the stones of this structure. Ebony being one of the hardest timbers of Ceylon, if not the hardest, the roots could not be removed in the normal method of felling the tree, because the stones too would have been damaged in the process. The disengagement of the stones from the roots of the tree therefore proved to be slow and laborious work.

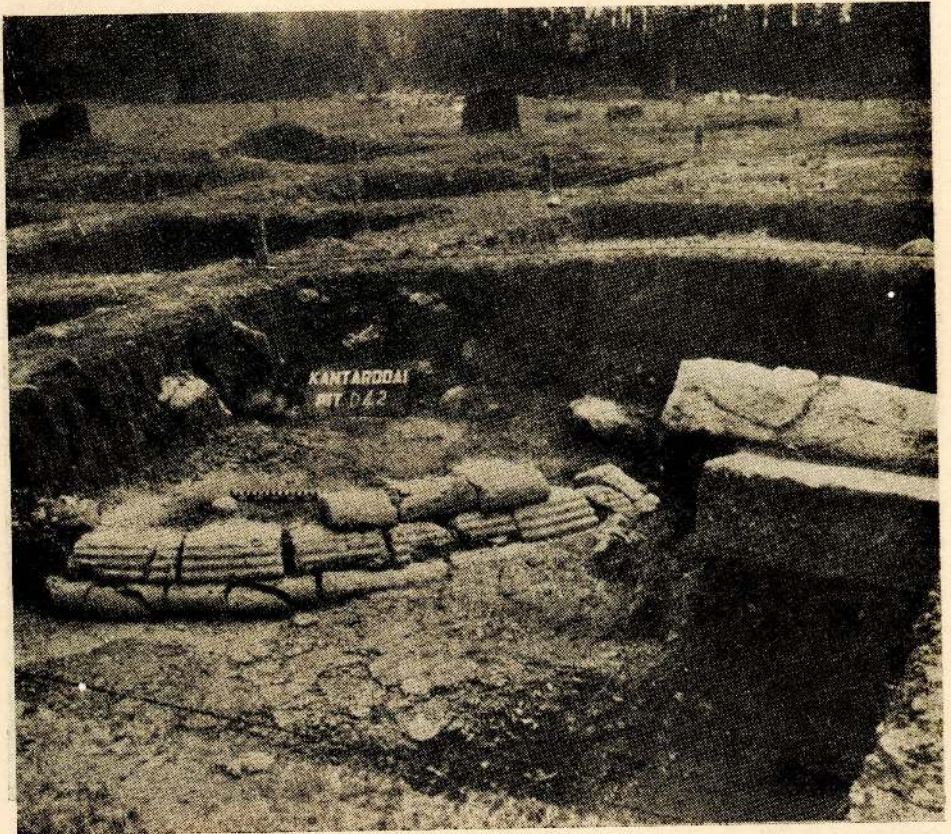
PLATE VII

Excavation at Kantarodai

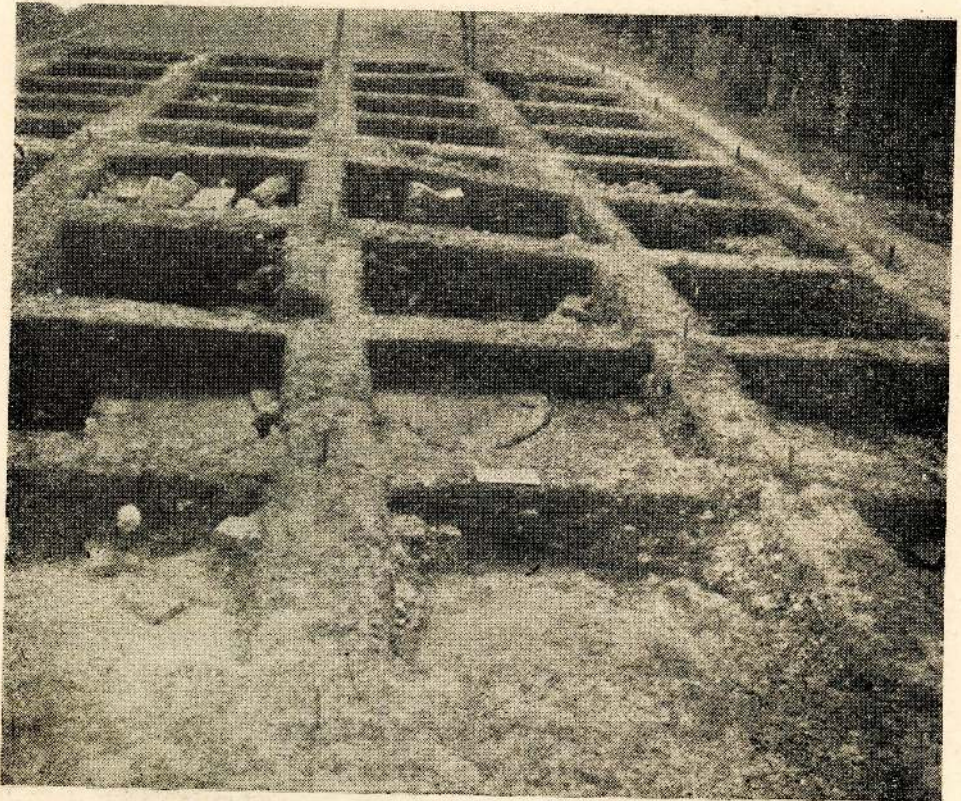
PLATE VIII

Excavation at Kantarodai

One of the first things which struck us at the early stages of the excavation was the unique character of the site in that it contained the limestone foundation of a number of small stupas (Plate VIII). These stupas range in diameter from about 8½ ft. to about 12 ft. and were very probably votive stupas. Twelve such stupas have so far come to light. A *stūpa* of diameter about 23½ ft. of which the foundations remain at the site, however, appears to have been a stupa meant for worship. These stupas were found at depths ranging from 2.5 ft. to 4 ft. below surface.

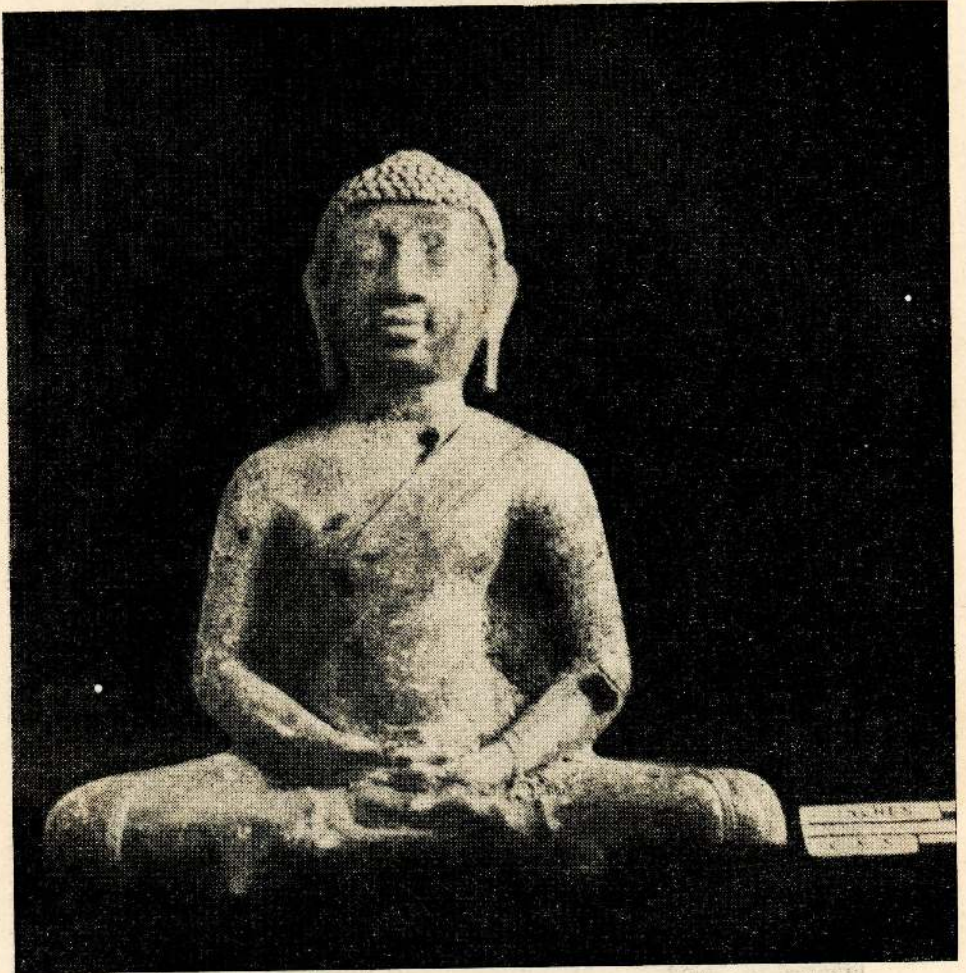
PLATE IX

පවුල්පාවෙන් සම්භවිත ලෝකඩ බුදුපිළිමය
Bronze Buddha Statuette unearthed from Pavulpava

Pavulpava.—A seated bronze Buddha statuette, height 5½" breadth 3", and a casket, height 1 ft. 2 in. girth 1 ft. 7 in. have been accidentally unearthed in the course of digging for clay in Pavulpava estate owned by Mrs. S. G. Singu, in the village of Pavulpava (Map ref. 1 20/49) in the headman's division of Kuragama of Udapalata Korale North of Tumpane Palata (Plates IX and X). The casket has a frieze of elephant heads on its bottom basal ring and above that a frieze of dancing figures. Both objects were found in a clay vessel which however, had broken into fragments in the digging.

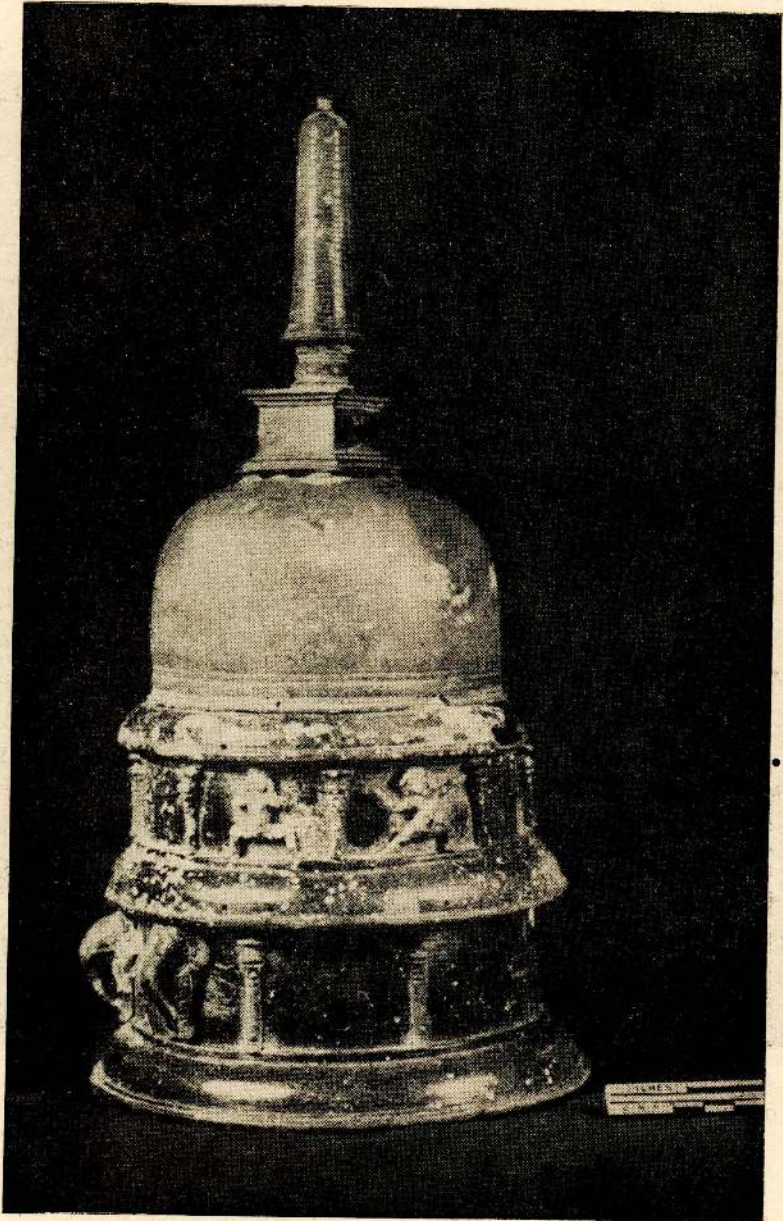
PLATE X

පවුල්පාවෙන් ලැබුණු ලෝකඩ කරඬුව
Bronze Casket unearthed from Pavulpava

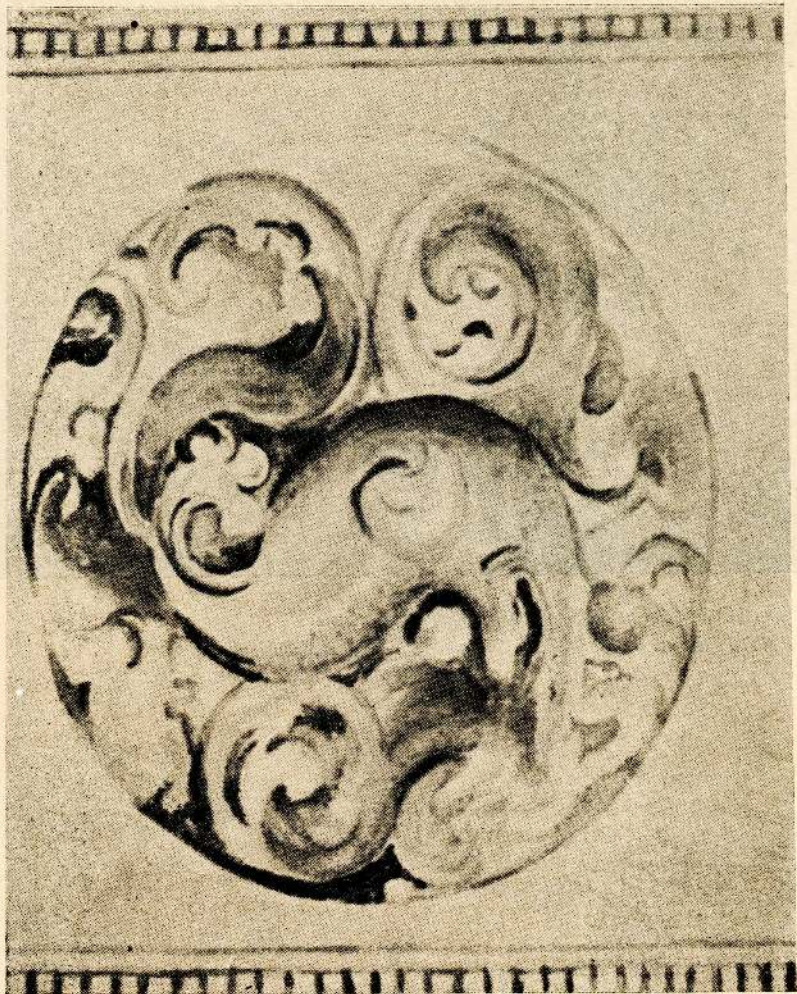
PLATE XI

සිගිරියේ නයිසෙණ ඉහළේ ඇති රජාගත මකර විනුයේ පිටපත
A Copy of the Stylized makara figure in the Cobra Hood Cave at Sigiriya

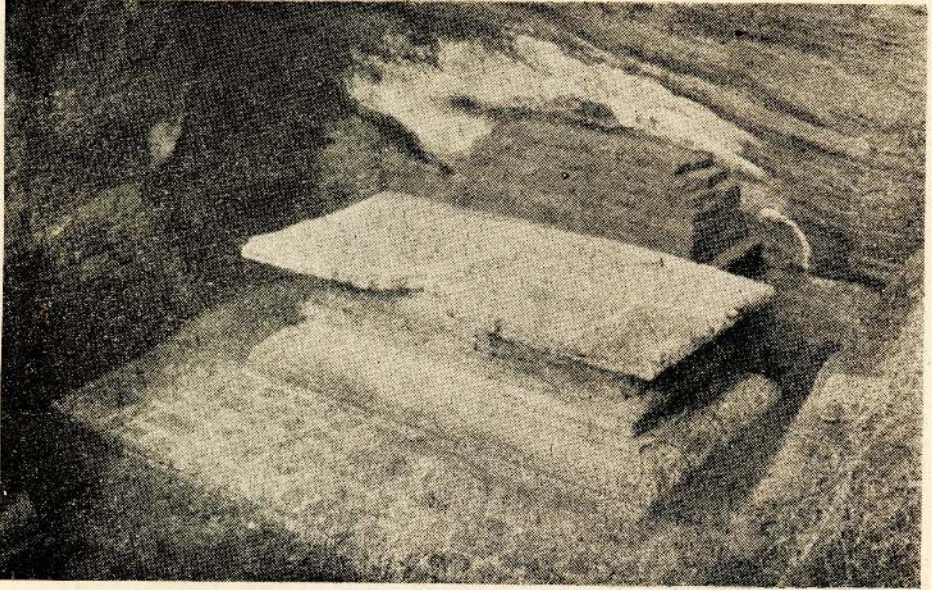
PLATE XII

සිගිරියේ අංක 3 බී 14 දරන ගුහාවේ ආසනය කහවුරුකිරීමෙන් පසු
The ASANA in the cave No. 3 B 14 at Sigiriya after Conservation

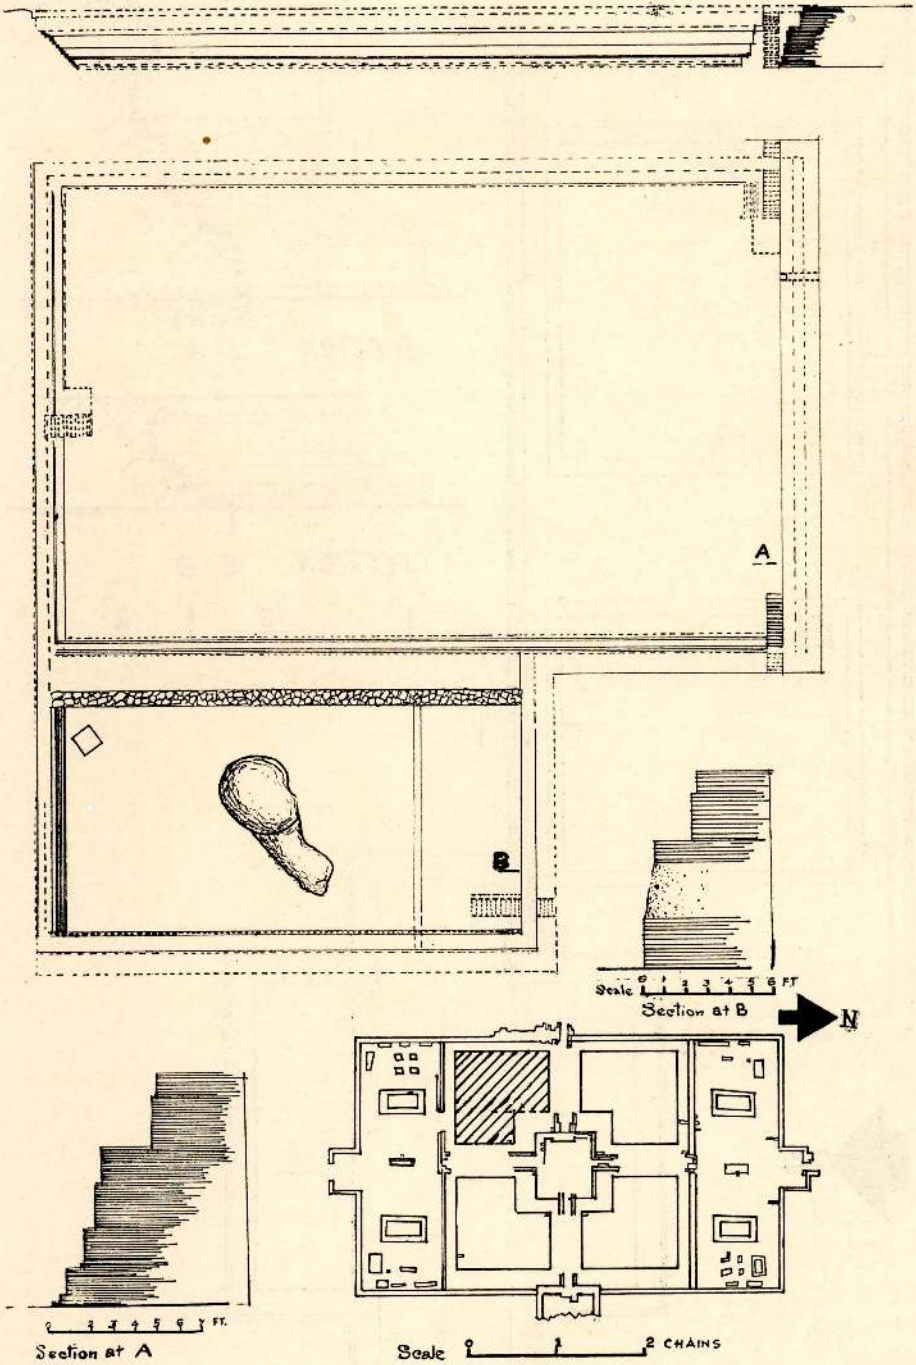
1 වන සැලසුම
PLAN 1

සිගිරියේ මහල් උයනේ පොකුණ
The pond in the pleasure-garden at Sigiriya

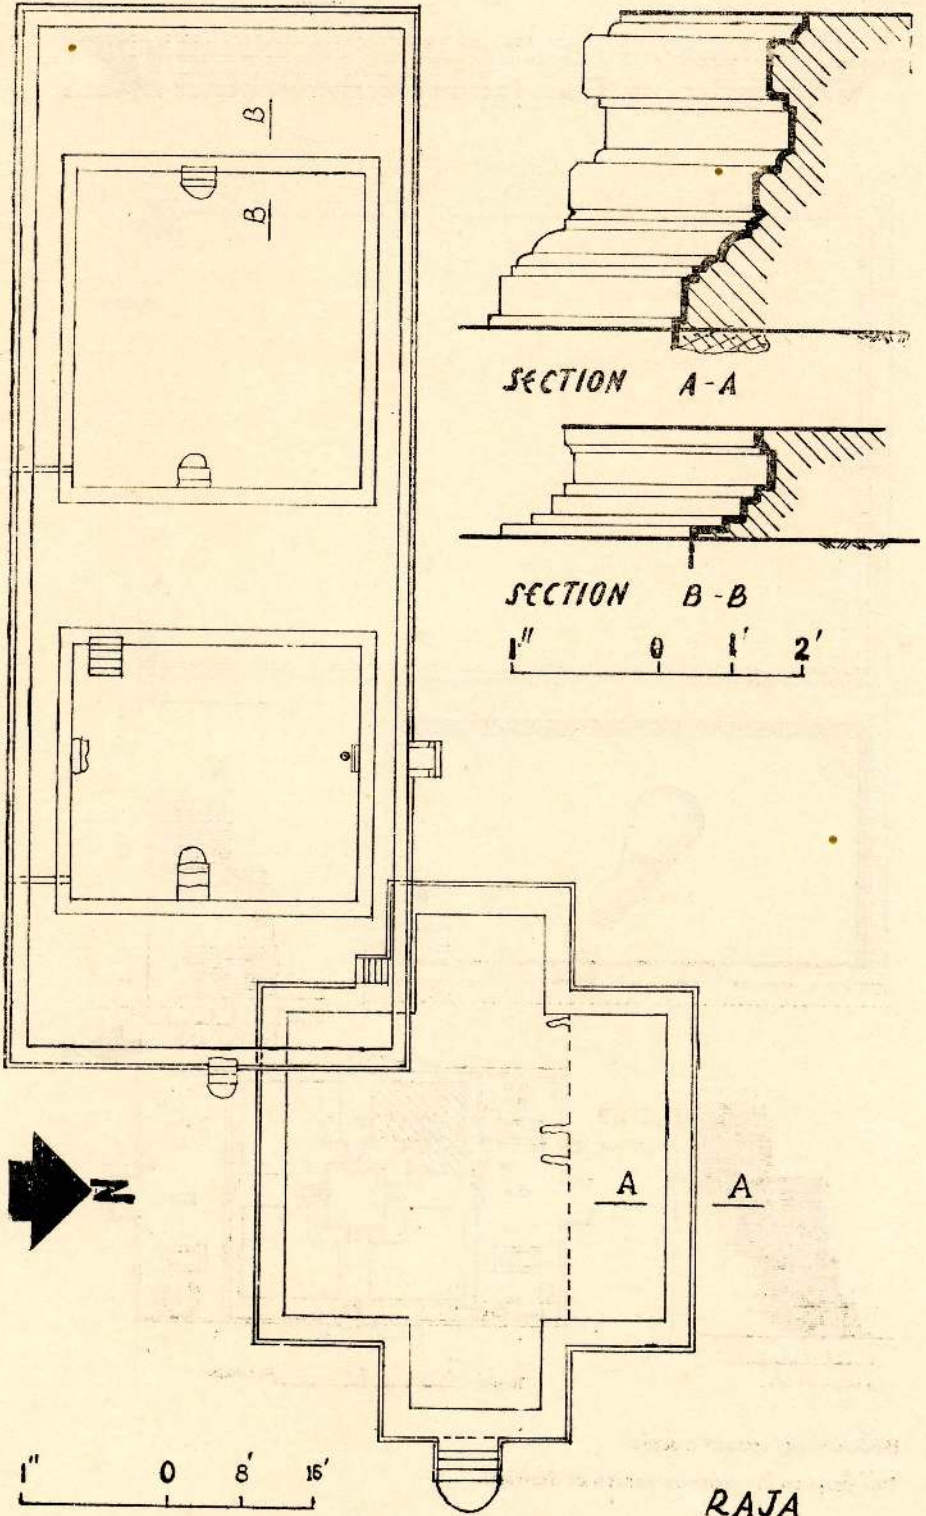
PLAN 2

පළුවස්නුවර පාසැල් නුවර ගොඩනැගිලි පිළිබඳව විස්තර කර ඇති සැලසුම
Plan and Section of the Building in the outlet at Panduvasnuwara

Building South-West of Palace.—A building excavated in 1963-64 is situated south-west of the palace at Panduwas Nuwara. This building begins at a level lower than that of the buildings already conserved, and hence its bricks were much mouldered. Two later-day structures probably of different dates reared on parts of the foundation of this building added to the difficulties of conserving it. The three phases of work at the same structure found here however provide an interesting study. The mouldings of the brickwork have been faithfully conserved where evidence for their shape, etc., was available, but where such evidence was not forthcoming the brickwork has been rendered in 'broken-face'.

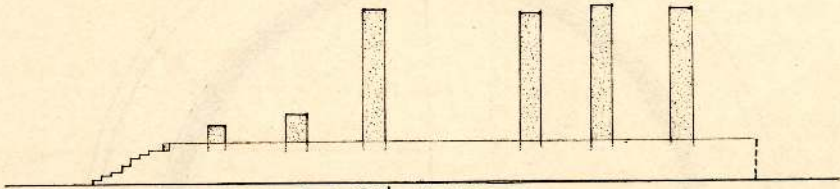
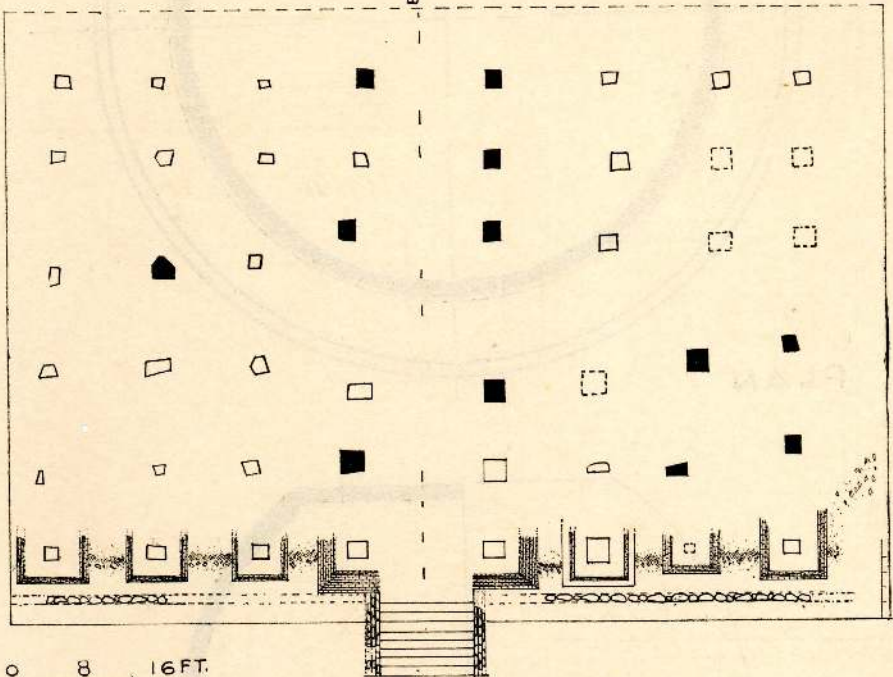
3 වන සැලසුම
PLAN 3

මහේස්වරුන් කැටුණුයනිත ගොඩනැගිල්ල Pillared Building Menikdena

A-B අතර හරස් කැපීම
CROSS SECTION AT A-B

බිම් සැලැස්ම
GROUND PLAN

fallen or thrown out of plumb and the stones of the plinth were for the most part found fallen on the ground beside the building. About half the building has now been conserved.

The fallen pillars were placed erect on slabs of stone, as had been done originally, and fixed with earth and rubble. Those pillars which were still standing though askew, were corrected to plumb and fixed similarly. The plinth slabs found more or less in *situ* were numbered and removed before being fixed in position, along with the fallen ones in cement mortar on a rubble backing.

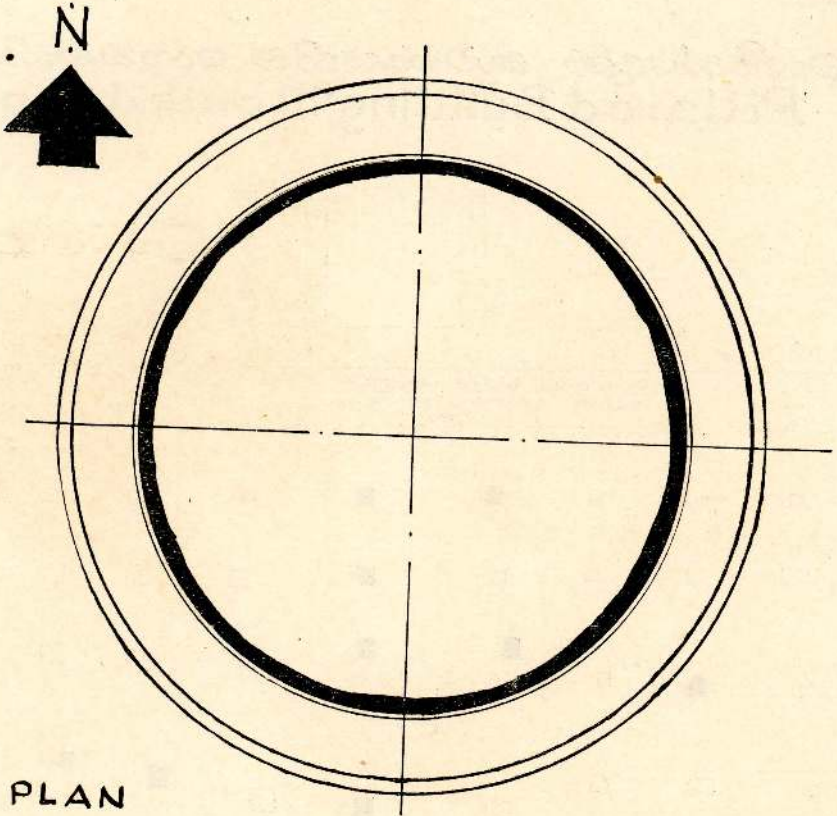
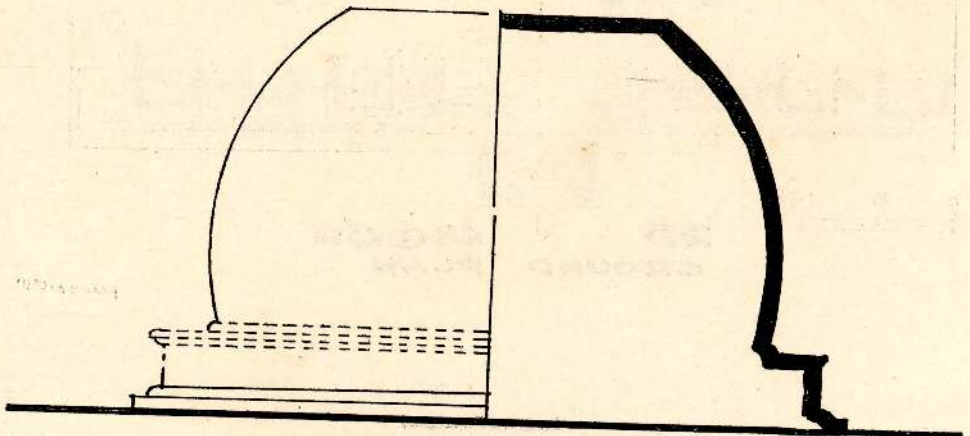
PLAN 4

Plan and Section of the dagoba at Yahangala

Dagoba.—Within one and the same rectangular platform on the rock of Yahangala (Map ref. P 13/43) in Magam Pattu of Hambantota District have been two dagobas of which only one now has sufficient of it to determine the shape. The dome of this dagoba does not rise at right angles from the basal terraces, but instead has a convex curvature in vertical cross-section (Plan 4). This shape which is usually found in the Southern part of the country may be that which is referred to in literature as the pot-shape (*ghat'kira*). The base of this dagoba was cleared of the debris in preparation for conservation, and in the course of this work it was seen that there were at least three phases of work at this dagoba. The conservation would therefore be so undertaken as to show out the work in all the phases. The bricks on the basal terraces have patterns etched on them. Some of the ancient plaster is also preserved.

It is evident that there were other structures on the rock before the construction of the dagoba, because a moonstone, probably of brick and stucco, with much of its plaster intact is found immediately beside the dagoba on the rock. The fact that this moonstone faces the wrong way about indicates that it cannot by any means be taken as belonging to the dagoba.

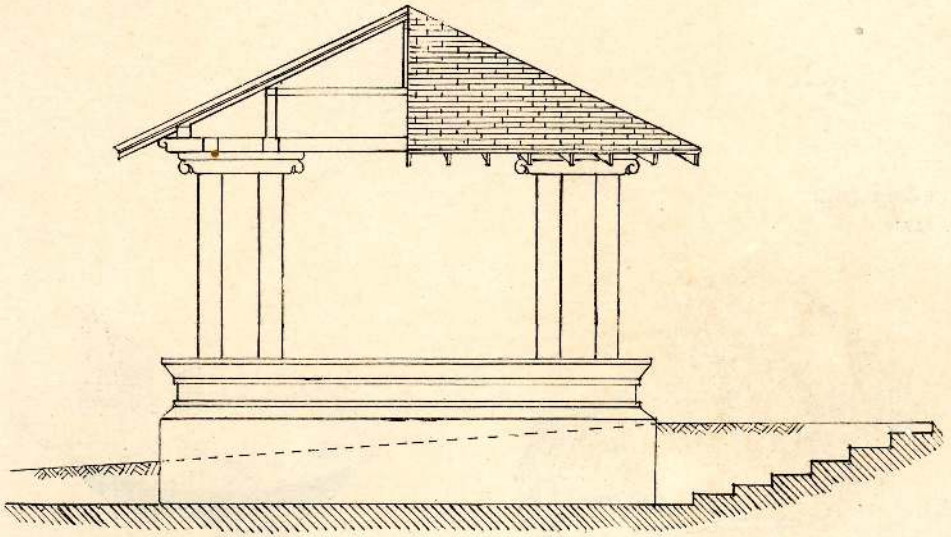
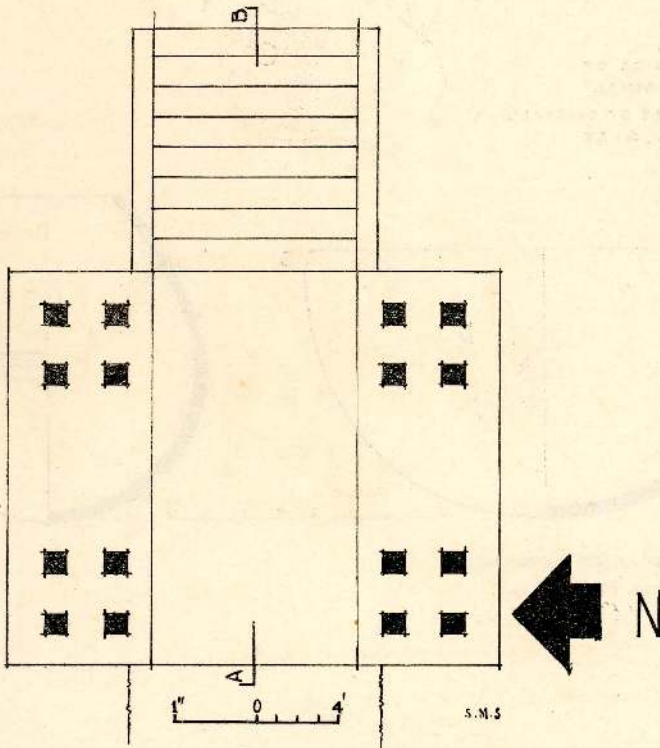
5 වන සැලසුම
PLAN 5

SECTION A-B

මහනුවර ලංකාතිලක විහාරයේ වාහල්කඩේ සැලැස්ම හා එය ඉදිරියට පෙනෙන අයුරු
Plan and Elevation of the Lan'atilaka-vihara at Kandy

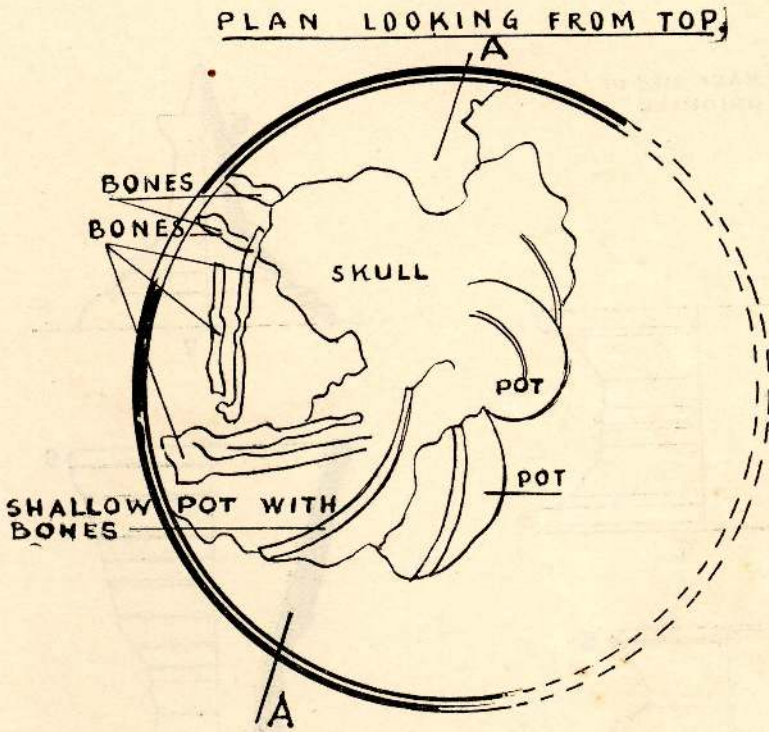
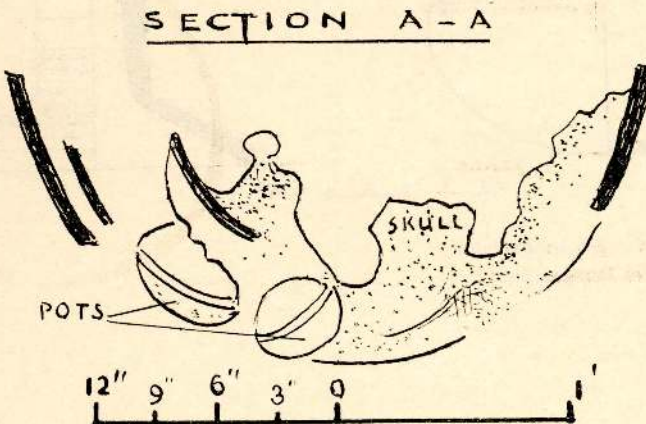
7 වන සැලසුම
PLAN 7

පොම්පරිප්පුවෙන් ලැබුණු ආඥන බඳුන්
Burial-urns from Pomparippu

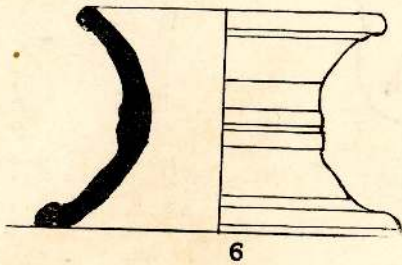
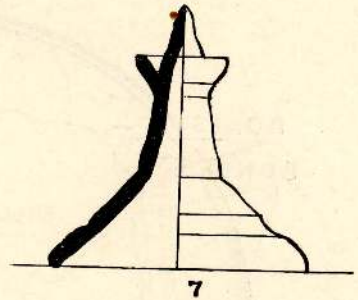
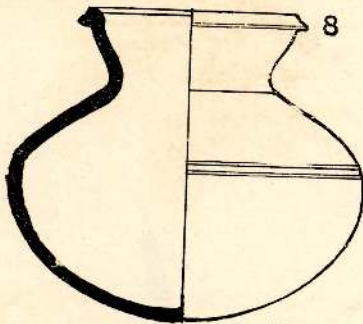
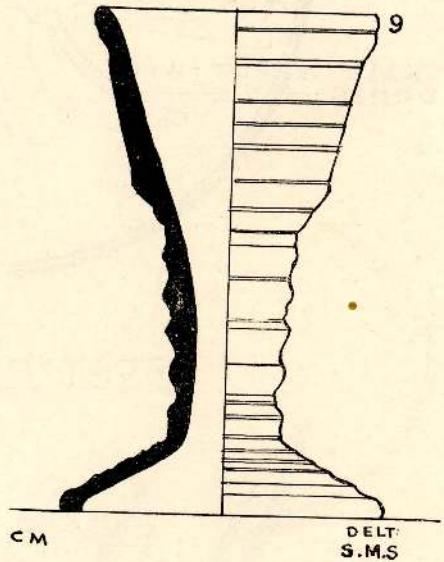
PLAN 8

NOS. 6 to 9 } HALF SIZE OF ORIGINAL

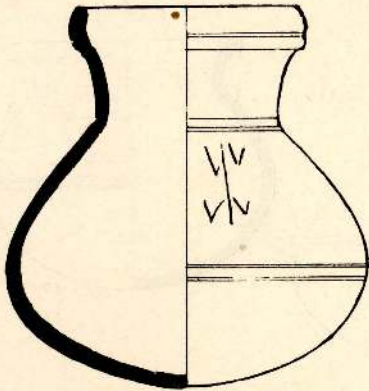
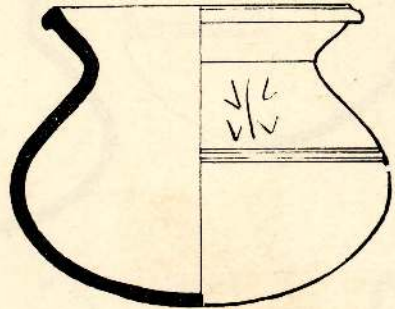
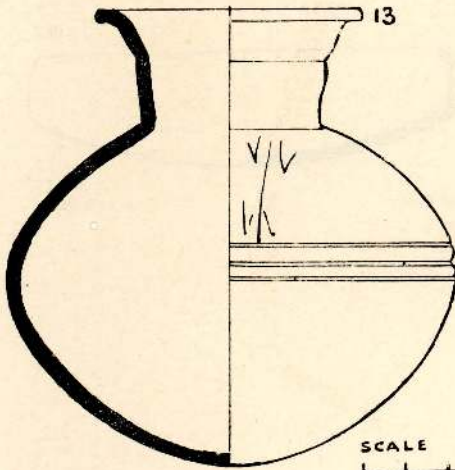
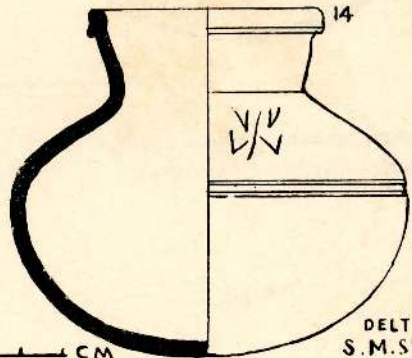
පොම්පරිප්පුවෙන් ලැබුණු ආදාන බඳුන්
Buriel-urns from Pomparippu

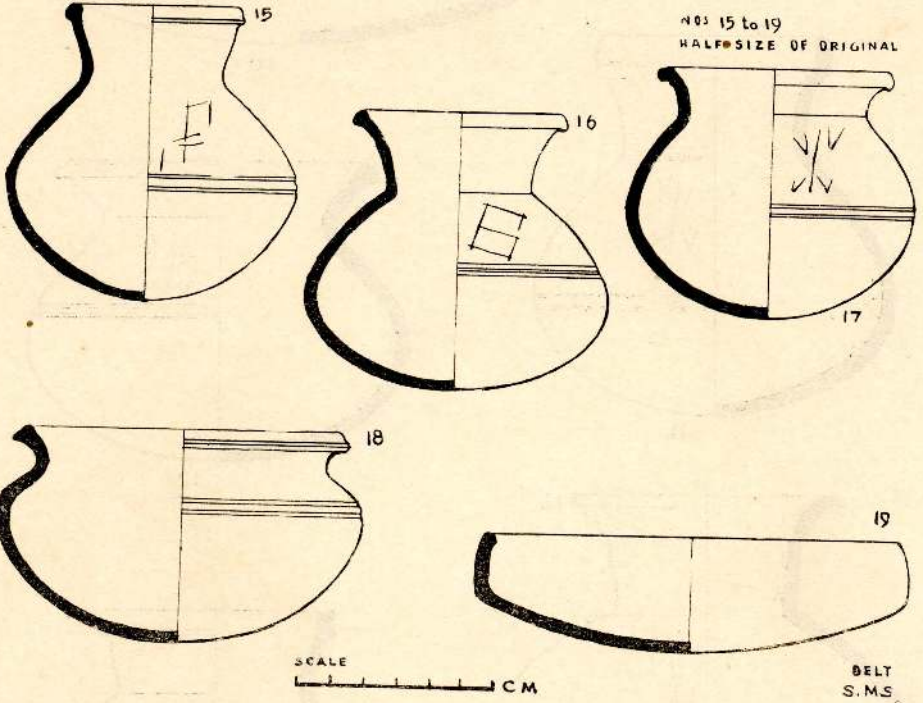
10 වන කැලසුම
PLAN 10

පොම්පරිප්පුවෙන් ලැබුණු ආදාන බඳුන්
Burial-urns from Pomparippu
