Administration Report of the Archaeological Commissioner for the financial year 1961-62

July, 1963

C. E. Godakumbura, M.A., Ph.D., D.Lit. (London)

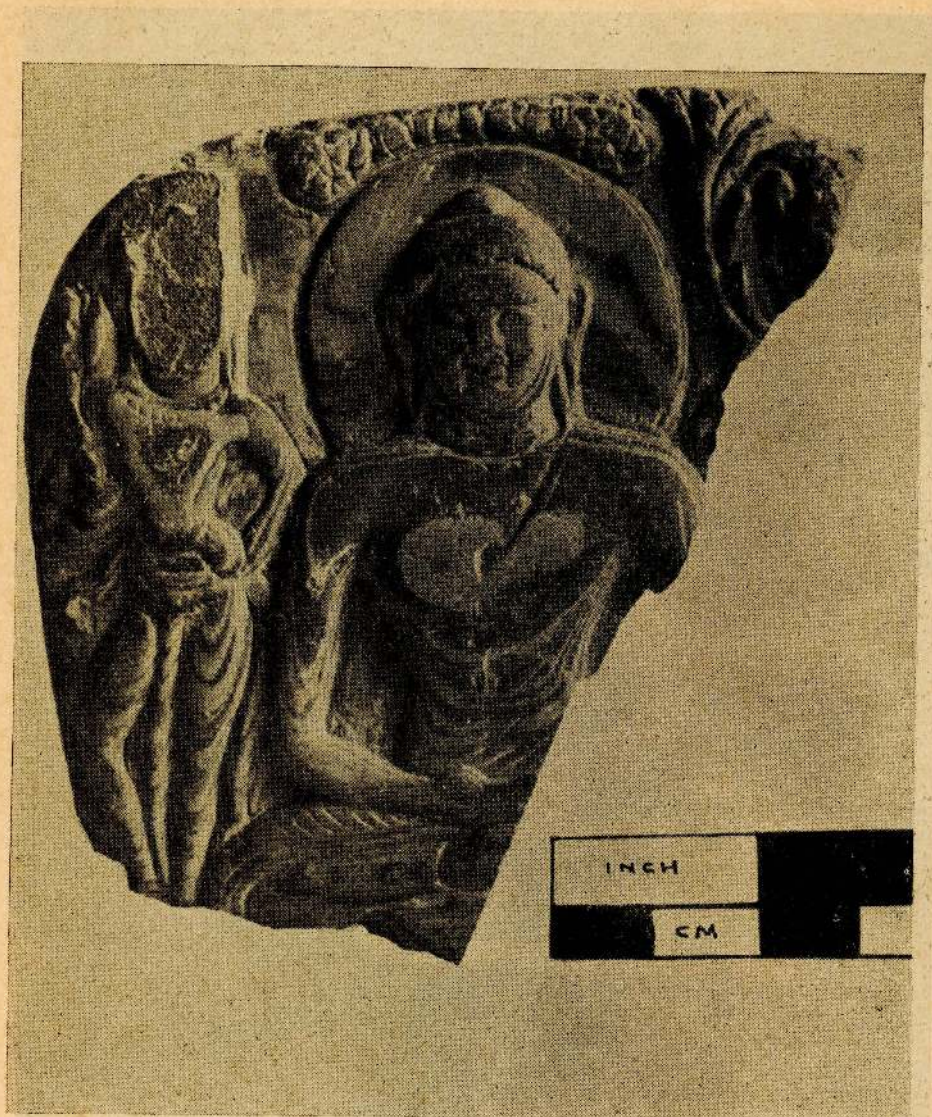
II—පෙරියකුලමෙන් ලැබුණු කැටයම් කළ ගලක්
 Sculptured stone plaque from Periyakulam

The excavations at the northern *prākāra* wall referred to in our last *Report*, 1960-61, pp. 28-29, were continued as a prelude to the conservation of this wall. On November 1, 1961, a very interesting stone plaque carved with figures in relief was recovered from this excavation. (See Plate II.) It is fragmentary having broken twice, once diagonally and again at the bottom. The portions thus severed are lost and could not be recovered despite diligent search. The stone appears to have been roughly square in shape and rounded at the corners originally. The maximum dimensions of the present fragment are 4" × 4½".

bo-tree. There are two attendant figures on either side of a seated Buddha figure. In the Buddha figure the nose is perhaps much wasted, and the long ears reach the shoulders. Of the attendant figure to the left of the Buddha, all but a small portion of the head is broken. Part of a sprig very probably held in the hand of this figure, reaches the top of the plaque making a sweep round the head of the figure. From the one figure that is preserved almost whole, it can be presumed that both were standing figures. Of the attendant figure on the right hand side of the Buddha figure the right leg is bent at the knee. The left arm is akimbo and a flower or a bunch of buds is held in the right hand. The feet of this attendant are missing and the face chipped off.

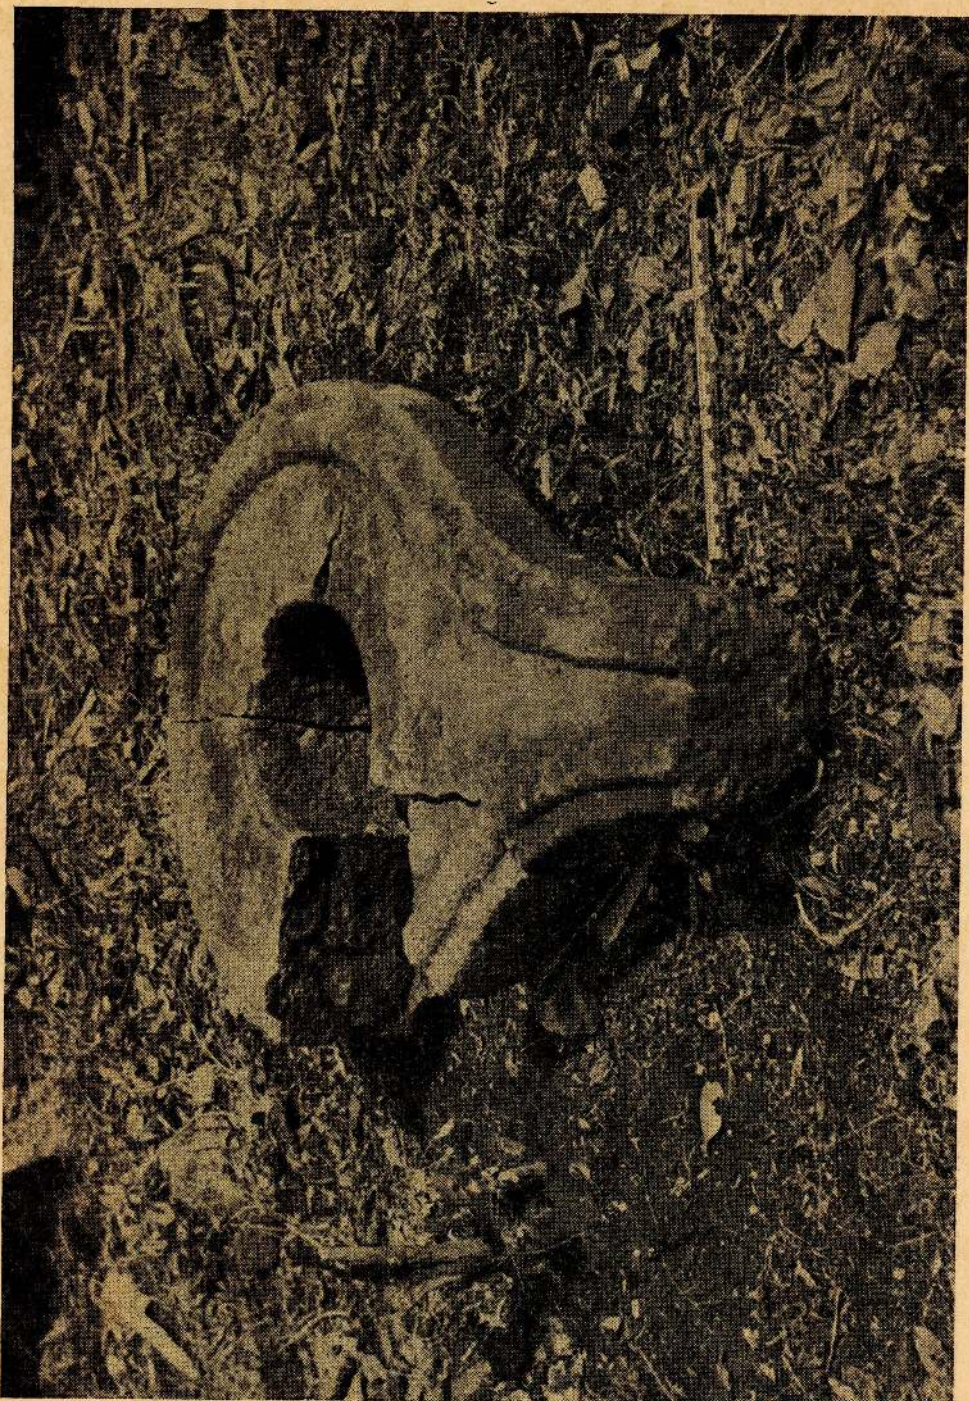
VI—പദ്മിതയുടെ തിരുവടം / *Shalingsa* pedestal from Padaviya

Outside the moat on the western side a site probably of a Siva-devale was excavated. Some stone pillars, one with an inscription, are *in situ*. The pedestal of a *lingam* (*yoni*) in fragments was found at this site (See Plate VI). On the eastern side, also outside the moat, a Siva-devale, which had been noted earlier was excavated. Here, a crystal reliquary shaped like a dagoba was found. The dagoba features above the dome, of this reliquary, were missing. The Slab inscription on this building and another one close by have already been noticed. This excavation showed that sculptured stones belonging to a building within the citadel were used in the structures here. Of these stones particular mention has to be made of an elaborately carved pillar which now stands at the entrance of the structure and a stone window sculptured with the lotus motif in chequer pattern (See Plate VII).
