### Administration Report of the Archaeological Commissioner for 1960

C. E. Godakumbura, M.A., Ph.D., D.Lit. (London)

# ලංකා පුරාවිද්‍යා දෙපාර්තමේන්තුව

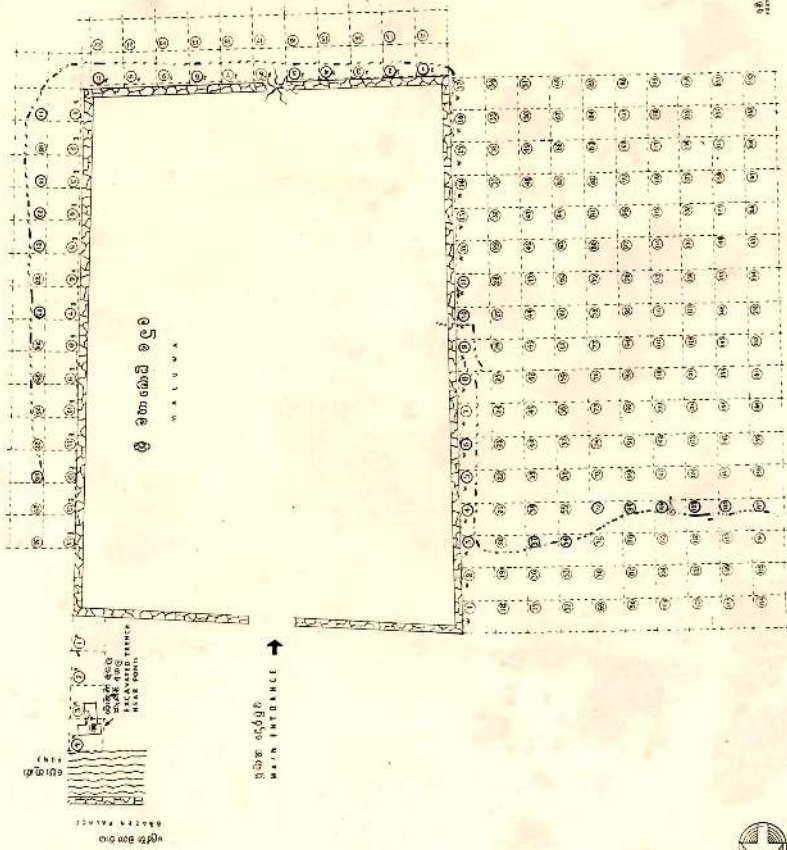
සැලැස්ම  
PLAN I (a)

ශ්‍රී ලංකා කේන්ද්‍රීය ඉතිහාසයේ සොයාගැනීම් ප්‍රකාශන  
GRID LINES OF TISSAHAMA EXCAVATION KUNDA THE PRASARA OF THE SACRED BU-IRIE

අනුරාධපුරේ ඉතිහාසයේ  
සොයාගැනීම් ප්‍රකාශන  
EXCAVATION DRAWINGS  
TISSAHAMA  
KUNDA THE PRASARA

This channel enters the terrace of the Sacred *bō*-tree under the ancient parapet wall, traverses round the new, and enters the pond of the Brazen Palace. The channel was built up of and paved with bricks except where it enters and leaves the storage tank. At these points the paving is of granite instead (sq. N. 4). It was covered on top with slabs of stone—no plaster is visible either on the sides or on the pavement, but a fine-grained clay has been used for the brickwork and a whitish clay (*kirimāṭi*) for fixing the granite cover-slabs. The brick paving was found all along the channel except where the existence of bed rock (distintegrating brown rock) precluded the necessity of the brick paving. A side wall of the channel

Very probably, in ancient times, the channel had been broken at a point in sq. E. 5 and its stone cover-slabs removed. Two of the slabs so removed still lie beside the path of the channel. The ruins of a contemporaneous structure were encountered at sq. No. E. 24. One wall with seven courses and another of five were noticed. No attempt was made to excavate this building. The channel was found damaged at the place where this structure was met with.

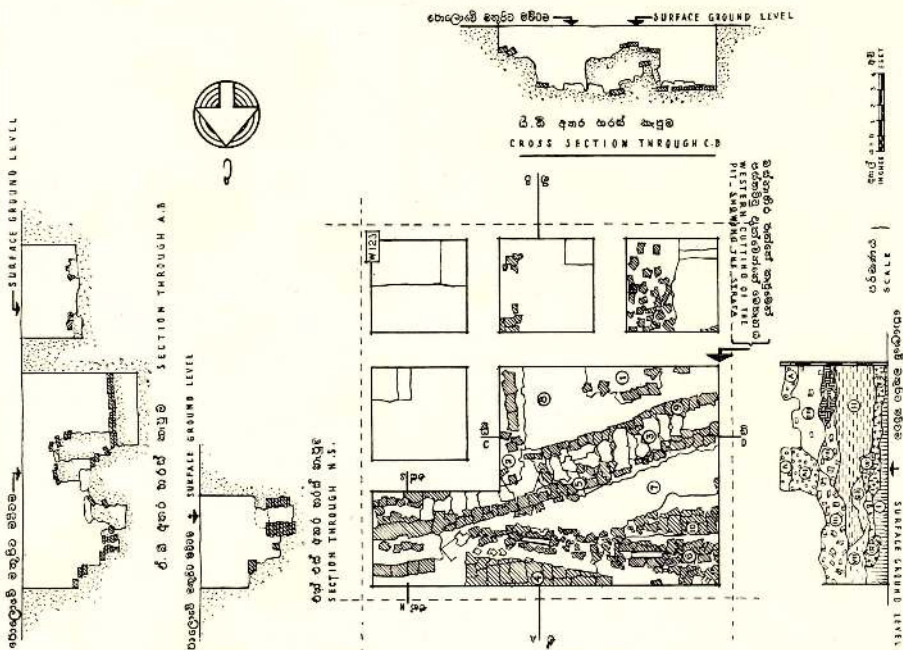
DRAWINGS OF THE EXCAVATION PIT  
(GRID NO 123) OF TISSARAMA TO THE  
WESTERN SIDE OF THE SACRED BO-TREE  
PRAKARA.

1. A brick from a wall of structure beside main channel sq. No. W. 123, 11" × 10" × 3";
2. A brick from channel No. 2—sq. No. W. 123, 15" × 9" × 2";
3. A brick from main channel sq. No. W. 123, 16" × 9" × 2½"; and
4. A brick from point where a large earthenware pot was found in the breached side of channel, sq. No. W. 37, 13½" × 7½" × 2½"

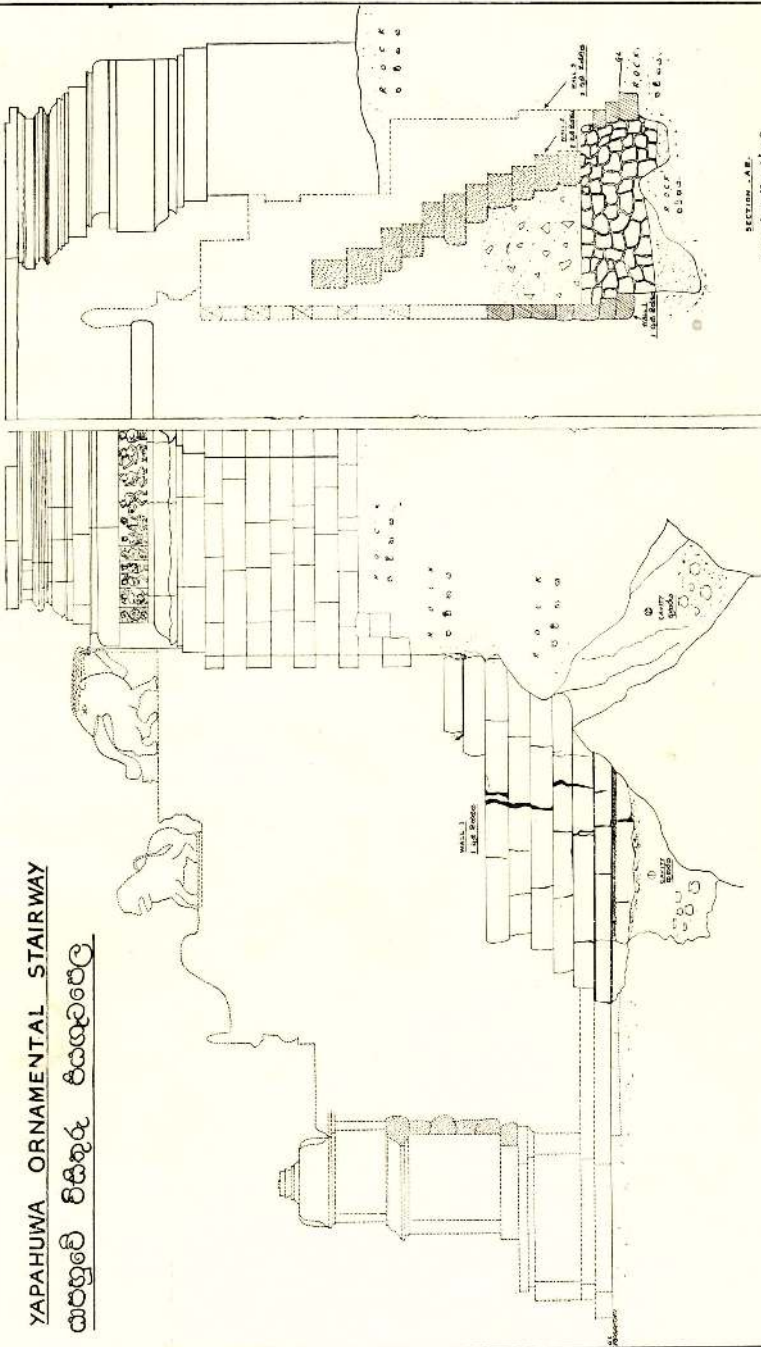
YAPAHUWA ORNAMENTAL STAIRWAY

SECTION A-B

“The outermost structure was a decorative wall which had been conserved by the Public Works Department in 1886. They had used a cement mortar rather lavishly in binding the structure together. The absence of such mortar in the bottom-most row of dressed stones and in the foundation was conspicuous. As such this lower portion perhaps belonged to the ancient work. The dressed stones have been laid on a rubble foundation in which some amount of lime mortar had been used. The bottom row of the dressed stones was fitted into a cut in the bed rock. As such some of the stones have been purposely made to fit into position. The dressed stones have been keyed into the bed rock by a continuous groove running along the outer edge of it. Thus the level and the position of the bottom-most row of the outer decorative wall are clearly established.

Immediately behind the decorative wall was a partially fallen structural wall consisting of 36 very heavy rough cut stones in nine rows built in clay mortar. Each successive course in this wall was recessed about 4" from the one immediately below. Apparently this wall had fallen at a time previous to the decorative wall being repaired by the Public Works Department in 1886, but the engineers who repaired the outer decorative wall do not appear to have appreciated the need for conserving this structural wall. This was perhaps why the decorative wall collapsed within such a short space of time. The structural wall has been built on a rammed earth foundation due to the unevenness of the bed rock. The foundation touches the bed rock only at a few points. The bed rock referred to above is in fact a natural boulder of very large dimensions. The structural problems pertaining to the foundation of the stairway had increased due to the boulder having a continuous fissure with an average breadth of 2½ ft. It was in this cavity of the boulder that most of the pottery was found.

The inner decorative wall is absolutely perpendicular. The line of this inner wall coincides with the edge of the steps and as such the sheer drop at the meeting point with the porch is 24 feet. This is perhaps the reason for the structural instability of this wall and the subsequent need for the structural wall. The bottom row of the decorative wall was on rammed earth. This wall touches the bed rock at three points as in the case of the structural wall. A clear set of cracks running along the inner decorative wall indicates a certain amount of settlement. As the cavity of the bed rock boulder runs perpendicular to the 3 walls the problems of settlement seems to have been common to all three of them but the settlement on the inner decorative wall is so marked that some structural reinforcement seemed imminent.

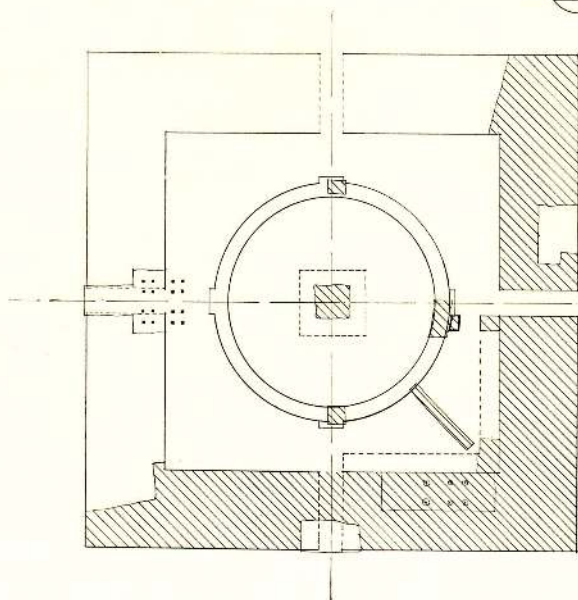
# කිරිවිහෙර මාවතේ කැණීම EXCAVATION OF KIRIVEHERA AT KATARAGAMA

The excavation revealed six different phases of work at the *maluva*, that is, six different periods of alteration or major repair. (Plan No. VI). The numbering of the phases is begun from the latest phase which is encountered first.

*Phase 2.*—During this phase the upper platform and the sand-strewn court. (*Vālimaluva*) have been made into one, ultimately making a *maluva* of 200 by 200 ft. The outer parapet wall (*piākāra*) of the *Vālimaluva* has been converted into a retaining wall. Examination of the dagoba itself indicated that the existing dome was constructed during this period. It was also learnt that bricks from the *maluva* had been used in the repairs or the enlargement of the dagoba. The reason for filling up the *Vālimaluva* up to the height of the platform (*Uḍamaluva*) may have been the inability to maintain it.

*Phase 4.*—The platform has been enlarged during this phase, a new flight of steps has been constructed over that of the preceding phase, and a pair of new brick balustrades had been built (Plate XVII). At this stage, the platform stands 10 feet above the lower-court. To this phase belong the heavily moulded bricks of the platform. Mixed with the lime plaster of this period are found broken sea-shells. The imposing *stucco* mouldings of the platform belong to this phase. (Plate XVIII).

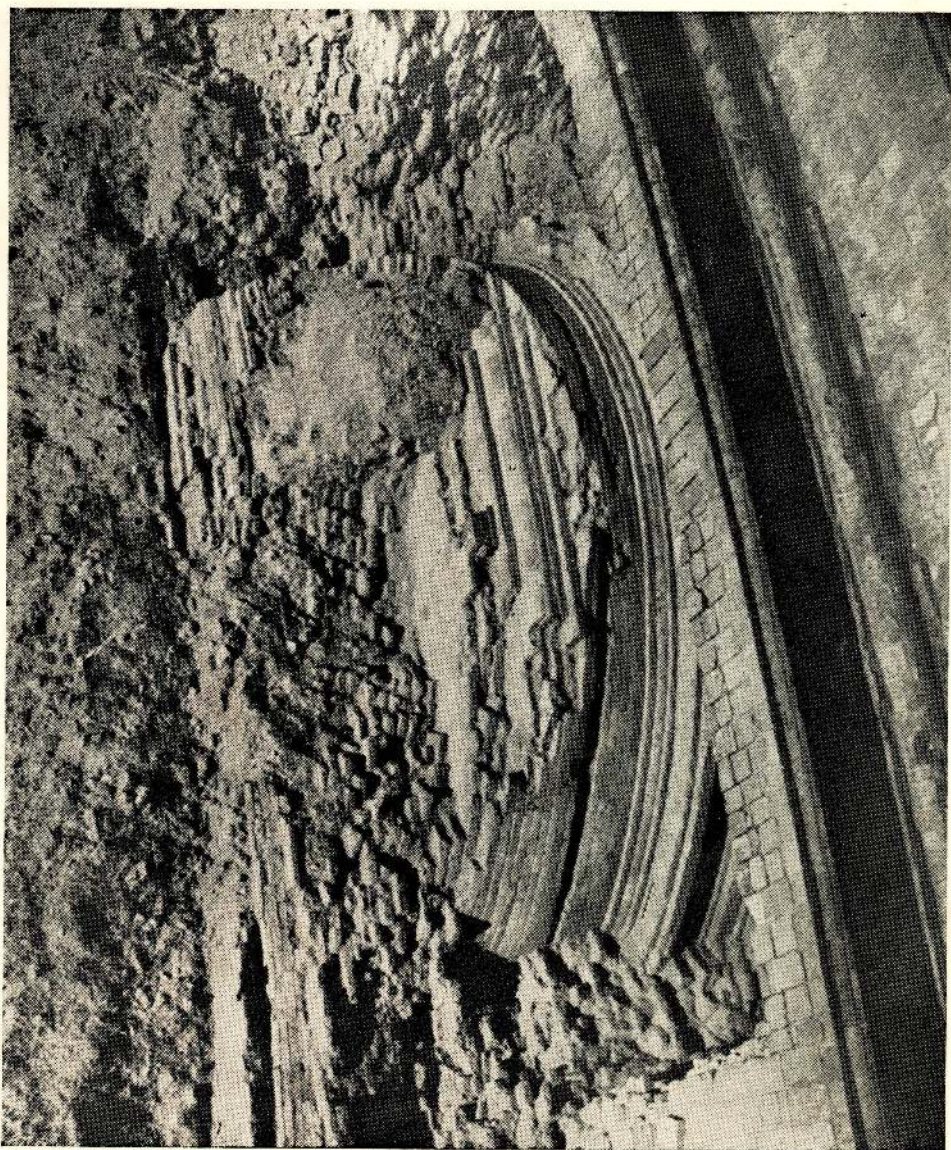
දැදිගම ලොකු ස්තූපය තුළ කුඩුණු කුඩා ස්තූපය  
SMALL *Stūpa* WITHIN THE LARGER ONE AT DĀDIGAMA

Later in the course of the conservation of this *stūpa* it was found that a much smaller *stūpa*, was covered by it, on its eastern fringe (Plate XIII). The department undertook the excavation of this small *stūpa* in July 1960. It was found that the plane on which the small *stūpa* begins is lower than that of the big *stūpa*. The results of the department's investigations are given below :—

During the course of the excavation of the small *stūpa*, at a height of 15', was found a small chamber in the centre. This chamber was investigated on 13.7.60. The sides of this chamber were on the cardinal points. It was 1' × 1' and 1' 3" in depth. The chamber was brick faced and covered with a stone slab of irregular dimensions and about 2½" in thickness. The brick paving of this chamber was raised by 3" along the western wall. On this raised portion was placed a seated Buddha statue made of gold foil height 3½"; breadth at legs 3½" and breadth at shoulders 2". This statue faced the East. Opposite the statue was a small, crystal replica of a *stūpa* height 1½" and diameter at base ¾". In line with these, near the East wall of this chamber was a bronze coconut-oil lamp, height 1' 2"; diameter at base 5½". As excavations proceeded further down, at a height of 12' 6" was found a circular brick paving 4' in diameter. Further down at a height of 11' 3" another circular brick paving was encountered. The soil in the *stūpa* was reddish upto a point, but, turned to a blacker hue at 13' 3".

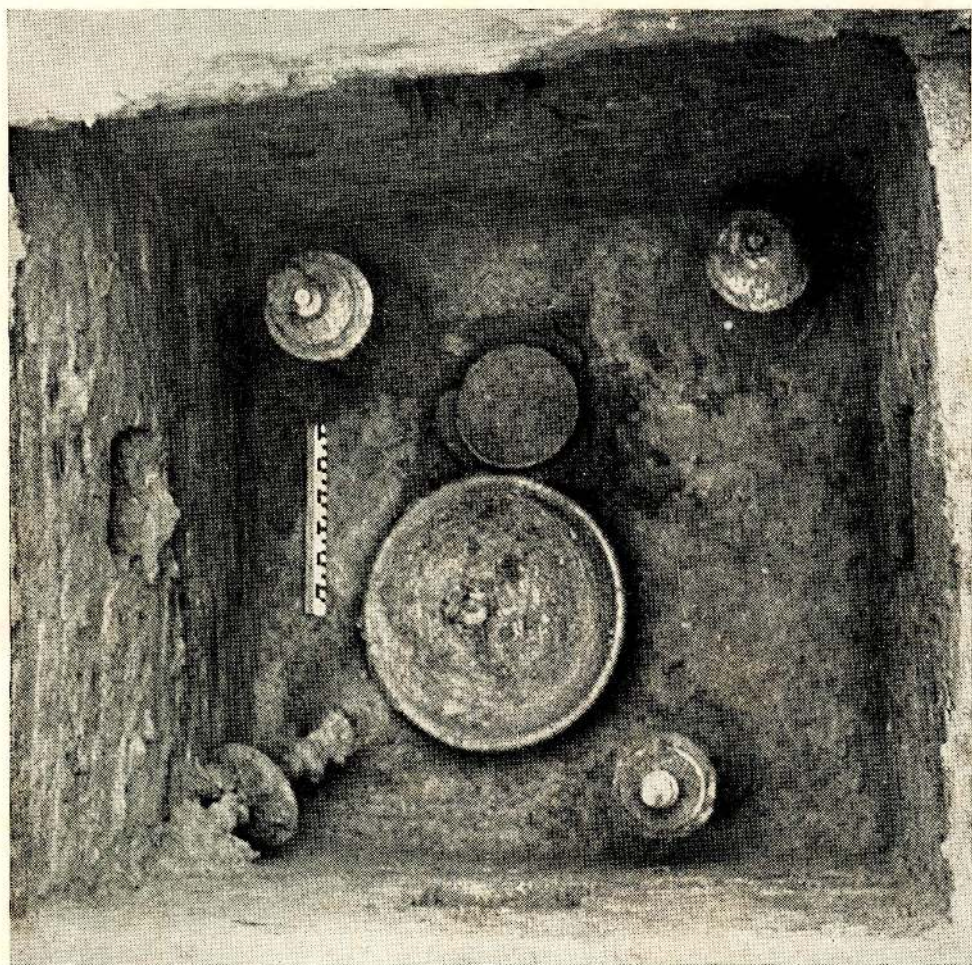
දැඩිගමින් ලැබුණු මැටි බඳුන් තුඩුණු හැටි  
EARTHENWARE POTS *in situ* DĀDIGAMA

Also were found two clay vessels in a good state of preservation. The bigger one was found to be 2'8" from the northern corner and 1'3" from the eastern. The smaller vessel was 1'10" from the northern corner and 2'8" from the western.

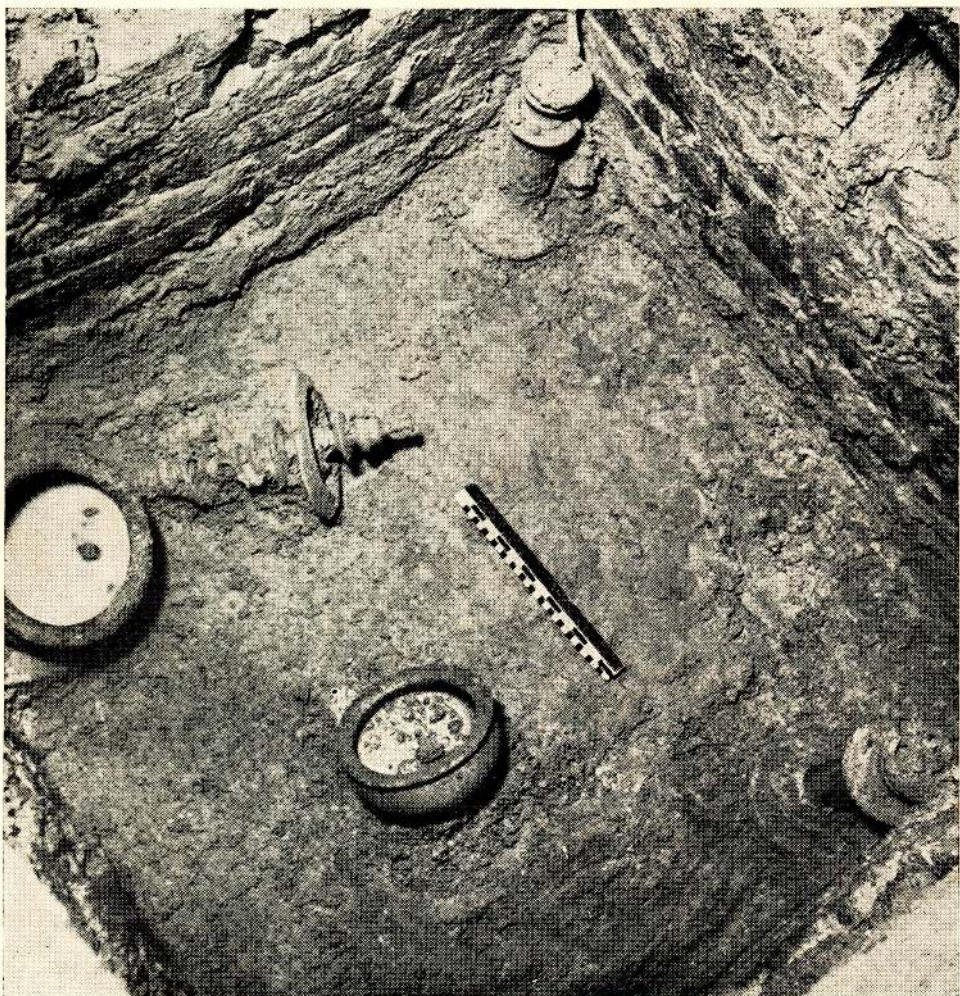
1960.10.11 දින දැදිගම විවෘත කළ ධාතු ගර්භය  
RELIC-CHAMBER OPENED ON OCTOBER 11, 1960 AT DĀDIGAMA

There was a small crystal *karaṇḍuwa* 1½" in height in the shape of a miniature dagaba in the centre of the chamber. On examination of the soil at the floor of the chamber were found a silver-plated coin of Vijayabahu (10th century) and one thousand two hundred and thirty-four—1,234 semi-precious stones.

There were four niches (one on each side measuring 8" × 7"), each niche being 2'0" above floor level of relic chamber and receding to a depth of 8". These niches were placed in the central vertical axis of each wall of the relic chamber. In each of the niches were four gold-foil Buddha statuettes in *samādhi* attitude. These statuettes were very badly damaged as the core, probably of paste, had decomposed.

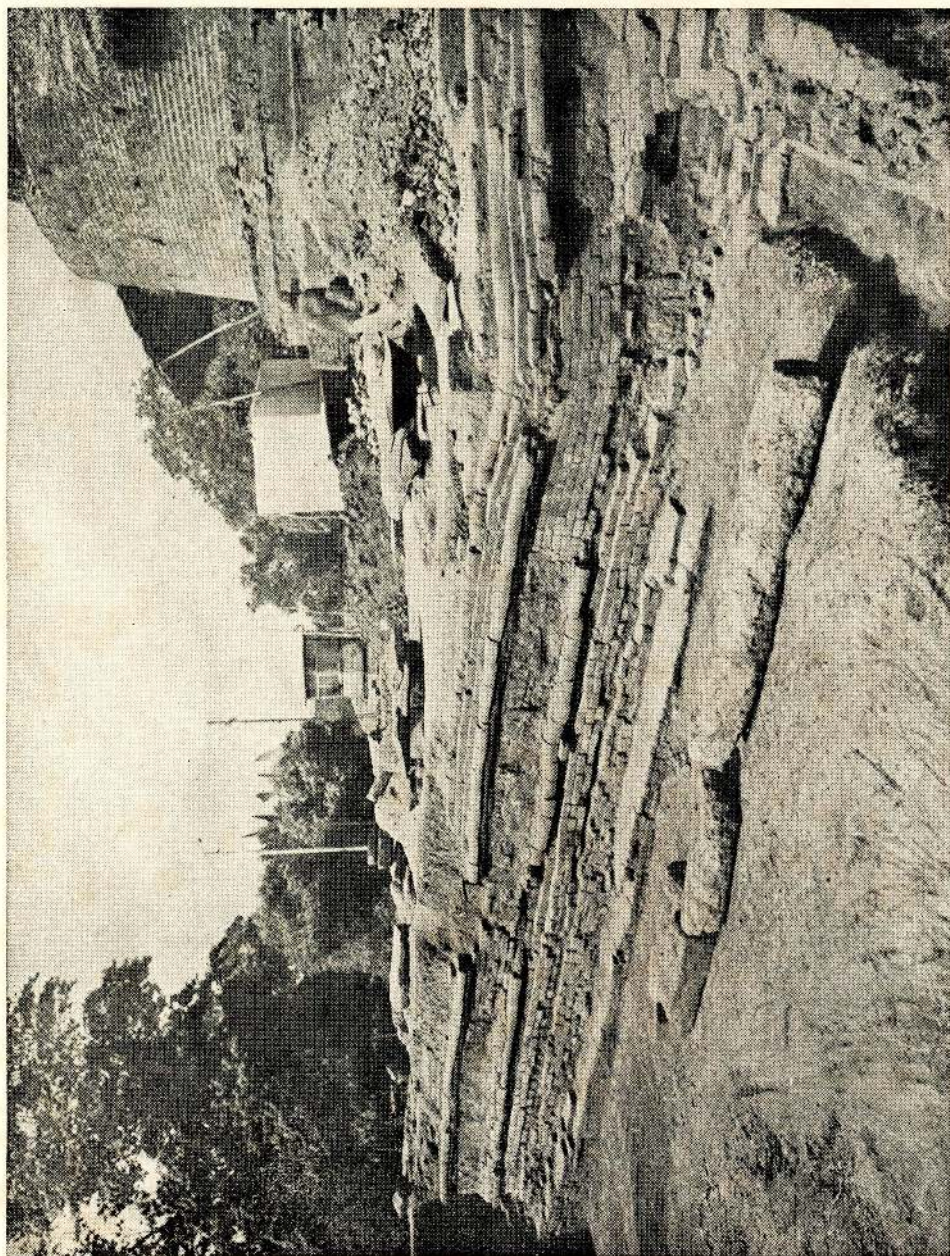
කතරගම කිරිවෙහෙරේ මලුවේ කැණීම  
EXCAVATION OF MALUVA OF KIRIVEHERA, KATARAGAMA
