Administration Report of the Archaeological Commissioner for the financial year 1960-61

November, 1962

C. E. Godakumbura, M.A., Ph.D., D.Lit. (London)

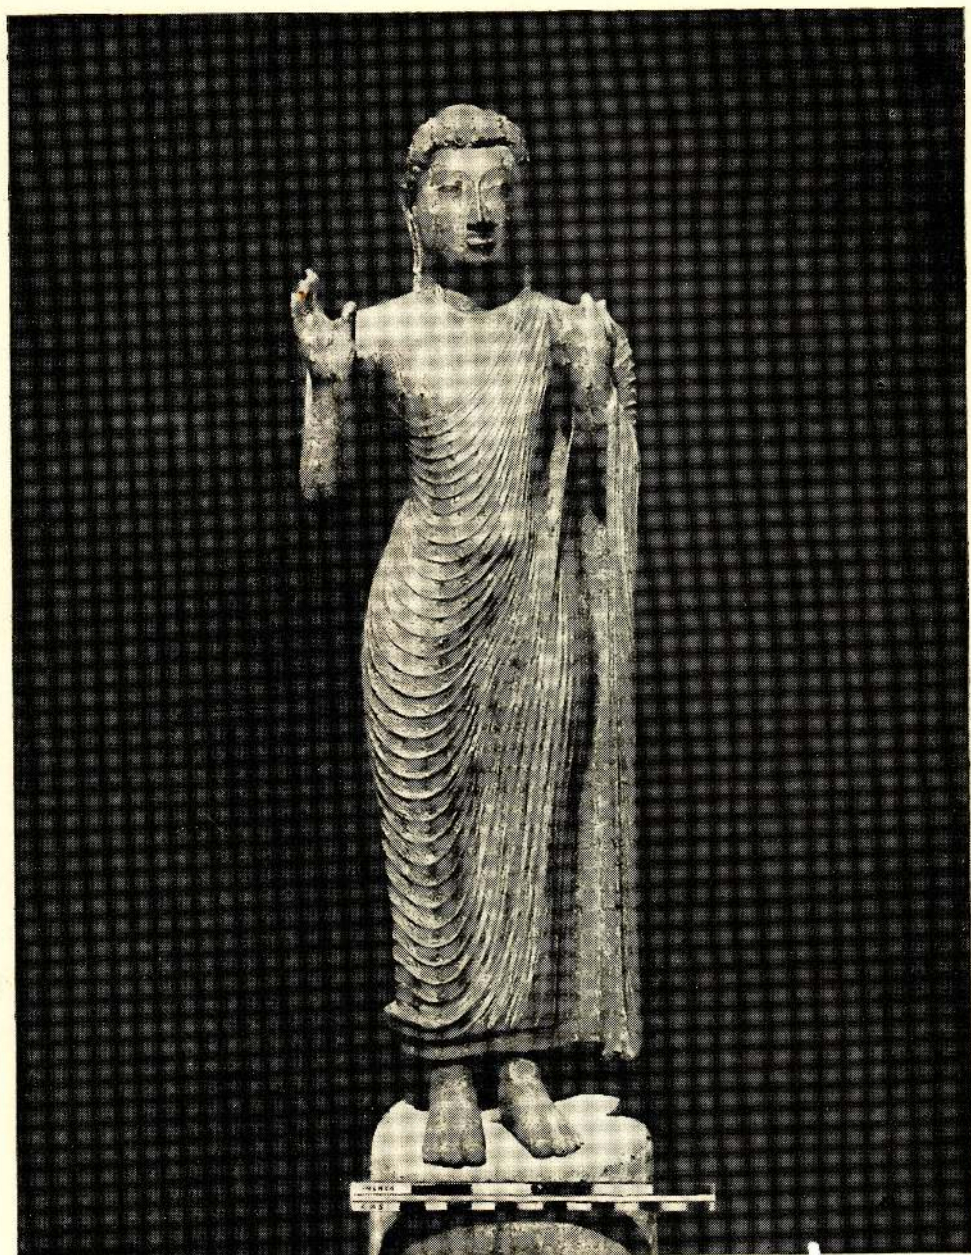
මදවච්චියෙන් ලැබුණු බුදු පිළිමය

BUDDHA STATUETTE FROM MADAWACHCRIYA

රාත්තල් නිහකුන් අවුත්ස අටක් බඳුනි මේ ප්‍රතිමාව උසින් අහල් 18 කි. පිළිමයෙහි රන් ආලේප කර තිබුණු බව පෙනෙනවා. මේ පිළිමය ගැන මා ලියූ ලිපියක් ආට්ලිස් ආසියා සභාවේ පළ කිරීම සඳහා පිළිගෙන ඇත. මේ ප්‍රතිමාව දෙවන ශත වර්ෂයට පමණ අයත්යැයි සිතිය හැක. (ජායාරූපය නො. 1)

During the year, what is perhaps the oldest bronze statue so far discovered in South-East Asia was added to the Museum through the intervention of the Hon'ble Minister of Industries, Home and Cultural Affairs, Mr. Maithripala Senanayake. The statue weighing 30 lbs. 8 ozs. and measuring 18 inches in height, found in the village of Virālmurippuva at Mādavacciya is a work of great artistic merit, and bears traces of its having been gilt. The present writer in whose opinion this statue may belong to about the 2nd. century A. D. has submitted a paper on the subject of this statue to the journal *Artibus Asia*. (See Plate 1).

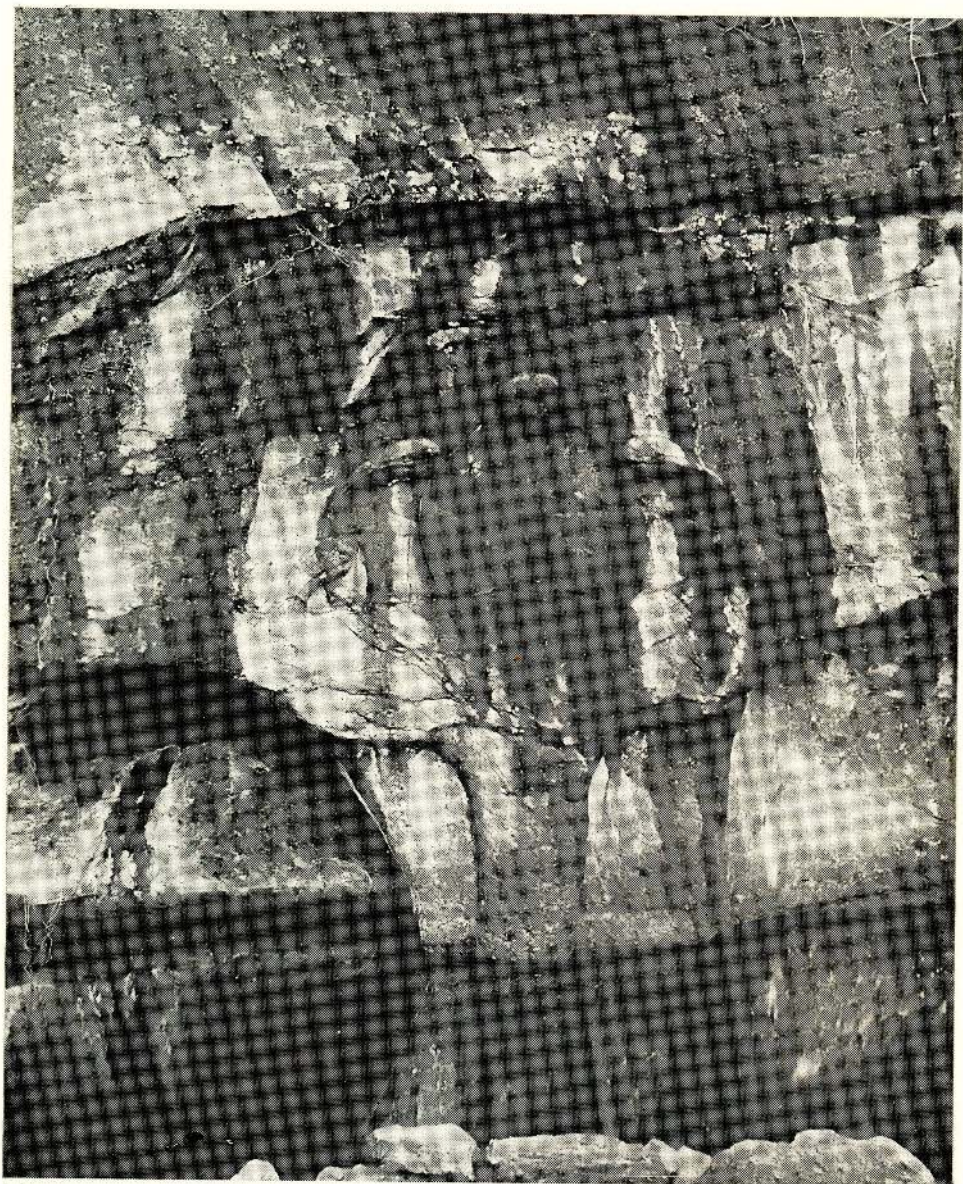
මිහින්තලයේ නාග පොකුණ වතුර තිබියදී
NAGAPOKUNA, MIRINTALE—WITH WATER

නාගපොකුණ පතුලේ එකතුව තිබුණු අඩි තුනක පමණ මඩ තට්ටුවක් අස්කිරීම සඳහා මිහින්තලයේ වැඩකරන මුළු කම්කරු ගණනම පුරා සතියක් වැඩට යෙදව්වා. නාගපොකුණට පොළව යට තියෙන උල්පතකින් වතුර ලැබෙනවාය කියා කට කතාවක් තියෙන නමුත් ඊට වතුර ලැබෙන්නේ වර්ෂාවෙන් පමණක් බව මේ වැඩ කිරීමේදී පෙනුන බව මෙහි සඳහන් කරන්නට හැකිය. (ඡායාරූප නො. II සහ III).

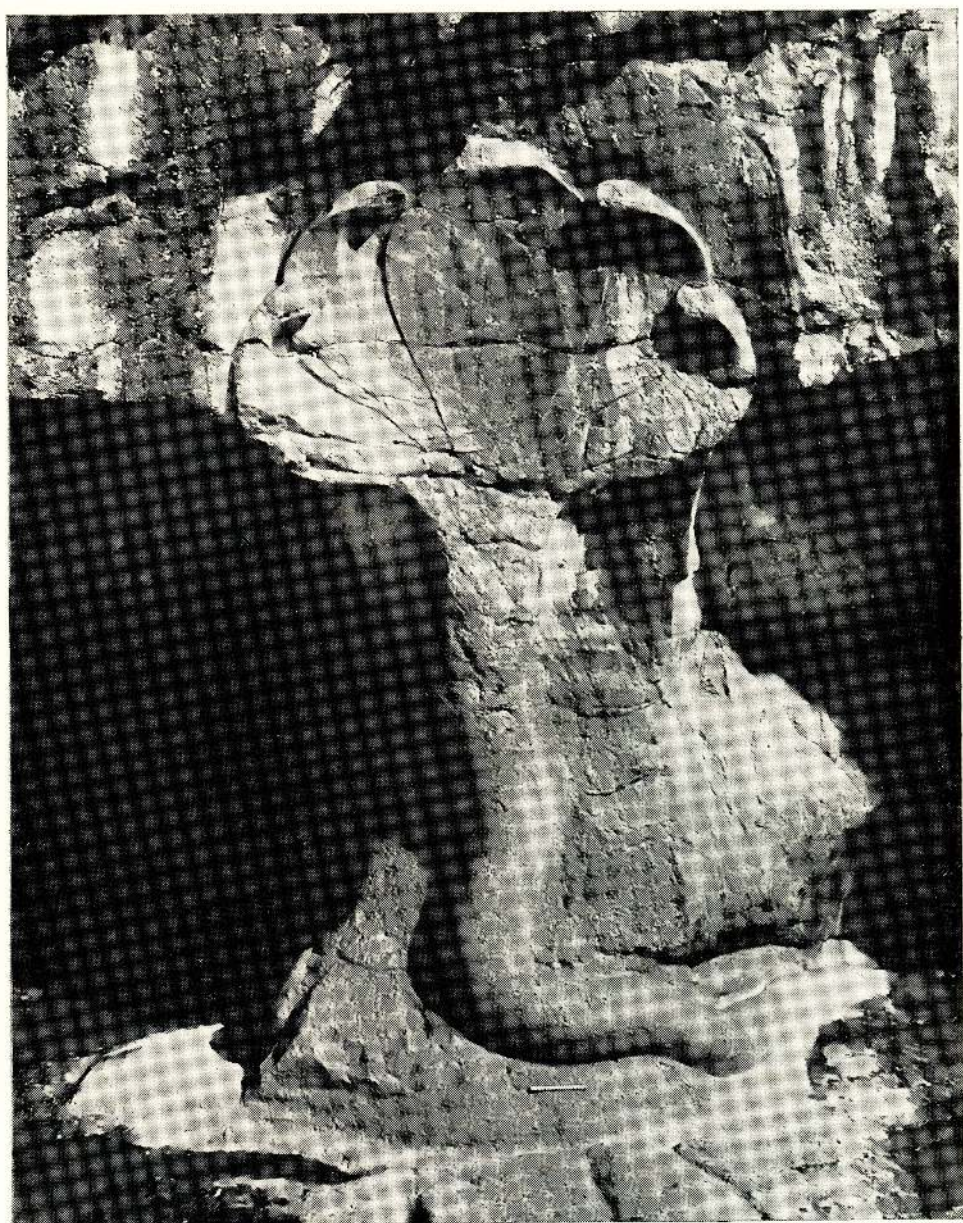
මිහින්තලයේ නාග පොකුණ-හිස්කළ පසු
NAGAPOKUNA, MIHINTALE—AFTER EMPTYING

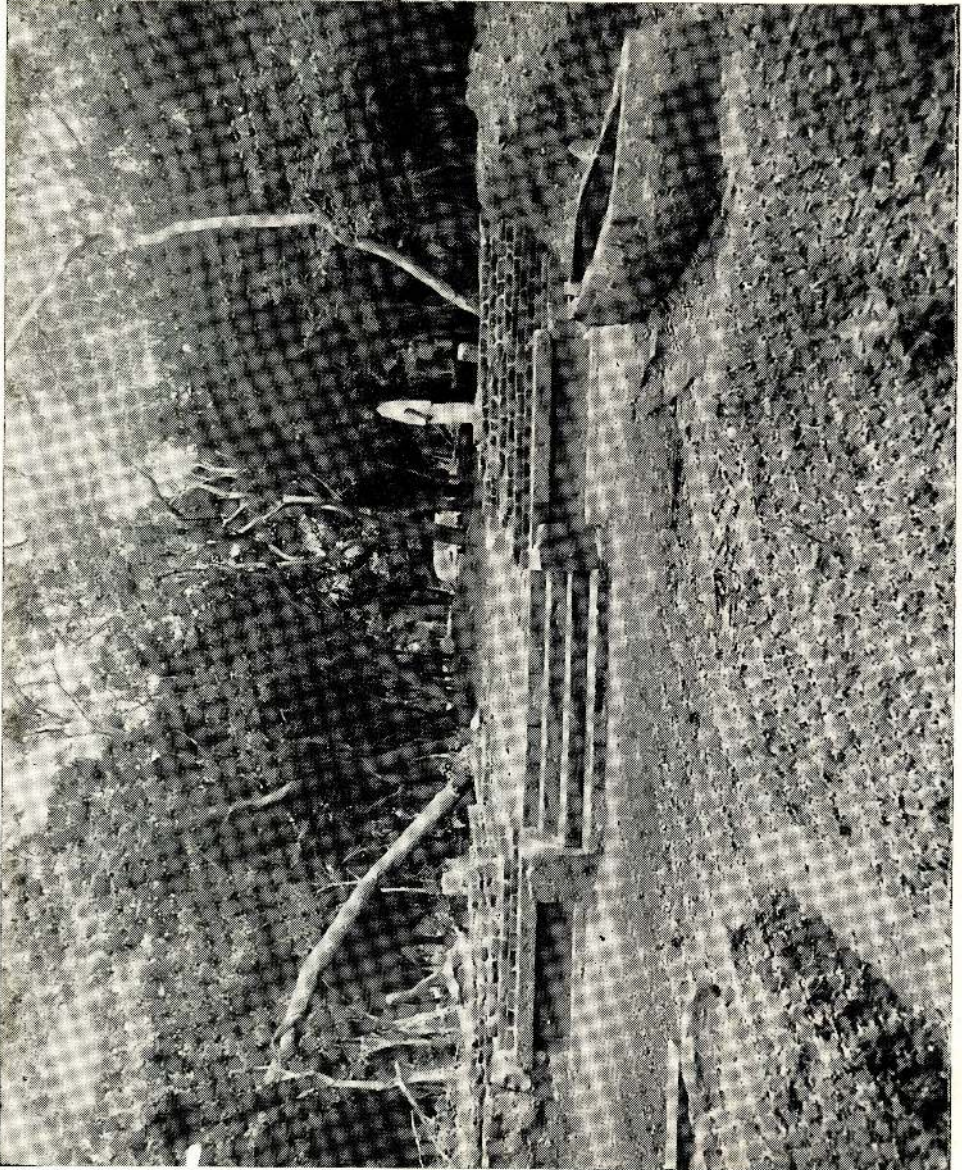
PLATE IV

പേരിയക്കുളം ദേവാലയത്തിന്റെ തെക്കുഭാഗത്തുള്ള കിരീടപ്പുറം

SOUTH PORCH OF IMAGE-HOUSE, PERIYAKULAM AFTER CONSERVATION

The southern porch of the image-house at Periyakulam was conserved. Here imitation steps in cement were supplied in place of the missing granite steps. The broken parts of one of the guardstones were put together with a steel rod. (See Plate IV).

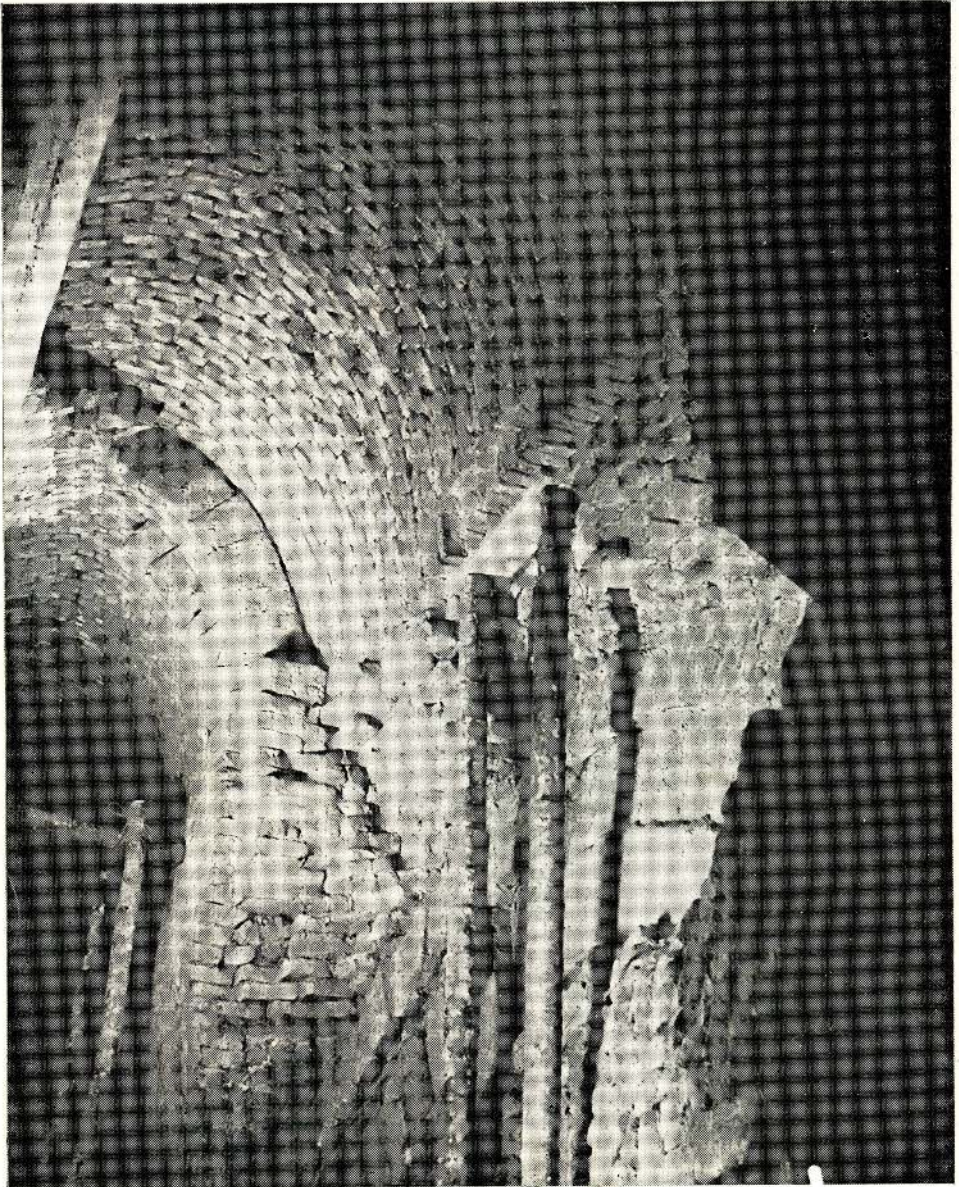
ලංකාතිලක විහාරයේ ආරක්කුටි, තහවුරු කරනට පෙර
VAULT OF LANKATILAKE VIHARA—BEFORE CONSERVATION

No conservation work was done at Polonnaruwa apart from the routine "pointing" work and the re-buliding of badly decayed portions of the brick-walls of the Lankatilaka and the Tivanka Pilimage. On both these shrines parts of the decorative work such as pilasters and mouldings had to be replaced.

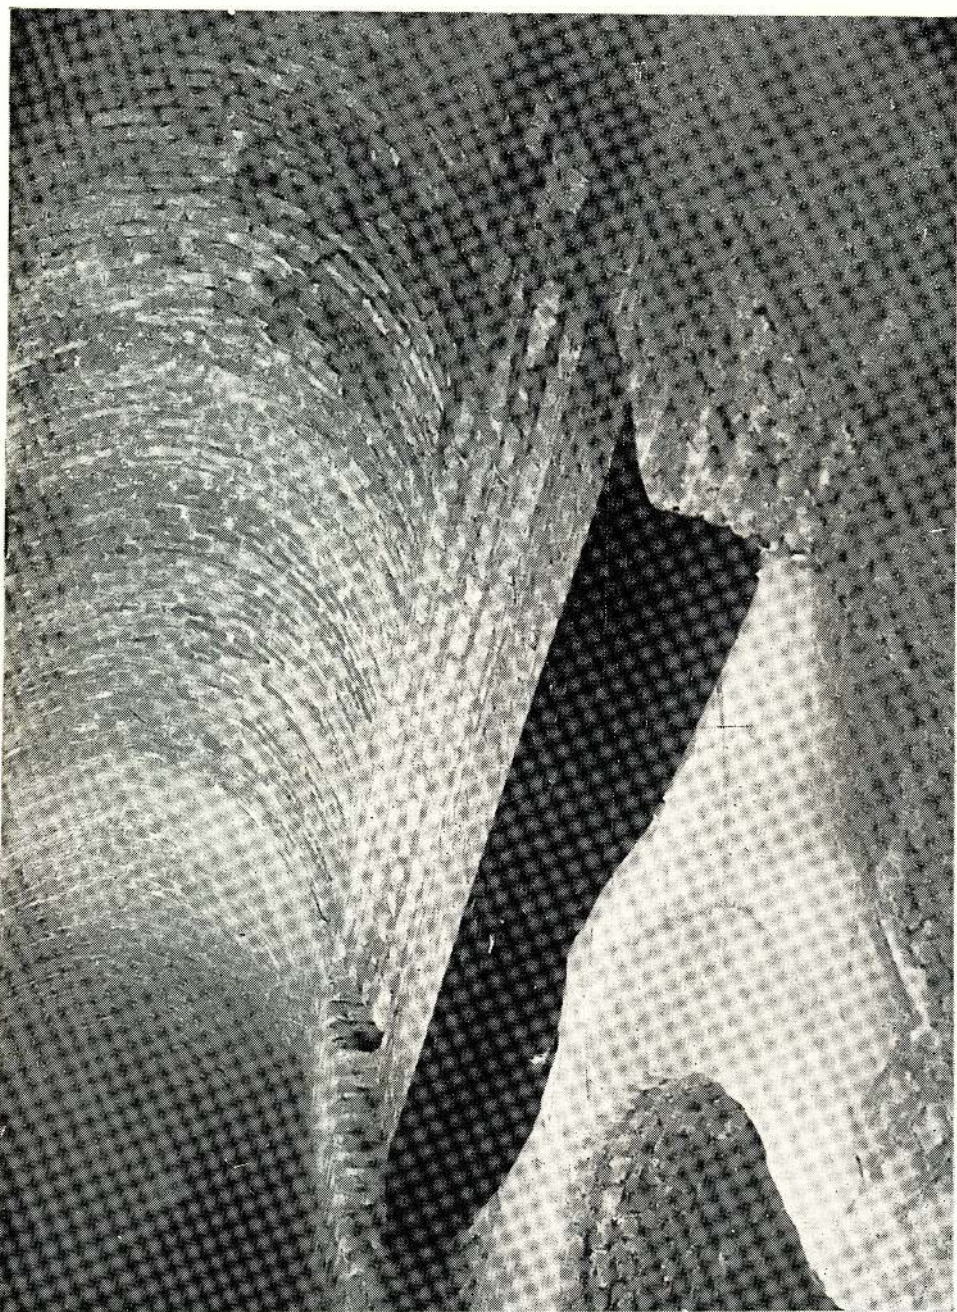
ලංකාතිලක විහාරයේ, ආරුක්කුටි තහවුරු කළ පසු
VAULT OF LANKATILAKE VIHARA—AFTER CONSERVATION

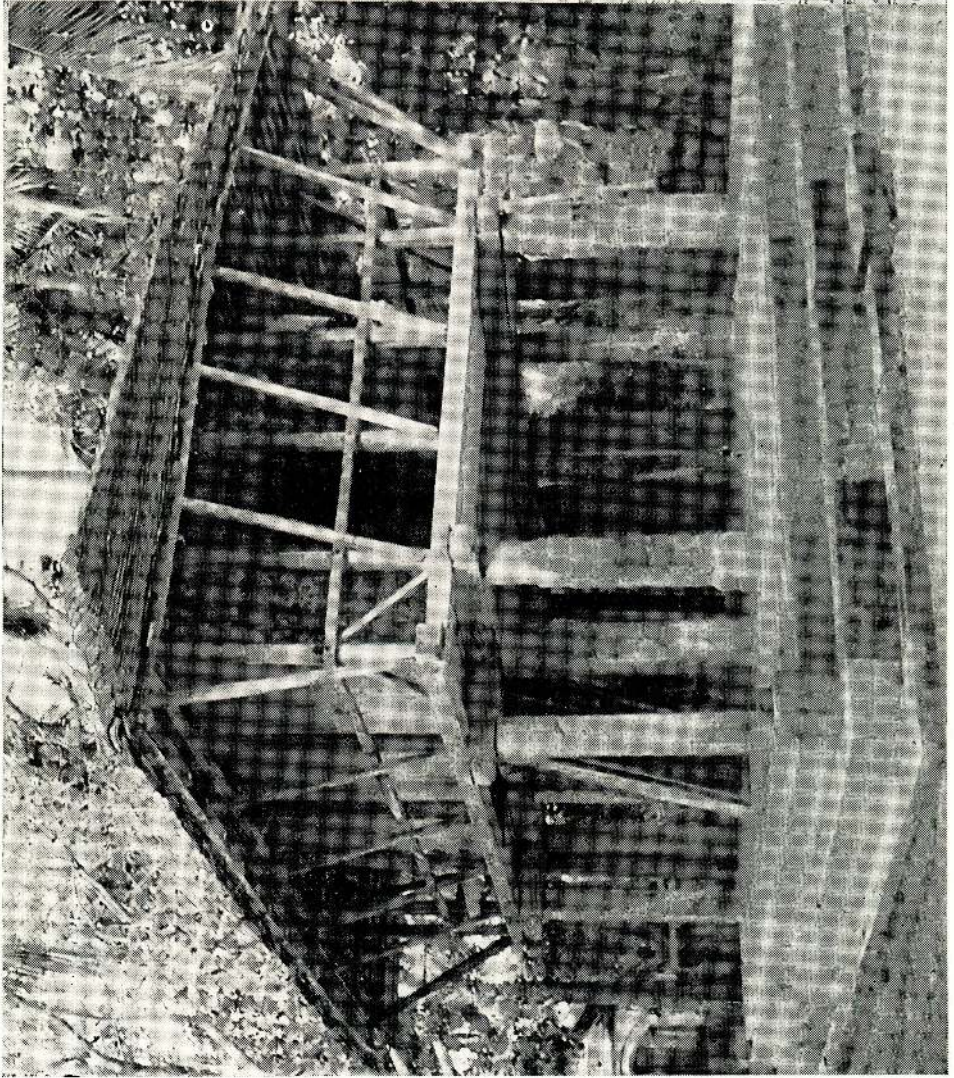
මැළිපිට විහාරය, දොරාවිල, නැගිටිලි, කරනට පෙර
TEMPLE ON PILLARS, DORAVILA—BEFORE CONSERVATION

The department found the roof of the *Vihāragē* crumbling. The tiles were carefully removed and the roof timber dismantled. A strong scaffolding was constructed to support the superstructure, and a temporary roof built over the existing *Vihāragē*. The next stage of the work was the removal of the decayed beams which supported the wattle and daub walls of the shrine containing frescoes and the plank platform on which the vihāra was built—an operation fraught with danger. This was done by supporting the weight of the walls on 2" planks placed on an intricate scaffolding, and then removing the stone pillars which carried the beams, from underneath, by the excavation and removal of earth at their bases. Once the old beams were replaced with beams of identical specifications the pillars were slipped back into position and erected on cement concrete foundations. The floor planks at shrine room level too were replaced. (See Plan III).

All timber pillars on the platform around the superstructure, which were badly decayed, were replaced with new pillars of same size. The boards on the ceiling above the *Vihāragē* could not be removed as they carried drawings, hence the boards were secured with beams provided above them.

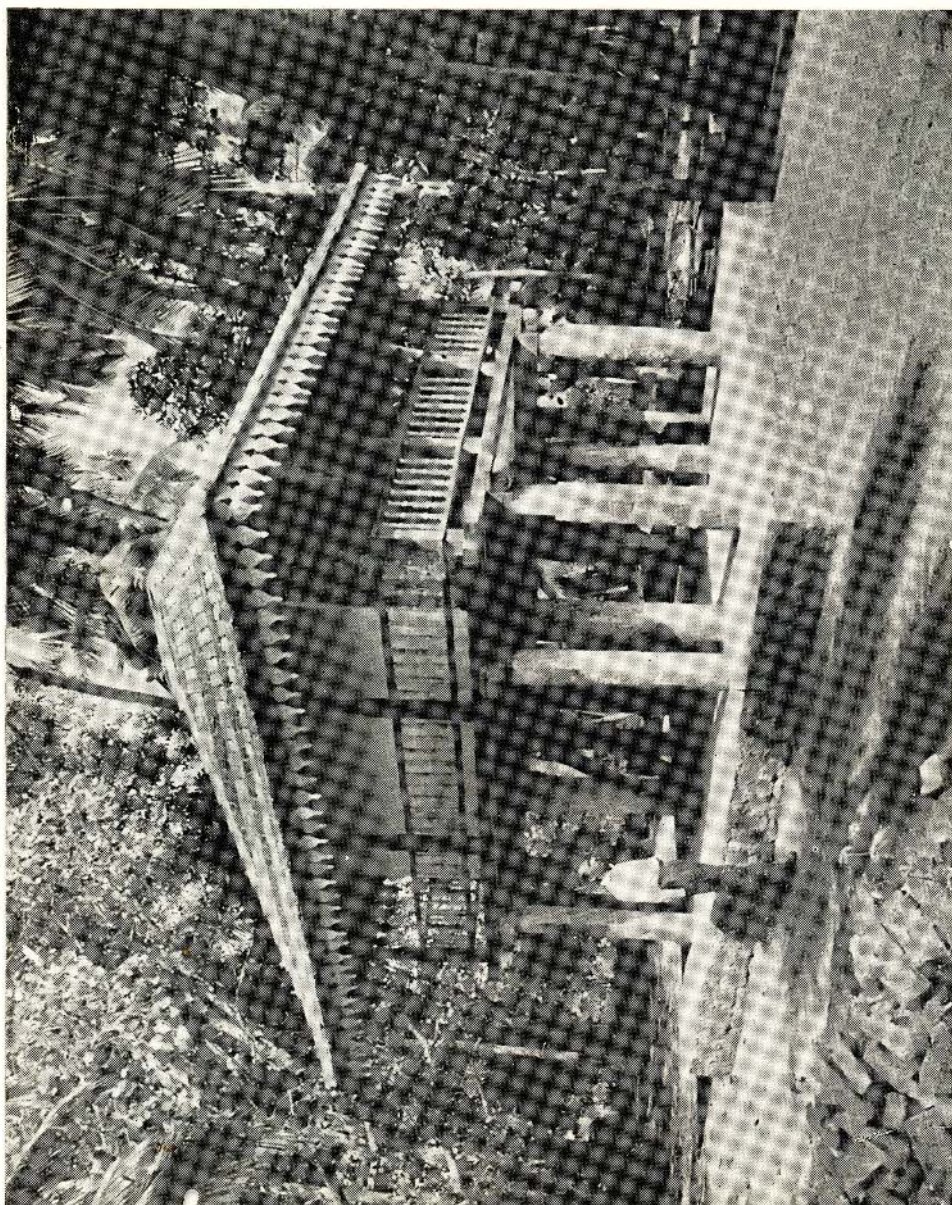
දොරවවිල, දොරවවිල, නවවරු කළ පසු
TEMPLE ON PILLARS, DORAVAVILA—AFTER CONSERVATION

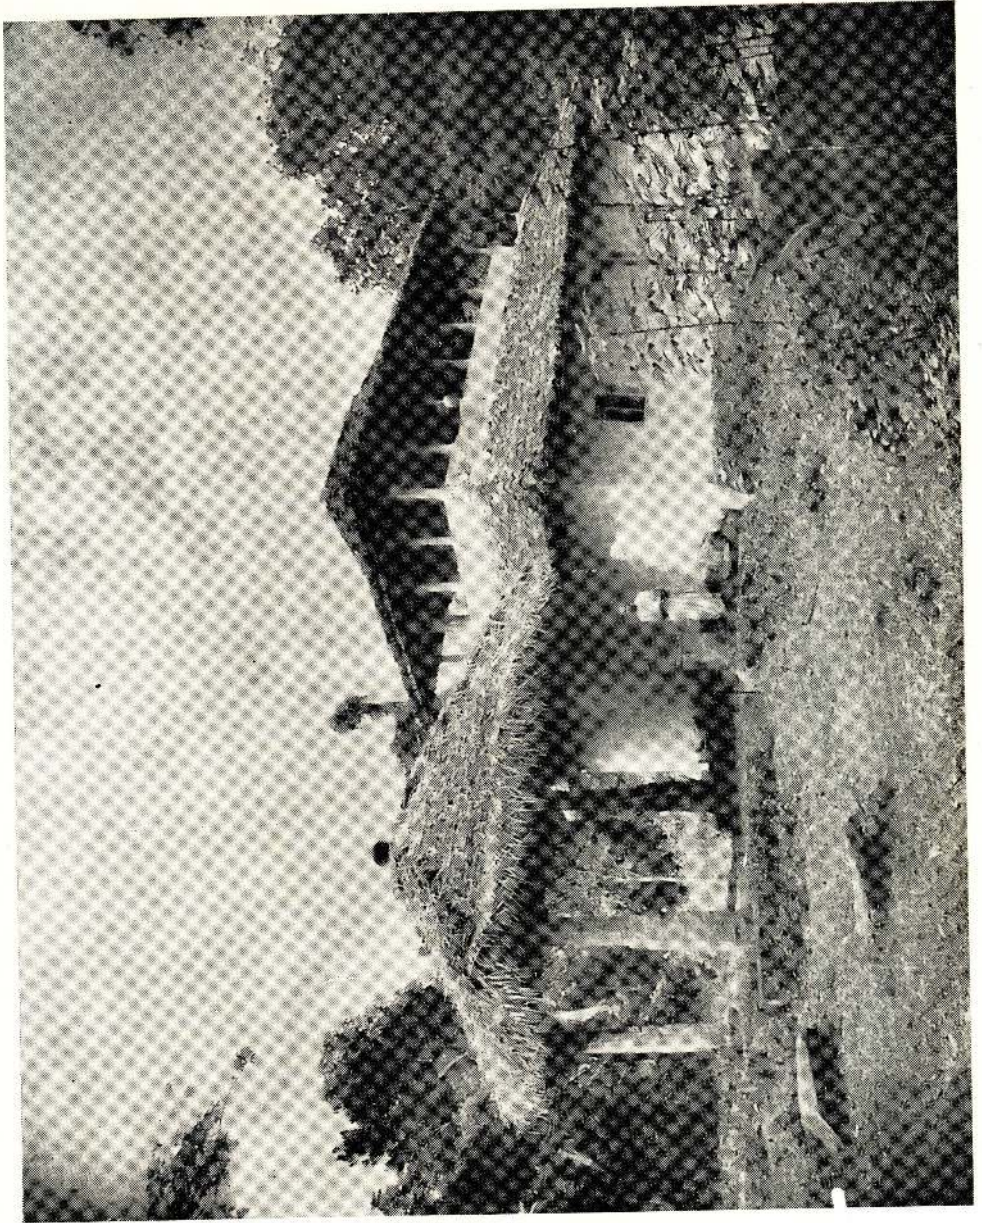
අම්බුලල විහාරය, නොවැරදි කැරැන්ට් පෙර
AMBULUGALA VIHARA—BEFORE CONSERVATION

The stucco elephants in bold relief on the western outer wall were found very badly damaged, with their tusks completely gone. These were conserved, using iron-reinforcement for the restoration of the tusks. In this connection it is interesting to note that the original "reinforcement" for the tusks of the elephants here, had been strips of *kitul*¹ wood wound round with coir strings, as is seen from the slightly damaged tusk of an elephant of the northern outer-wall.

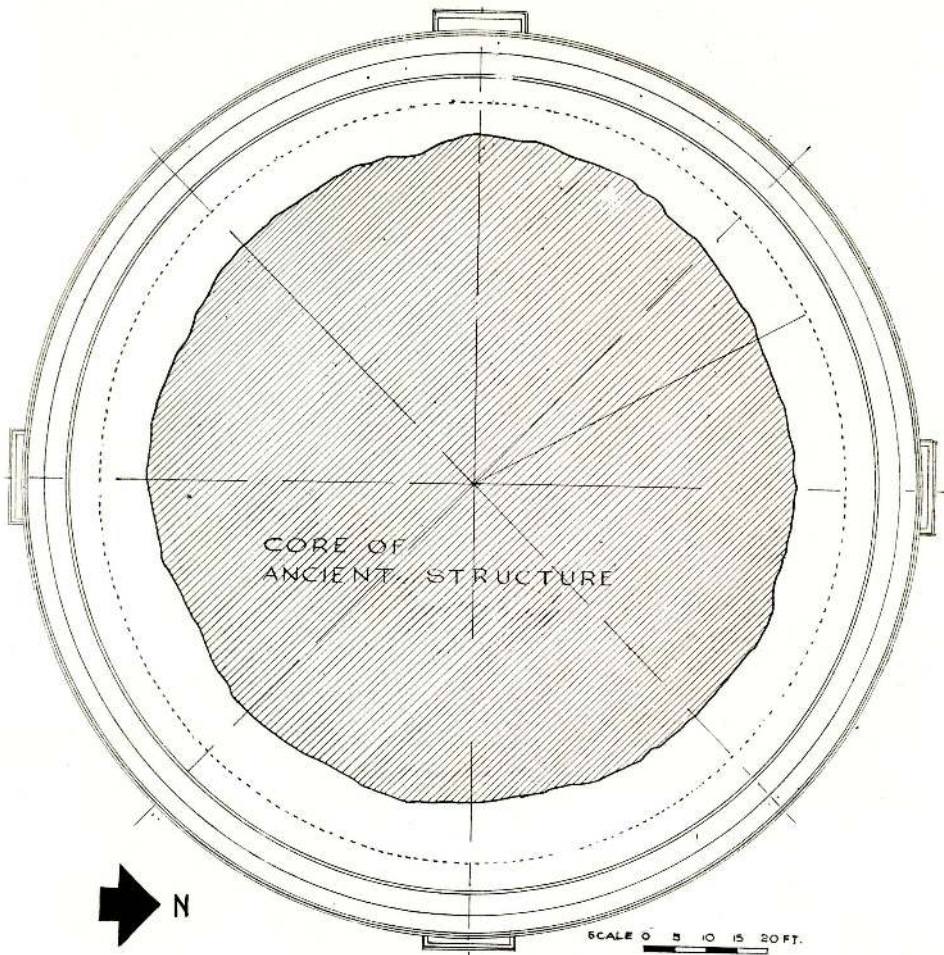
PLAN Ia.

MAHASĀYA, MIHINTALE

මාස 18 ක් තුළදී රුපියල් 10,34,650 ක මුළු වියදමින් මහාසෑය ප්‍රතිසංස්කරණය කිරීම සඳහා 61.9.1 දින සීමාසහිත වනිගසිංහ හා පුත්‍ර සමාගම සමග කොන්ත්‍රාත්තුවක් අත්සන් කළා. සම්පූර්ණ කළ පසු දැනටමත් උස අඩි 154 කුත් අඟල් 7 කි. මේ ප්‍රතිසංස්කරණයෙන් අපට සොයා ගත හැකි සාක්ෂි අනුව පුළුවන් තරම් දුරට දැනට සෑම අංගයකින්ම පැරණි දැනට හා සමවේවී (පිඹුර 1). මේ ප්‍රතිසංස්කරණයට පැරණි දැනටවලට ද්‍රව්‍ය හෝ වැඩ පිළිවෙල යොදන්නට බැරි වුන බව කියන්නට ඕනෑ. එහෙත් ඒට පසුව වැඩ කළ තැනක පැරණි ද්‍රව්‍යවලට ගැලපෙන ද්‍රව්‍යත් පැරණි ගොඩනැගිලි ක්‍රමත් යොදන්නට පුළුවන් වුනා.

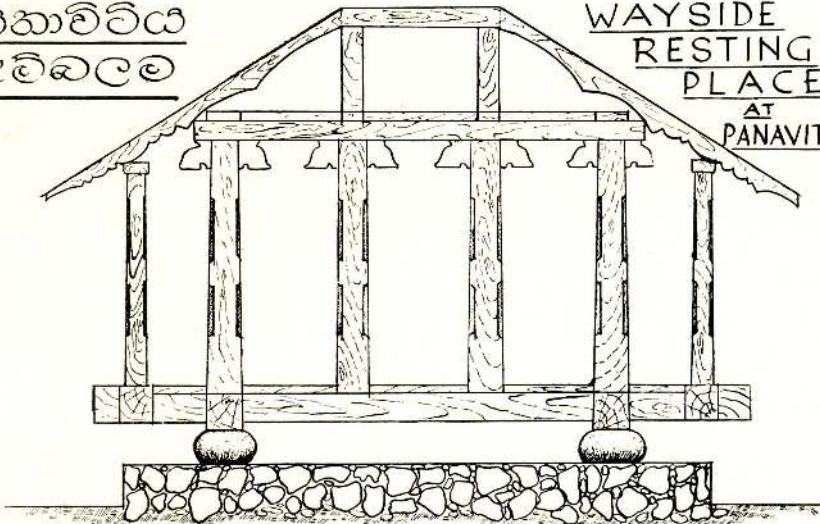
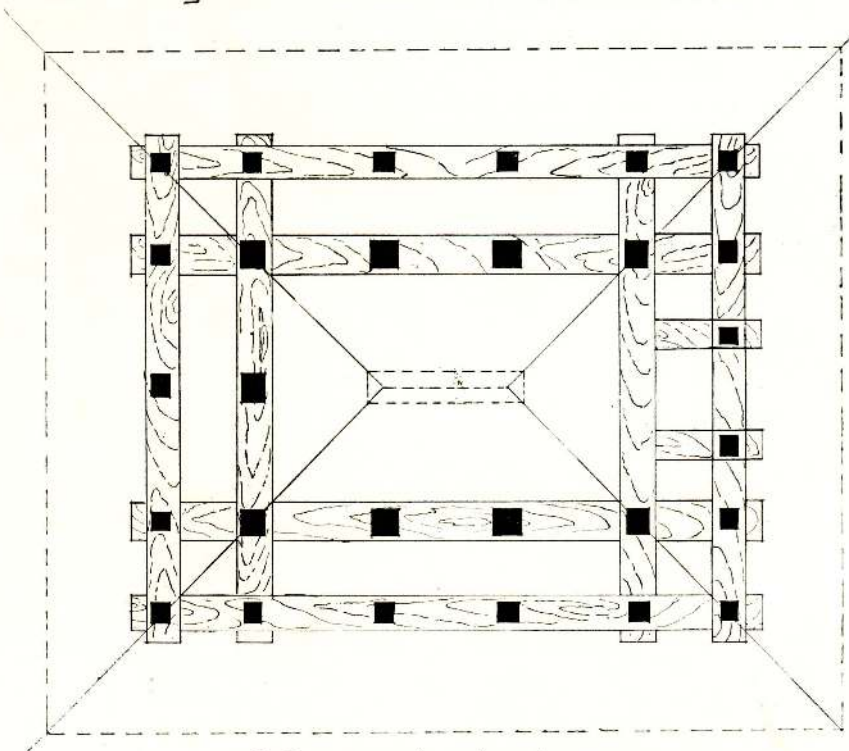
පිනාවිටිය
අවිකල

WAYSIDE
RESTING
PLACE
AT
PANAVITIA

හරස් කැපුමෙහි පෙනෙන හැඩ SECTIONAL ELEVATION

බිම් සැලැස්ම GROUND PLAN

This year the conservation of the ancient *ambalama* at Panavitiya in Mayuravati Korale of Devamadi-hatpattuva in Kurunegala District was taken in hand. The timber of this *ambalama* which may perhaps go back to a time beyond the 18th century were for the most part decayed but enough of it remained to bear testimony to the genius of the Sinhalese wood-carver of that day. The timber of this structure have now been dismantled and the old work is being copied on new timber which will be assembled at the old site—along with as much of the original timber which can be salvaged. No pains have been spared to make the copies as faithful as possible to the originals. Wherever possible the same variety of timber as in the original has been used. Every new piece of timber used carries the date of carving and the carver's name inconspicuously incised on it. (See Plan V).

The conservation work in hand at the *ambalama* at Panāvīṭṭiya is described at page G 31 of this report. Here the decayed portions of the carved wood to be re-used were filled in with plastic wood filling.
