**Administration Report of the Archaeological Commissioner
for the Financial year 1962-63**

August, 1964

C. E. Godakumbura, M. A., Ph. D., D. Lit. (London)

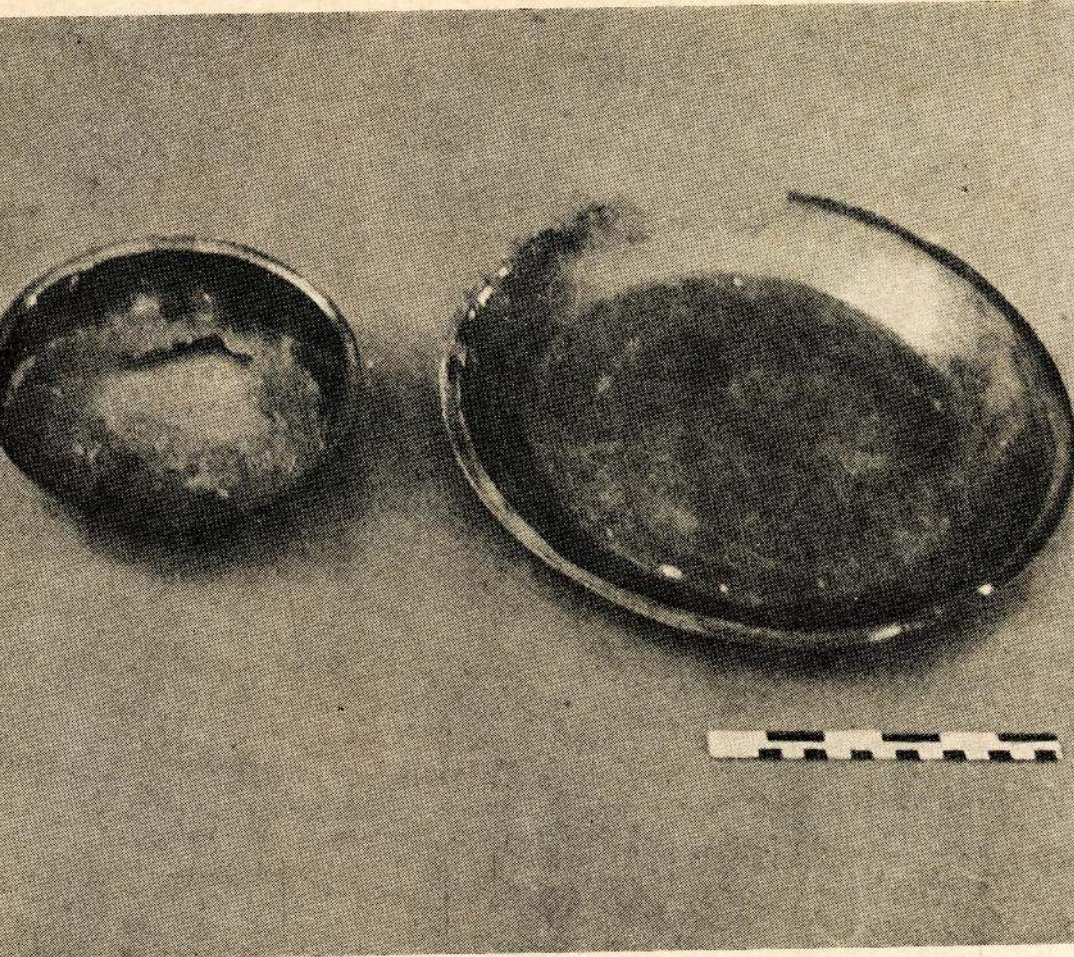
I වන ඡායාරූපය
PLATE I

වැකුඹුර ගමේ හිටිනාවත්තෙන් ලැබුණු ලෝහඩ හාණ්ඩ
BRONZE OBJECTS FROM HITINAWATTA IN VAKUMBURA VILLAGE

Three bronze objects said to have been discovered by one Mr. P. B. Liyanage while digging in a rubber estate called Hitinawatta in the village of Vākuṃbura in Otara Pattuva of Beligal Korale, Kegalla District (map ref. I 23/30). The first of these objects is a tray one foot in diameter. The second is a shallow bowl found inverted on it, diameter 7 inches and depth 2 inches. The third about 4 inches in diameter said to have been found placed on the tray and covered with the bowl is a flat circular object with a small handle of the same material. The disc of this third object is highly polished and is marked on one side with a series of concentric rings in relief with its centre rising to a small peak. These objects have not yet been identified (see plates I and II).

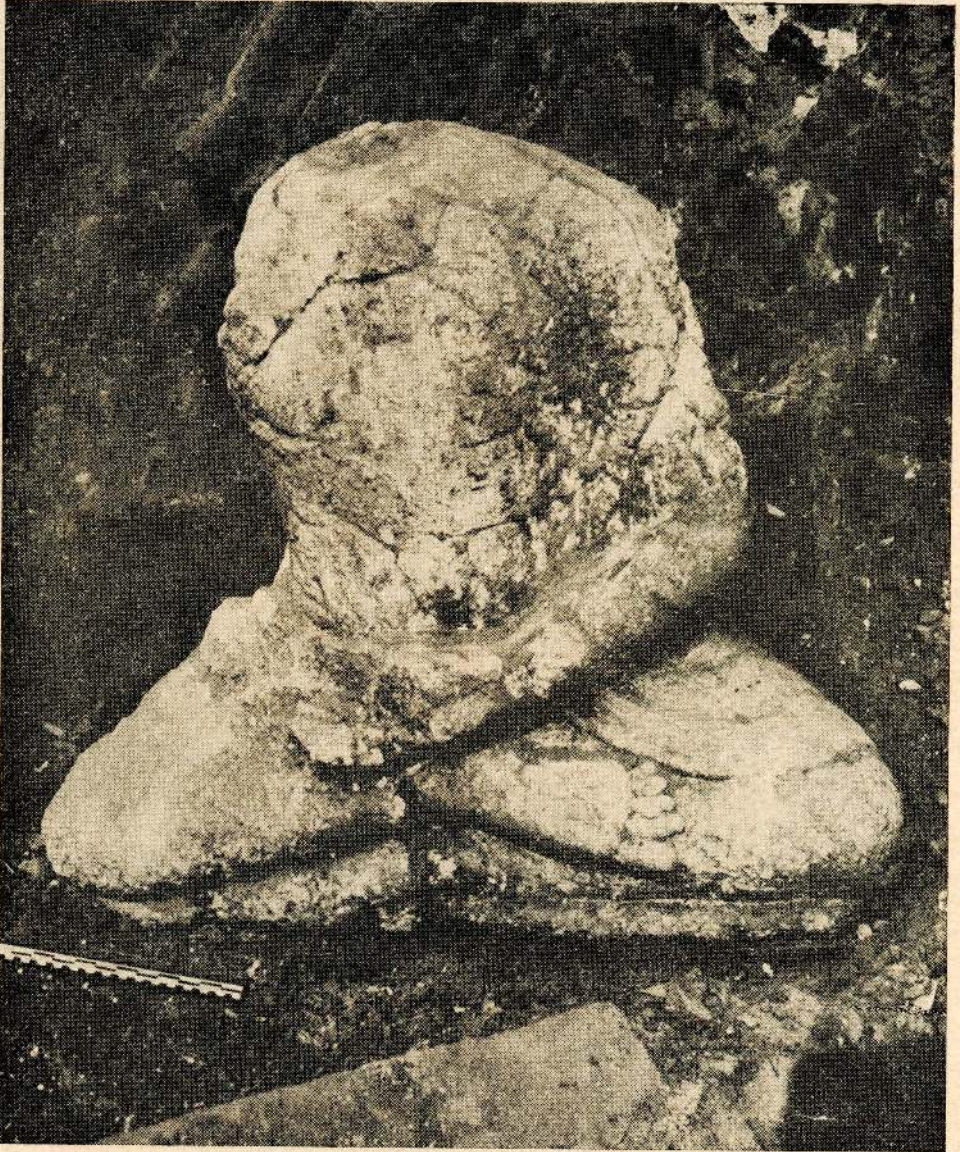
අනුරාධපුර ආසනහර කැණීමෙන් ලත් හිස නැති වැඩහිඳින බුදුපිළිමයක්
HEADLESS SEATED BUDDHA IMAGE FROM ASANAGHARA EXCAVATION, ANURADHAPURA

In the process of exposing the pillars so buried, a seated stone Buddha image minus the head was found at 1 ft. 9 inches below the level of the road (see plate III). A few days later the severed head of this statue was found about 2 feet below the position of the statue (see plate IV). Traces of colour still adhering to the statue indicate that the statue was painted over originally. Most stone statues from Ceylon do not clearly indicate the trend of the robe at the back of the statue, but in this statue the folds of the robe at the back are clearly delineated (see plate V).

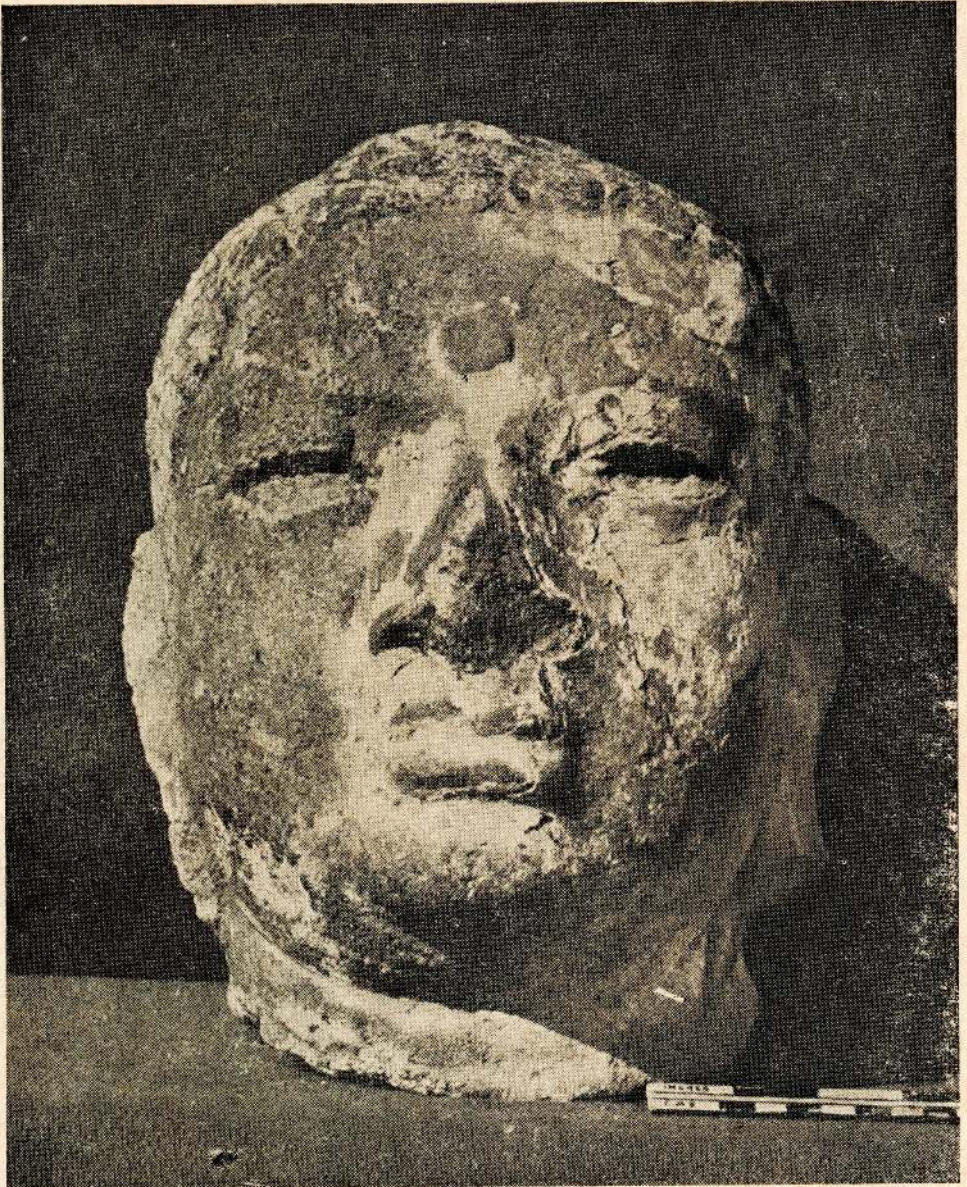
III වන ඡායාරූපයේ පිළිමයෙන් වෙන් වූණු හිස

SEVERED HEAD OF STATUE IN PLATE III

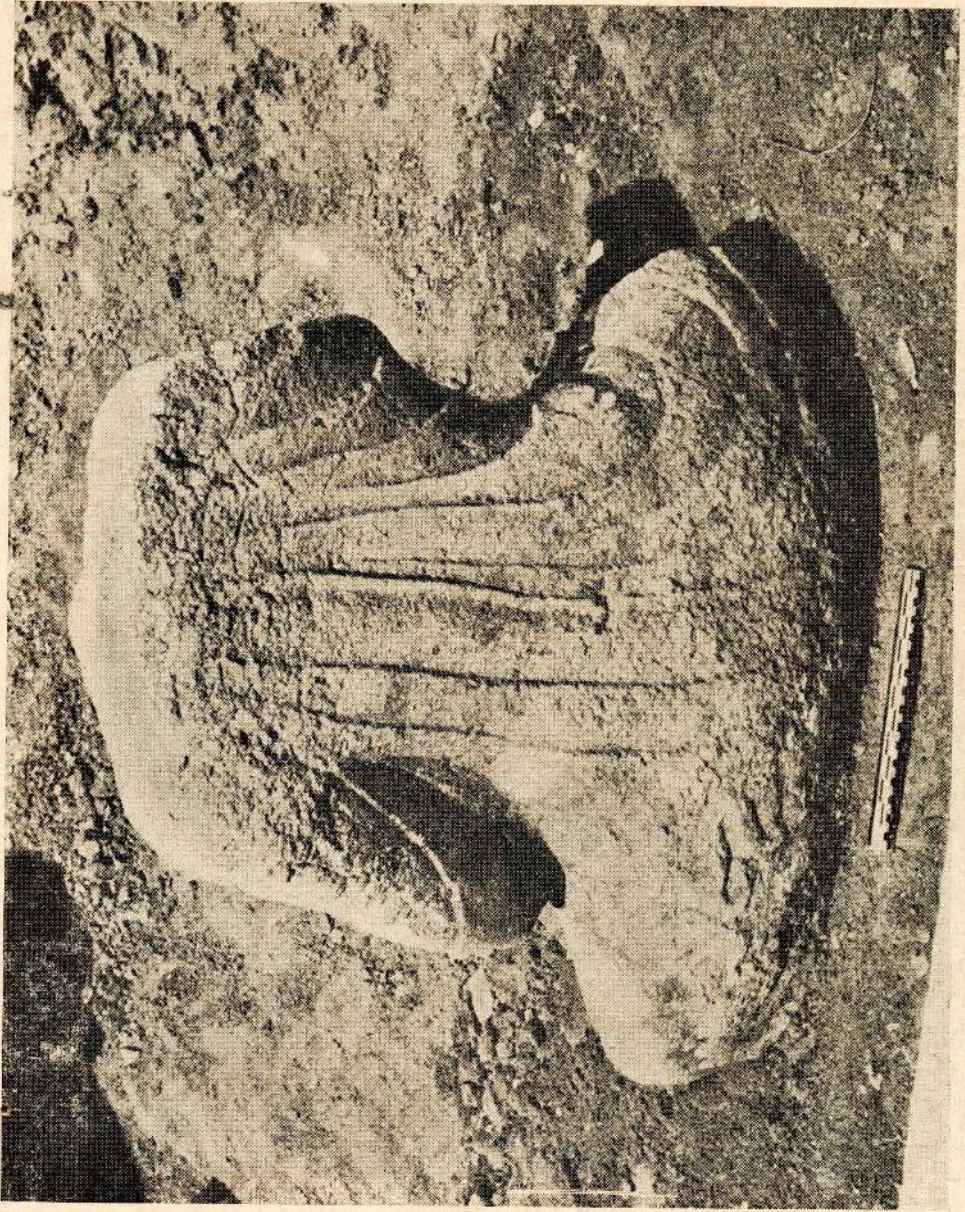
V III ප්‍රකාරයේ ප්‍රතිමාවේ පිටුපස පසුබිම
BACK VIEW OF STATUE IN PLATE III

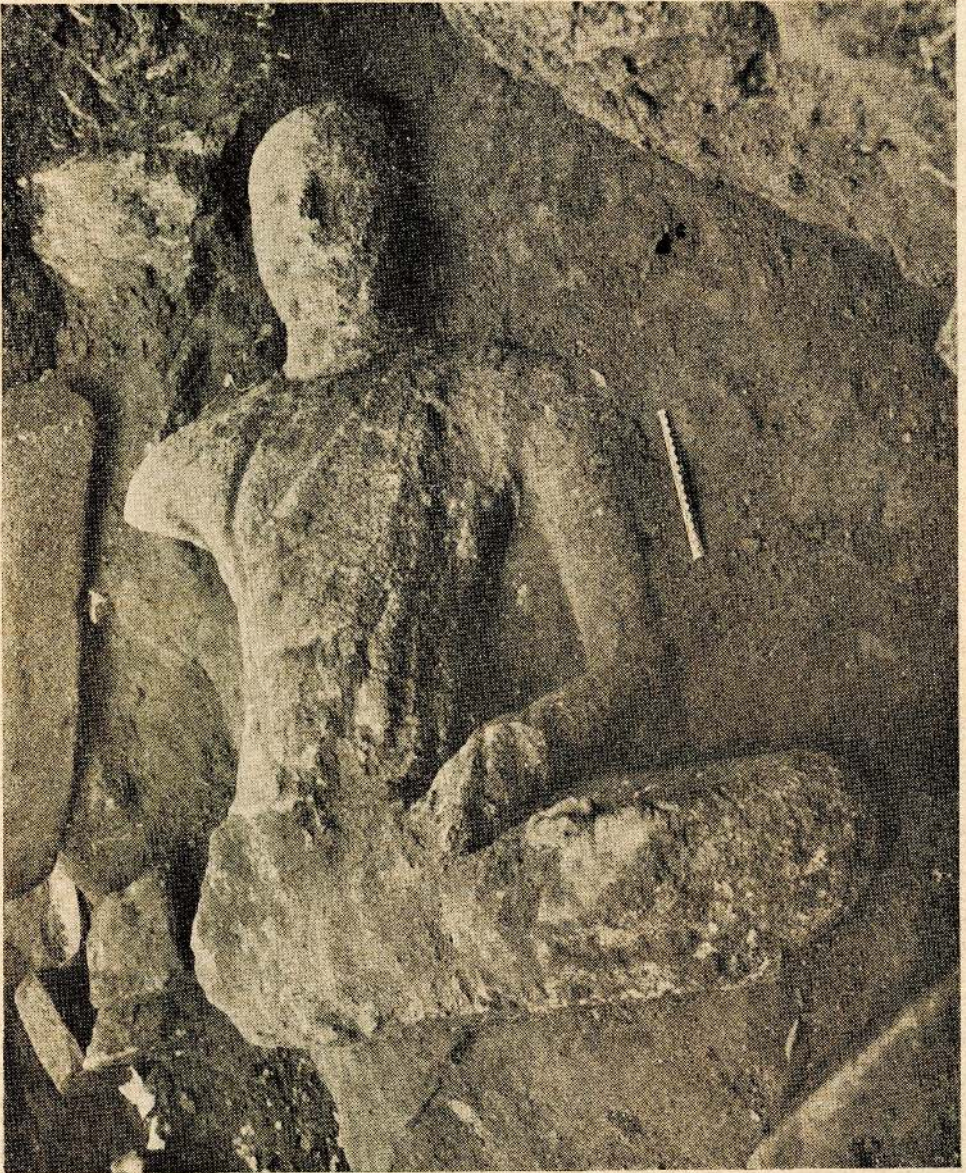
අනුරාධපුර අසනාහර කැණීමෙන් ලත් වැඩිහිඳින බුදු පිළිමයක්
SEATED BUDDHA STATUE FROM ASANAGHARA EXCAVATION, ANURADHAPURA

Another seated Buddha statue was found in line with about the middle of the aforesaid road, at a point 4 feet 6 inches below the road surface (see plate VI). This statue in coarse grained limestone was found in a highly weathered state and broken into several fragments. As is to be expected exposure threatened to hasten

the process of disintegration and the Assistant Commissioner (Chemist) was sent immediately to treat the statue with suitable chemicals. This statue which had fallen face upwards had originally been placed on a brick pedestal. Close to the head of this statue was found an ancient gold ring.

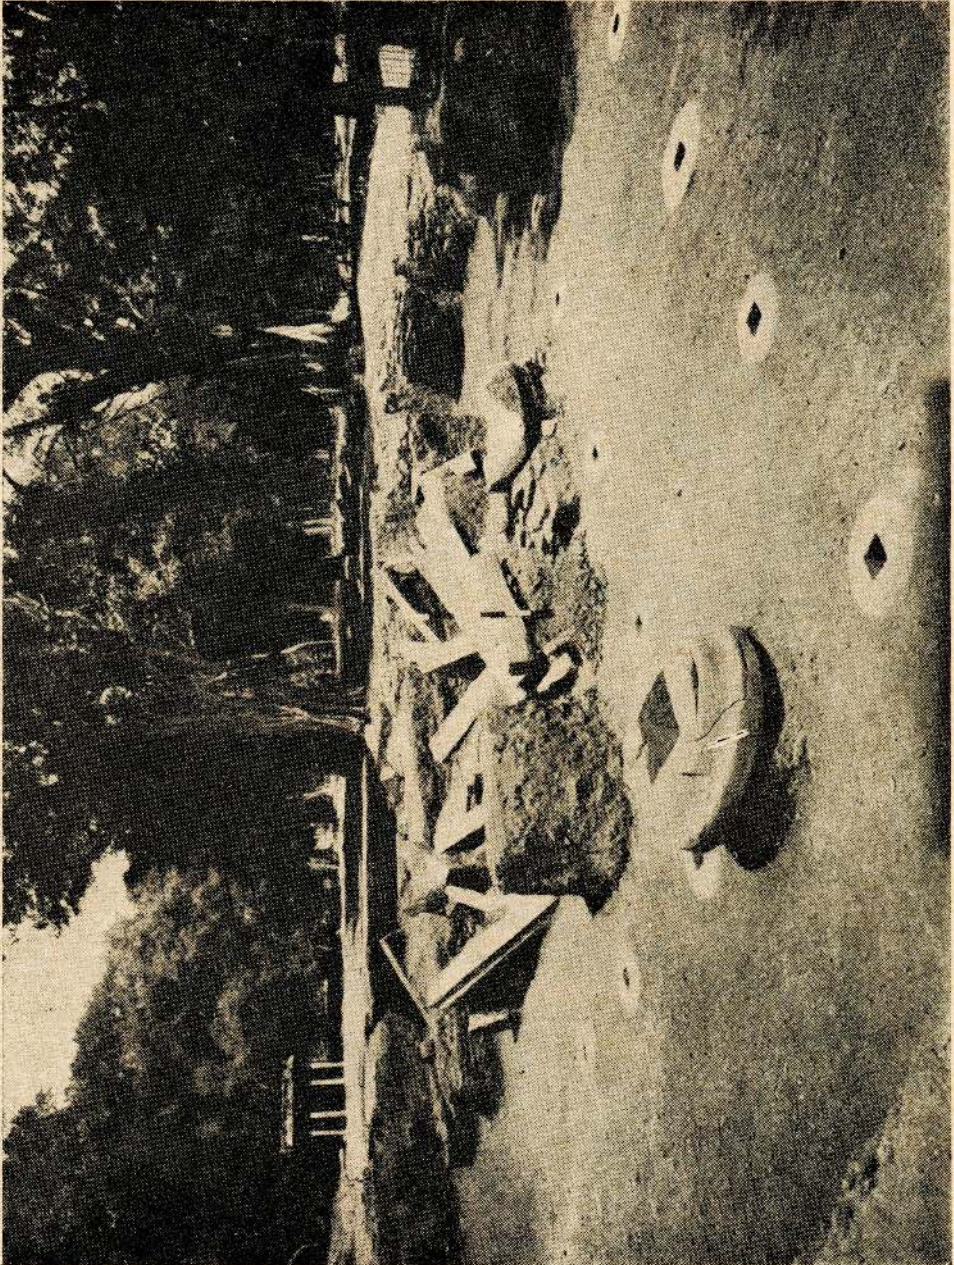
VII లోక కుబేరస్థలం ప్లేట్ VII అక్షరముల అక్షరాల కుబేరస్థలం లోక కుబేరస్థలం లో
SPUR STONES OF PILLARS IN SITU FROM ASANAGHARA EXCAVATION, ANTRADHAPURA

The spur-stones are about 6 feet below present floor level. The *āsana* stone referred to above which was found on the surface even before excavation, in all probability, originally belonged to a lower level, and has been raised up little by little through the centuries.

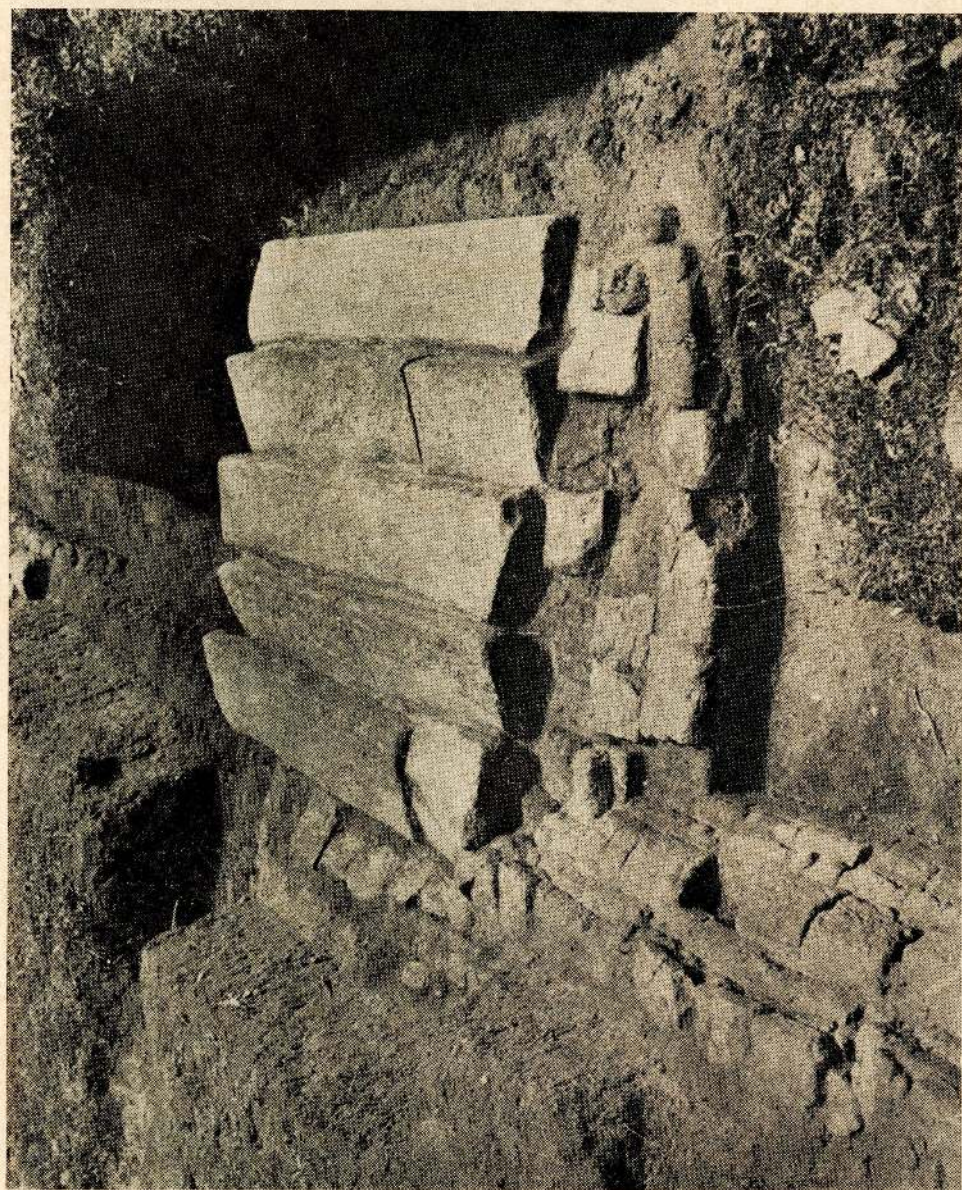
XII ലെ ഘടനാ പ്ലേറ്റ് XII മുതലുള്ളതാണ് ഘടനാ പ്ലേറ്റ് മുതൽ പ്ലേറ്റ്
FLIGHT OF STEPS ON THE WESTERN SIDE, ASANACHARA AT KUDAKATTUVANNAYA

The ancient structure here is a roughly 60 feet 6 inches square terrace raised about 5 feet from the ground level. At about the middle of each of the southern and western (see plate XII) sides of the terrace is a flight of steps. Twenty octagonal pillars set up at regular intervals in a circle on this terrace are, all but one, *in situ*. The other pillar lies fallen at the spot where it once stood. Four of the standing pillars, however, are stumps, their upper parts having broken away. The side of an octagonal pillar is about 6 inches on the average and each whole pillar stands about 8 feet above the ground and carries a mortise hole at its top. The buried portion of each pillar is about 1 foot 6 inches and is square in cross section.

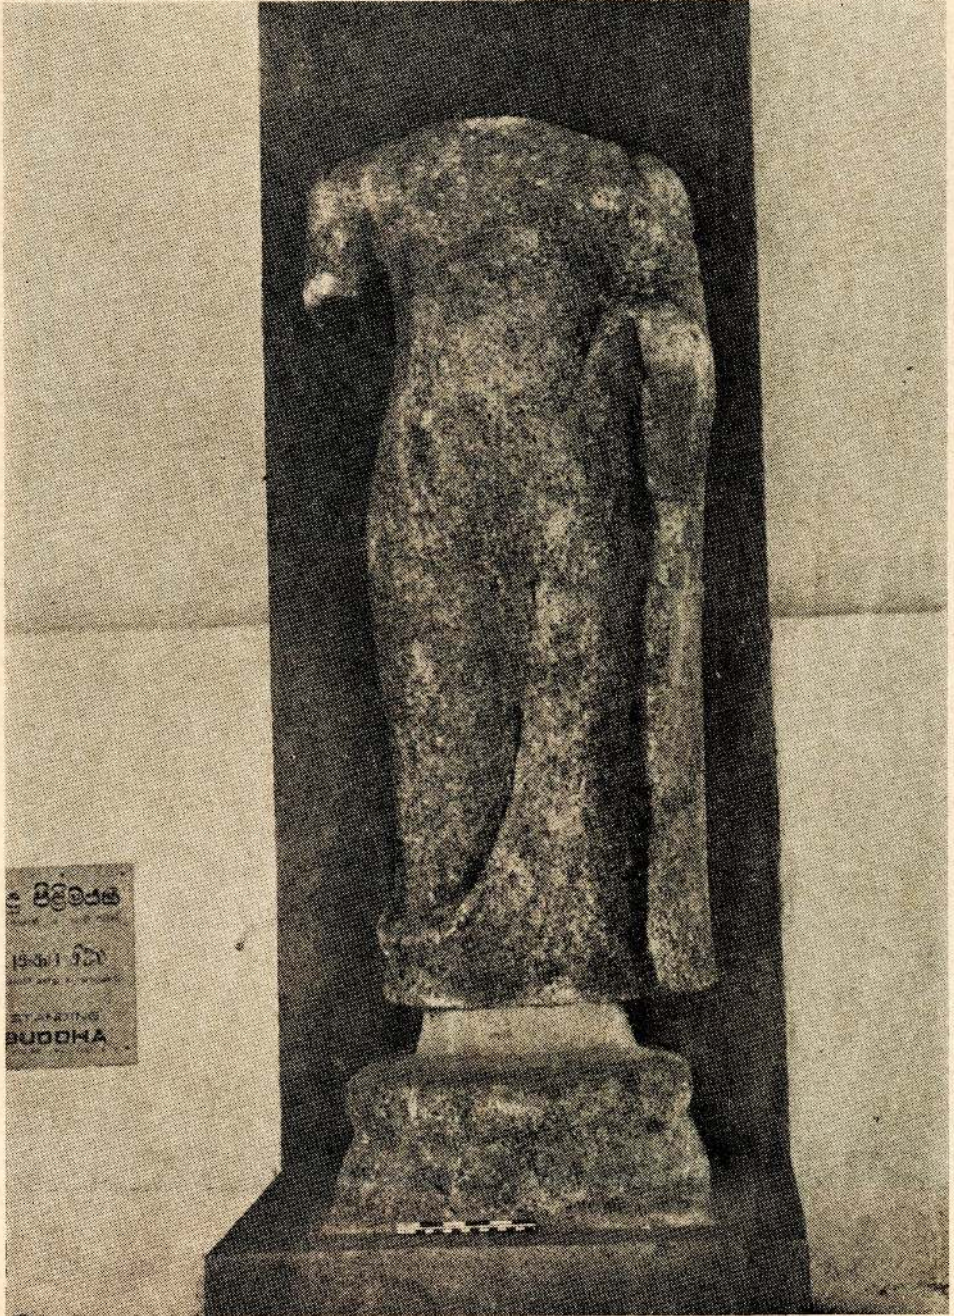
XIII වන ඡායාරූපය
PLATE XIII

කොක්දෑවේ බුදුලන්දෙන් ගෙනා භික්ෂුණි හිටි පිළිමය
TORSO OF STANDING BUDDHA FROM BUDULANDA IN KOK-EBE

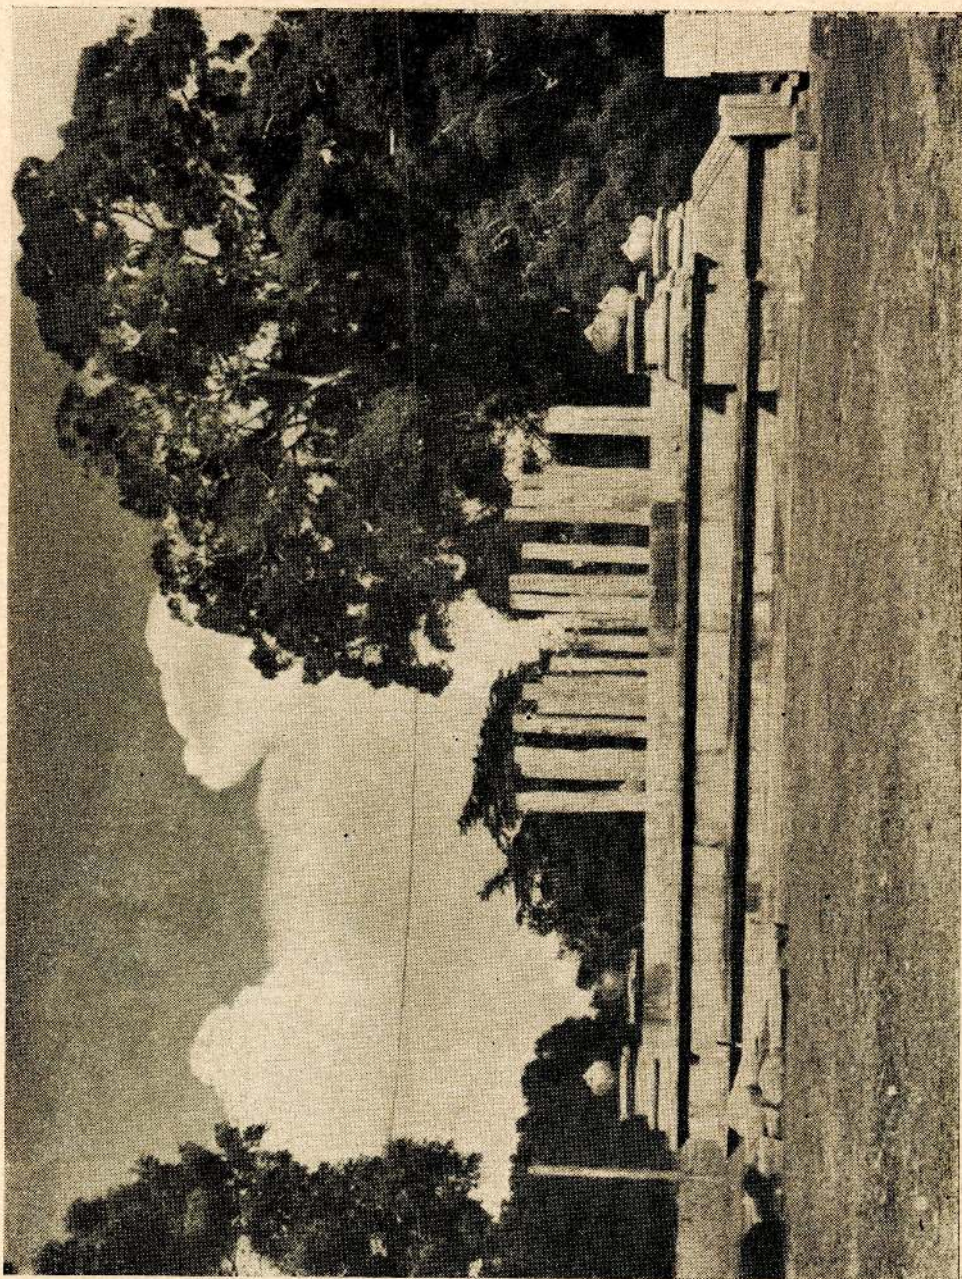
XIV වන ශ්‍රී සෞඛ්‍ය PLATE XIV අනුරාධපුරයේ ආසනිවි දොරටු (කැණි ගෙවුම් කැණවිමේ පසු)
 SOUTH PORCH OF ABHAYAGIRI DAGOBA, ANURADHAPURA, AFTER CONSERVATION

The stones of the stone trough near the south gate of the Abhayagiri dagoba were dismantled and reset levelling the foundation and closing up the gaps at the joints and the cracks in the stones.

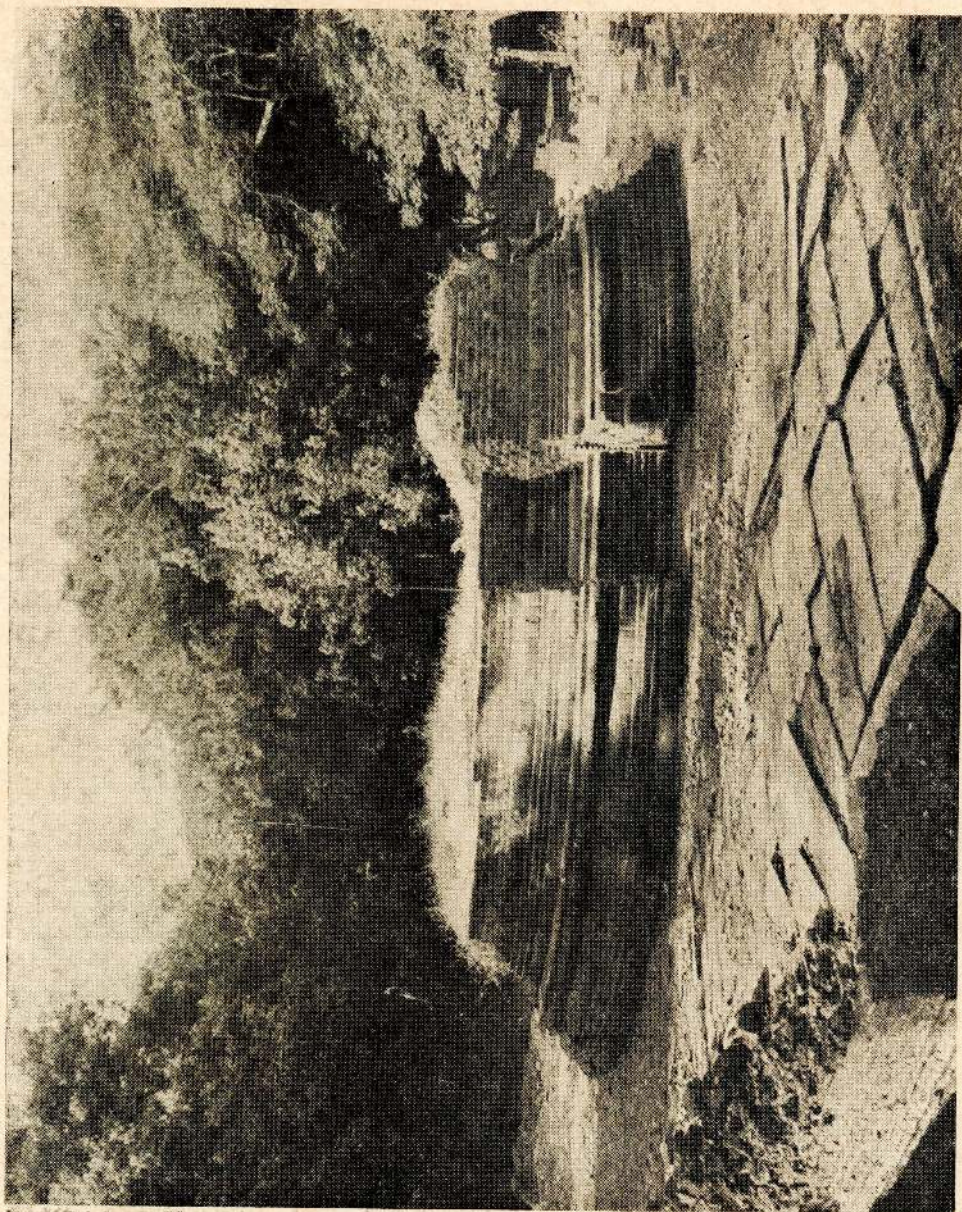
XVI වන ප්‍රාග්ධර්ම ප්ලේට් XVI ප්‍රතිකර්මයෙන් පසුව නැගෙනහිරින් පසු
DAGOBA AT PERIYAKULAM AFTER CONSERVATION

The dagoba constructed on a rectangular platform at Periyakulam was examined preparatory to conservation, and was found to have been constructed enclosing a smaller dagoba built earlier. Conservation work on the dagoba was commenced in July. Brickwork to a height of 8 feet on its 38 foot circumference has already been done. A gap of about 4 feet on the outer dagoba has been provided in order to expose part of the inner dagoba (see plate XVI).

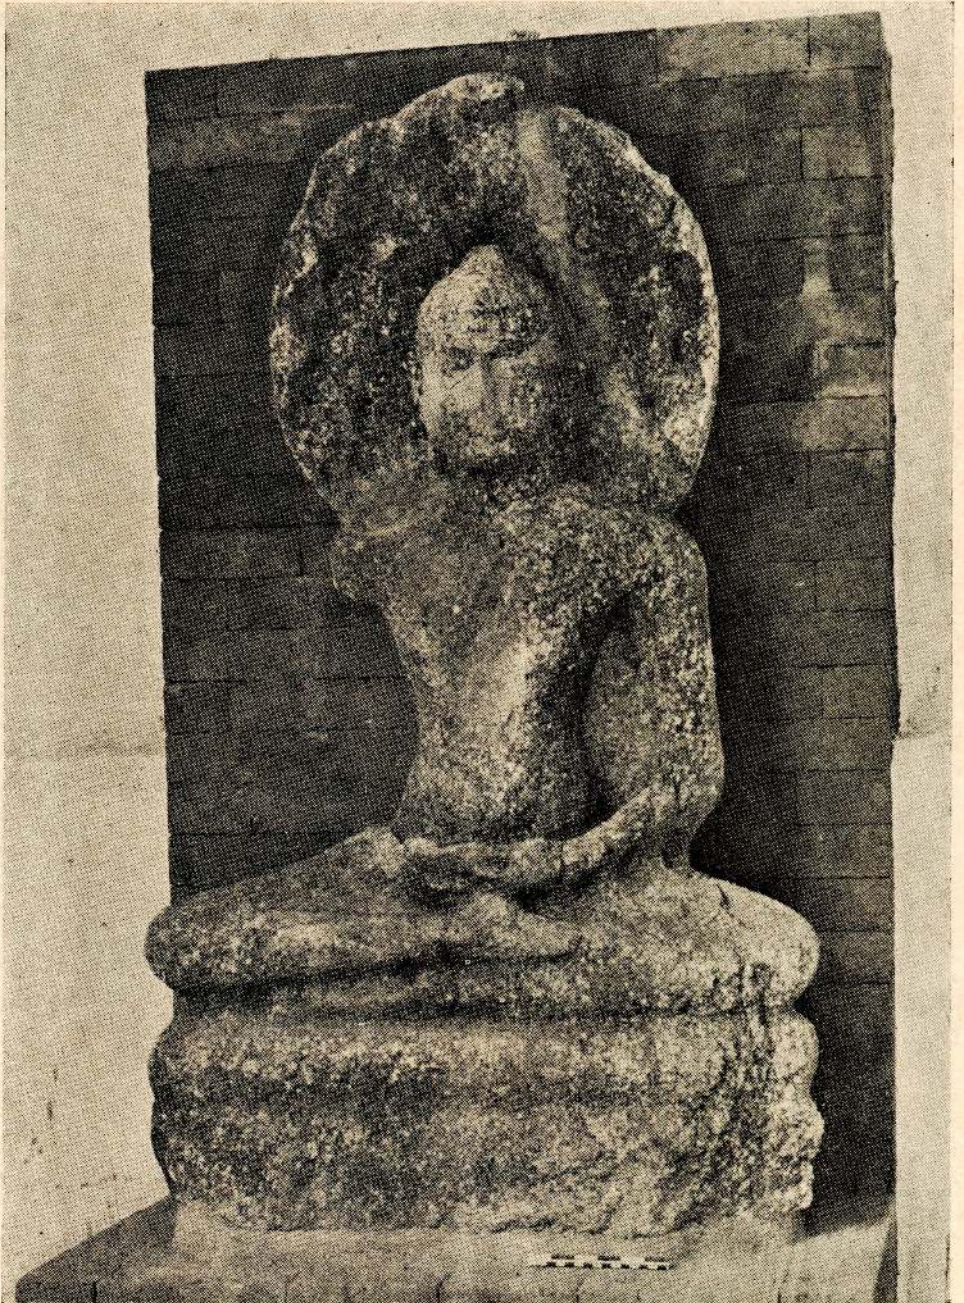
XXI වන ඡායාරූපය
PLATE XXI

කන්තලේ මුක් 13 නෙන් ලැබුණු පිළිමය
STATUE FROM TRACT No. 13, KANTALAI

Newly added to the sculpture gallery is a Buddha figure seated under the hood of a nine headed cobra found from tract No. 13 in Kantalai.
